ALERT SERVICE BULLETIN

SUBJECT: **REVISION "A" TO ALERT SERVICE BULLETIN 206-01-96: (CHIP
DETECTOR ASSEMBLY, TEDECO B3188B**

NO. 206-01-96

SUBJECT: CHIP DETECTOR ASSEMBLY, TEDECO B3188B

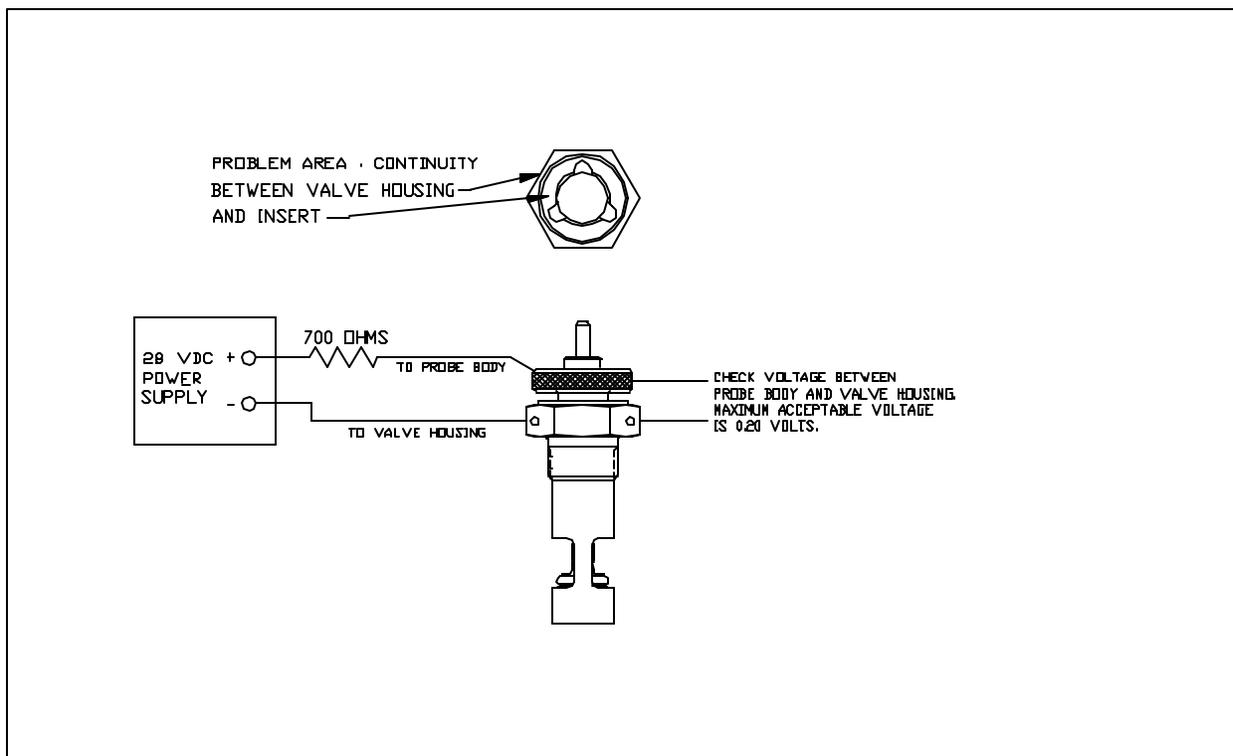
FIGURE 1

1. Connect the chip detector to a 28 Volt DC power supply using a 700 ohm, 2 watt resistor as shown in Figure 1.
2. Measure the voltage between the probe body and the valve body. The voltage drop must be 0.20 volts or less across the unit. If the voltage drop is larger than 0.20 volts, then return the unit to Tedeco (See 3. Part Replacement.)

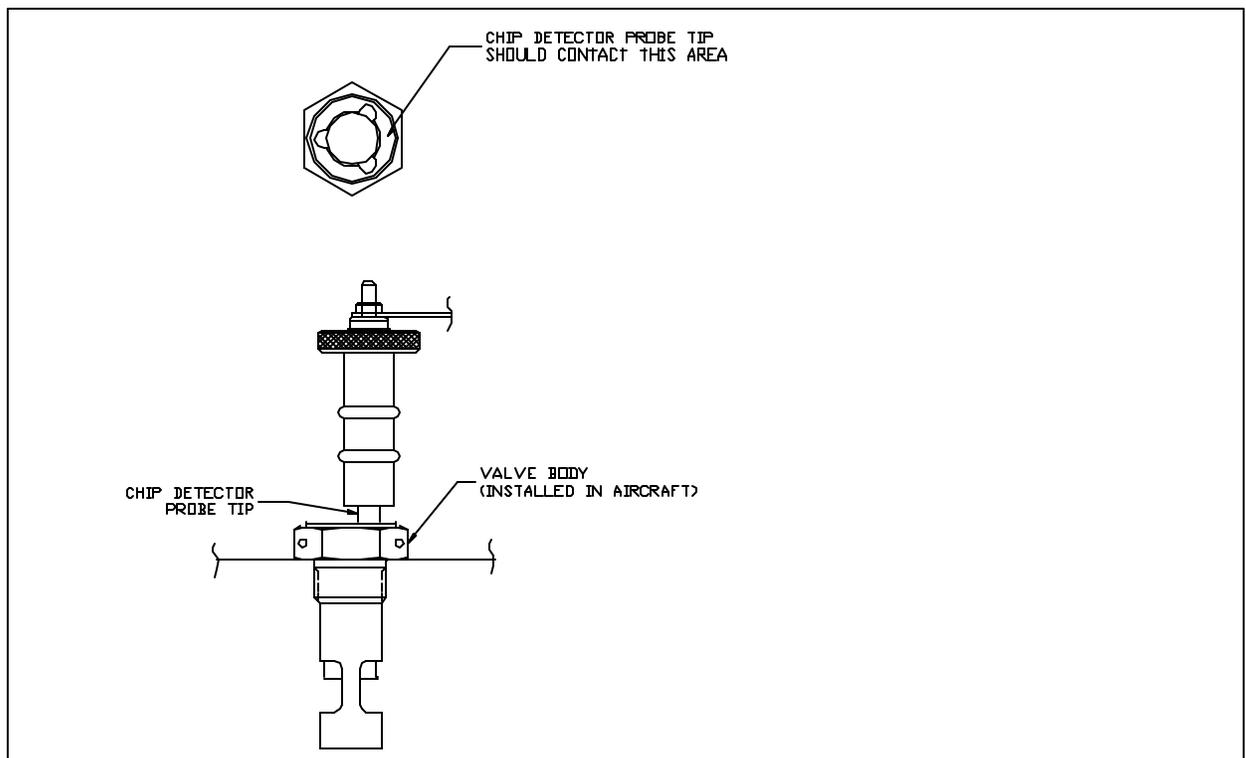
FIGURE 2

1. Ensure that electrical power is supplied to the chip detector.
2. Remove the chip detector probe from the self-closing valve.
3. Hold the tip of the center stud of the chip detector probe firmly against the steel insert as shown in Figure 2 while checking chip indicator light in cockpit. If the cockpit light illuminates, the unit is acceptable. If the light does not illuminate, then proceed to the next step.

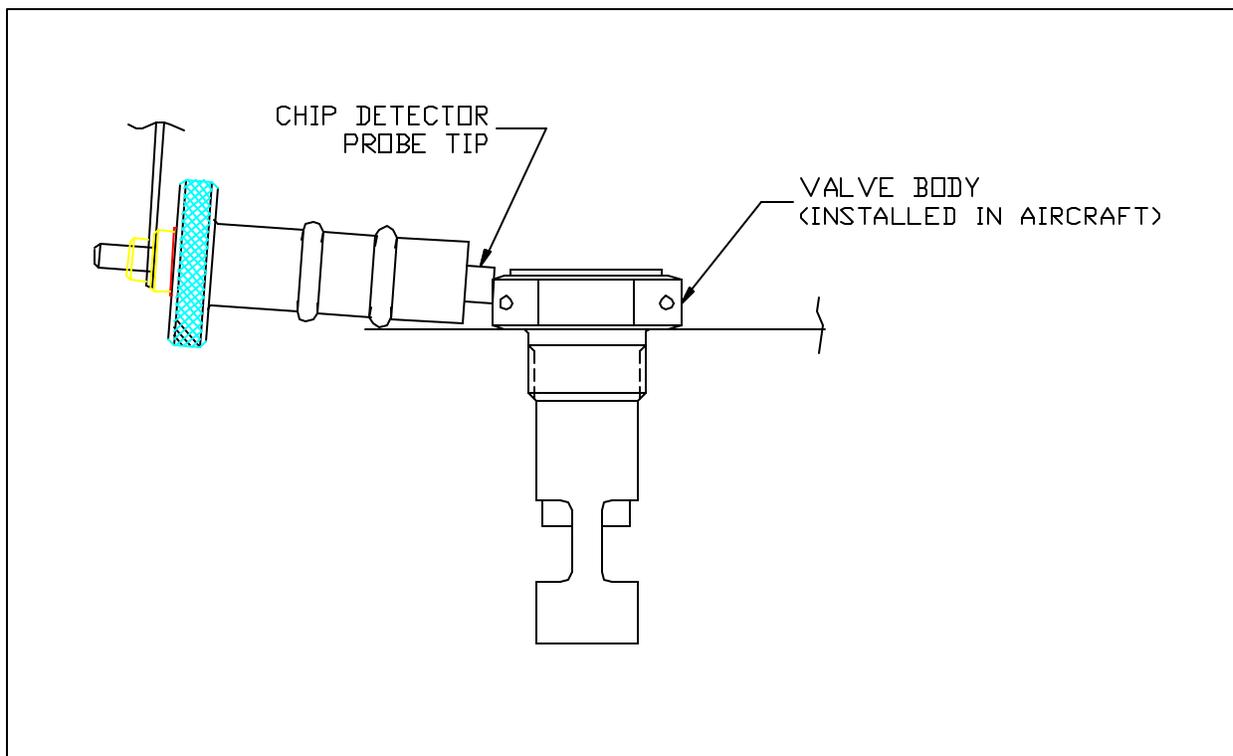
FIGURE 3

4. Hold the tip of the center stud of the chip detector probe firmly against the valve housing as shown in Figure 3 while checking chip indicator light in cockpit. The cockpit light should illuminate. Illumination of the light in this step isolates the electrical discontinuity to the valve insert. Repair the unit per the repair instructions in section 2 of this document.
