ALERT SERVICE BULLETIN

SUBJECT: REVISION "A" TO ALERT SERVICE BULLETIN 206-02-99: (MAIN ROTOR BLADES 206-010-200-ALL INSPECTION AND REWORK OF)

NO. 206-02-99

SUBJECT: MAIN ROTOR BLADES 206-010-200-ALL
INSPECTION AND REWORK OF

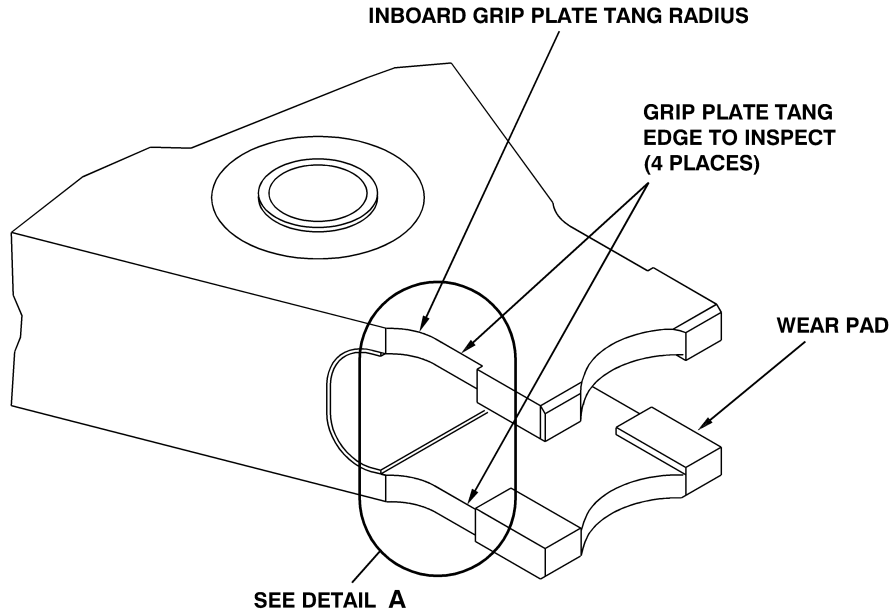
Figure 1. Area to inspect

Bell Helicopter found that some main rotor blades may have tool marks made during manufacturing on the edges of the grip plate tangs. These tool marks if not removed may lead in cracking of the grip plate tang.

- A**
1. Inspect the blade grip plate tangs leading and trailing edges between the wear pads and the inboard radius for presence of tool marks (Figure 1). The surface should be flat, with no waves or notches (Figure 1, DETAIL A).
 2. If a damage or an irregularity on the surface as shown on the Figure 1 is found, do PART II of this Alert Service Bulletin.
 3. If no damage or irregularity on the surface as shown on the Figure 1 is found, the blade is serviceable.
 4. Using a vibrating stylus, mark ASB 206-02-99 on the blade Modification Plate to indicate that this Alert Service Bulletin has been accomplished.
 5. Make an entry in the Helicopter and the Component Historical Records to show that this Alert Service Bulletin is completed.

AREA TO INSPECT

3. Measure the depth of the damage.
4. If the depth of the damage exceed 0.050 inch (1.27 mm) remove the blade from service.
5. Send the defective blade to Bell Helicopter Customer Property Return with a Malfunction Report attached with the ASB number in reference.
6. If the depth of the damage is at 0.050 inch (1.27 mm) or less do PART III of this Alert Service Bulletin.

1. Using a single cut general purpose half round file No 2 or 3 (smooth cut) blend smooth the damages in a ratio of 10 to 1. As an example, if the damage is 0.040 inch (1.5424 mm) deep, blend 0.400 inch (15.24 mm) on each side of the damage. The maximum depth after rework is 0.050 inch (1.27 mm).
2. After blending with the file, polish the surface with 180-220 grit Aluminum Oxide Fabric Cloth to obtain a finish of 63 RMS.
