SUBJECT: **REVISION "C" TO ALERT SERVICE BULLETIN 206-04-100 (TAIL ROTOR BLADES 206-016-201-133 / -131, CHECK/INSPECTION OF).**

NO. 206-04-100

SUBJECT: TAIL ROTOR BLADES 206-016-201-133 / -131,
CHECK/INSPECTION OF

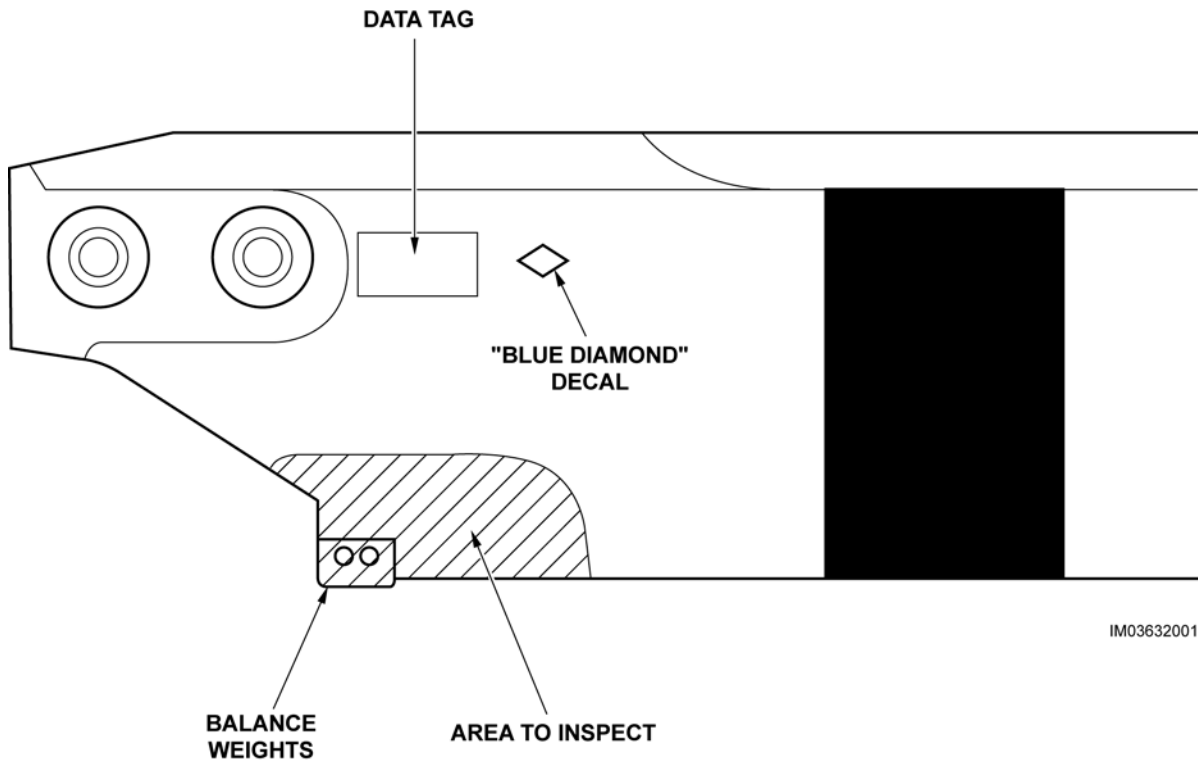
Figure 1. Tail rotor blade inspection.

Bell Helicopter has received three reports of skin crack in the area of the trailing edge balance weight. OSN 206-03-38 published in January 2003 emphasized the requirement to pay particular attention for cracks in the chordwise weights area of the tail rotor blade during daily checks and scheduled inspection.

1. Use detergent (C-318) and thoroughly clean the area to be inspected on both sides of the blade. Refer to Figure 1.
2. Inspect both sides of the blade at the area indicated on the Figure 1 as follows:
 - a. Visually inspect the skin for deformation.

- b. With a 10 X power magnifying glass inspect the skin for cracks.
 - c. If skin deformation or cracks are found remove the blade from service.
 - d. Inspect the weights for bends or deformation.
 - e. If the weights are bent or deformed, remove the blade from service.
3. If no damage is found, the blade is serviceable.
 4. Make log book entries to show that the PART I b. of this Alert Service Bulletin has been accomplished.

4. In order to provide a quick visual reference and identify the blades affected by this ASB, apply the "blue diamond" decal provided with this ASB on both sides of the blade at the location indicated on the Figure 1. To prolong the life of the decal, apply Edge sealer on the decal. Replace missing or damaged decal as required.
