**ALERT SERVICE BULLETIN**  
**Bell Helicopter** **TEXTRON**

NO. 206-04-101

**MODEL AFFECTED:** 206A/B-SERIES

**SUBJECT:** TAIL ROTOR BLADE 206-016-201-131, CHECK AND REMOVAL FROM SERVICE OF.

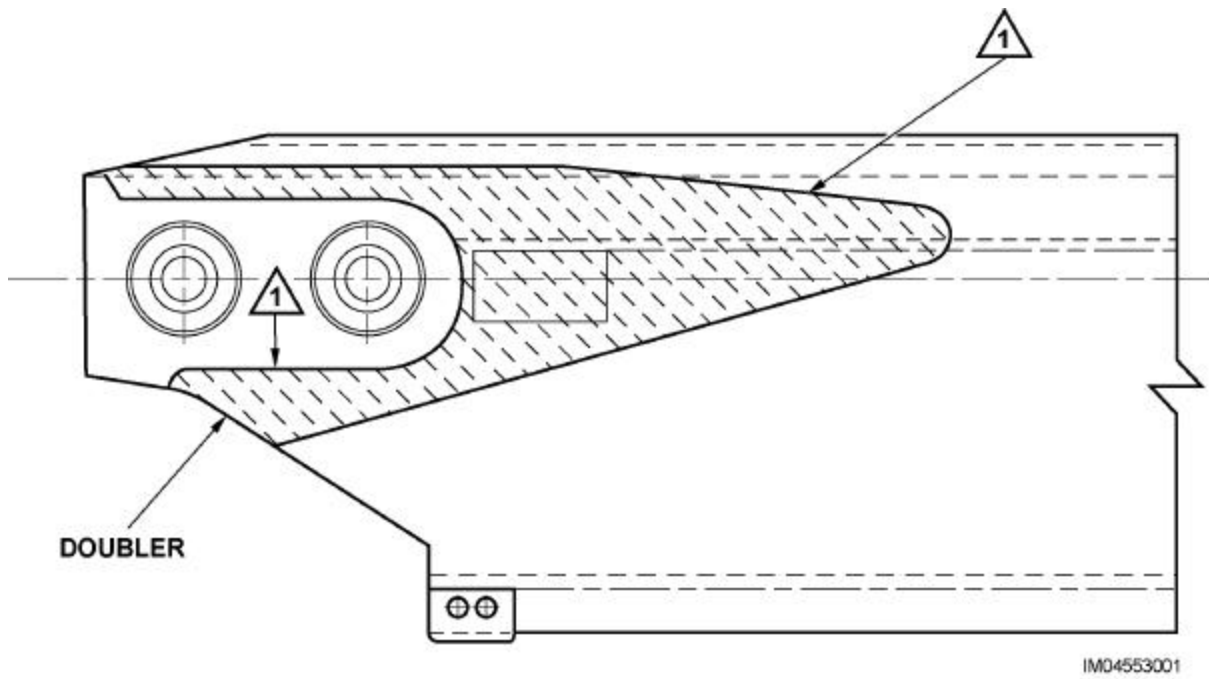
Bell Helicopter has received two reports of de-bonding of the blade root doubler. In both cases this situation was noticed as part of the pre-flight inspection on the affected helicopters. Investigation revealed that inadequate surface preparation on a limited number of blades resulted in poor adherence of the doublers.

Inspect the doubler for edge void or evidence of de-bonding on both sides of the blade.

Figure 1. Inspect the doubler for edge void on both sides of the blade

1. Use detergent (C-318) and thoroughly clean the area to be checked on both sides of the blade. Refer to figure 1.
2. Check both sides of the blade at the area indicated on figure 1 as follows:
  - a. Visually inspect the doubler for edge void on both sides of the blade.
  - b. If void or de-bonding is found, remove the blade from service immediately.
3. If no void or de-bonding is found, the blade is serviceable continue Part I until Part II is completed.
4. Make log book entries to show that the PART I of this Alert Service Bulletin has been accomplished.

1. Remove and replace affected tail rotor blade. (Refer to the BHT 206A/B-SERIES-MM)
2. Make log book entries to show that the PART II of this Alert Service Bulletin has been accomplished.
