**ALERT SERVICE BULLETIN**

**NO.** 430-00-17

**MODEL AFFECTED:** Model 430

**SUBJECT:** HYDRAULIC ACTUATOR SUPPORT P/N 222-040-125-001, INSPECTION OF

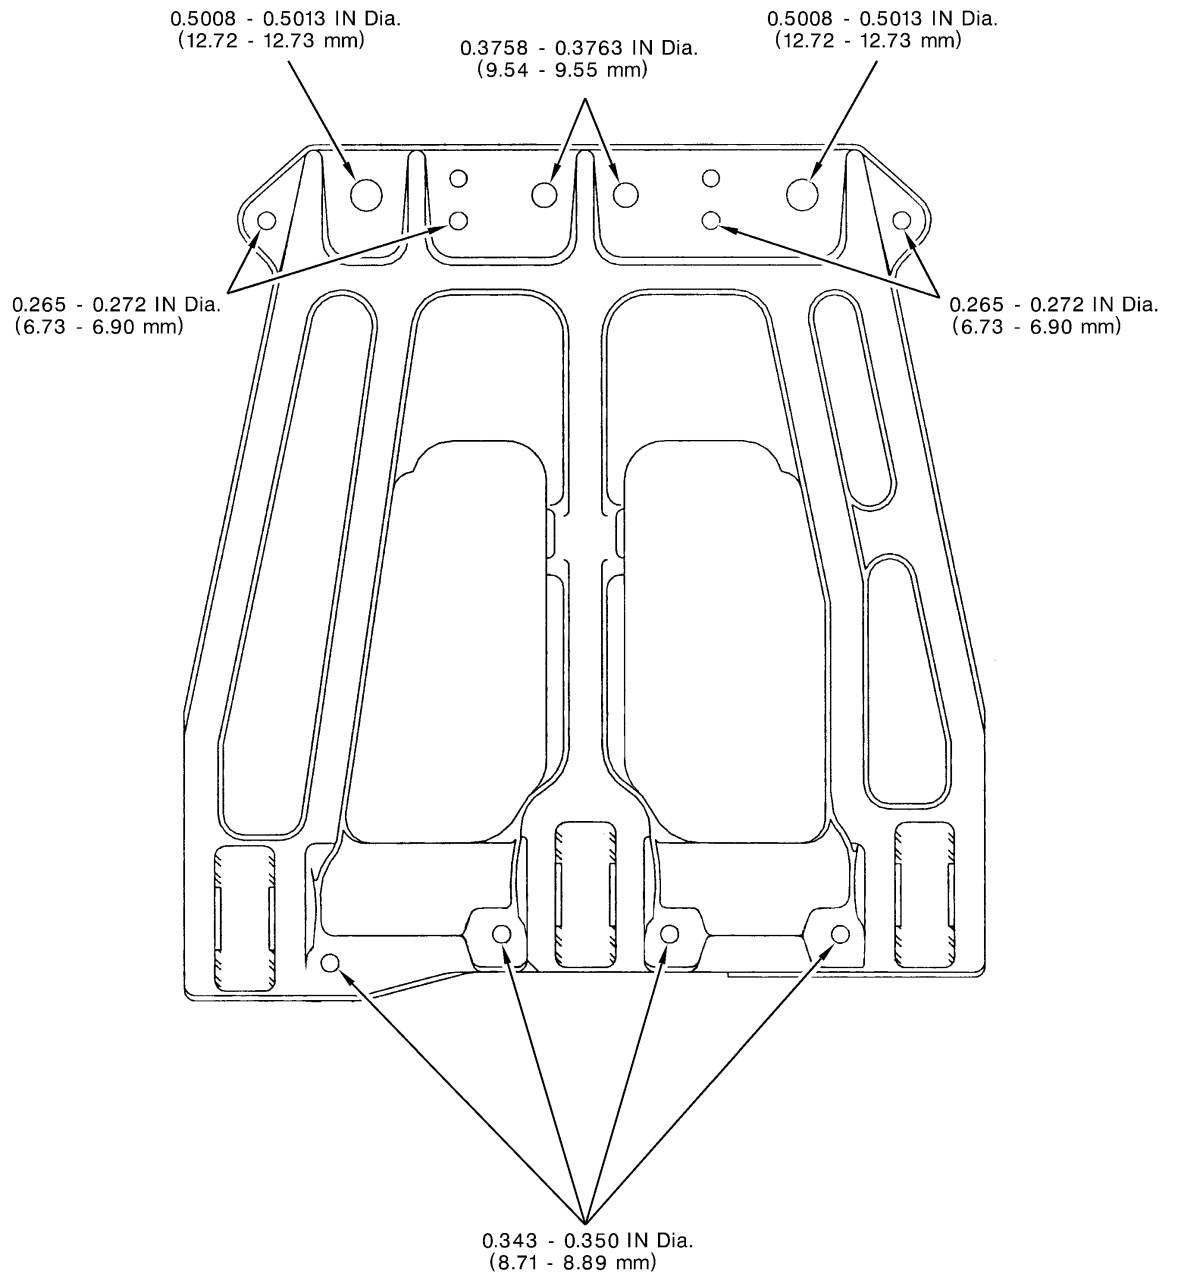
**Hydraulic Actuator Support Assembly**  
**P/N 222-040-125-001**  
**Figure 1**

4. If two or more of the nuts within the upper row of the support attaching nuts move below 40 in.lb torque or two or more of the nuts within the lower row of the support attaching nuts move below 90 in.lb torque, remove the hydraulic actuators support from the transmission for further inspection and repair. Refer to BHT-430-MM-6, Chapter 63 and BHT-430-CR&O-2, Chapter 63 for removal instructions. Discard nuts and washers.
5. If required, inspect the support P/N 222-040-125-001 in accordance with instructions in BHT-430-CR&O-2, Chapter 63. The holes at the lower and upper end of the support were manufactured to the dimensions shown in Figure 1.

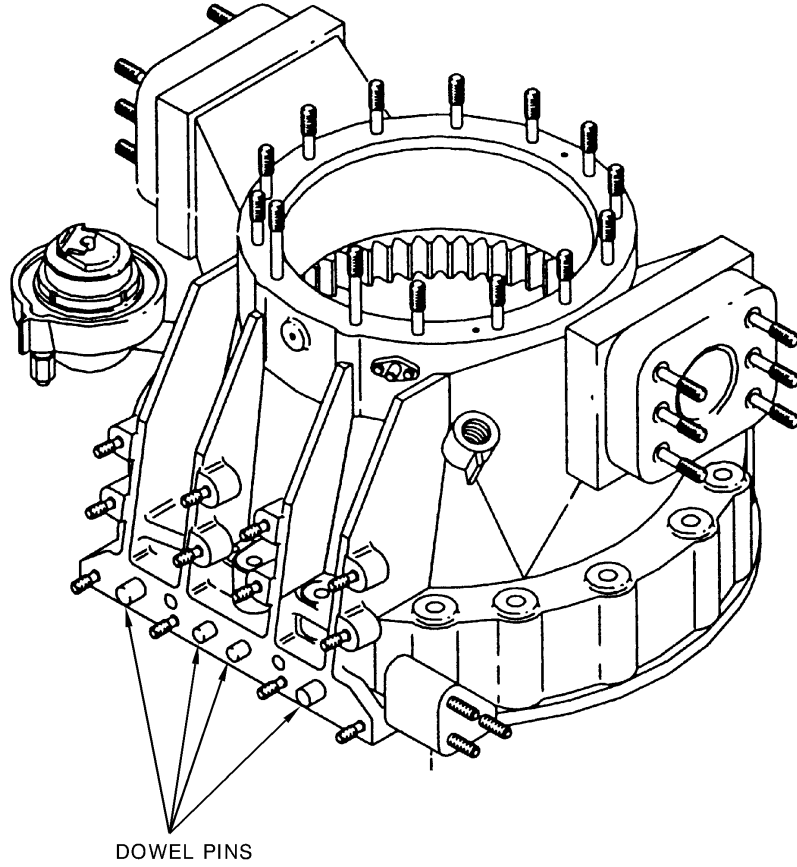
**Transmission Top Case Assembly**  
**P/N 430-040-061-101**  
**Figure 2**

- c) Inspect the dowel pins in transmission case for damage, fretting, corrosion and looseness. The large outboard pins should measure 0.500 inch minimum and protrude 0.55 inch from the surface of the case. The small inboard pins should measure 0.375 inch minimum and protrude 0.45 inch from the surface of the case. Refer to Figure 2
