ALERT SERVICE BULLETIN

NO. 430-01-21

MODEL AFFECTED: 430

**SUBJECT: UPPER FUEL ENCLOSURE, RIGHT SIDE,
ADDITION OF DRAIN PROVISION**

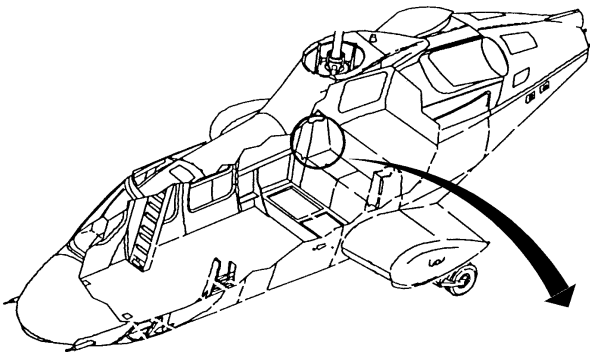
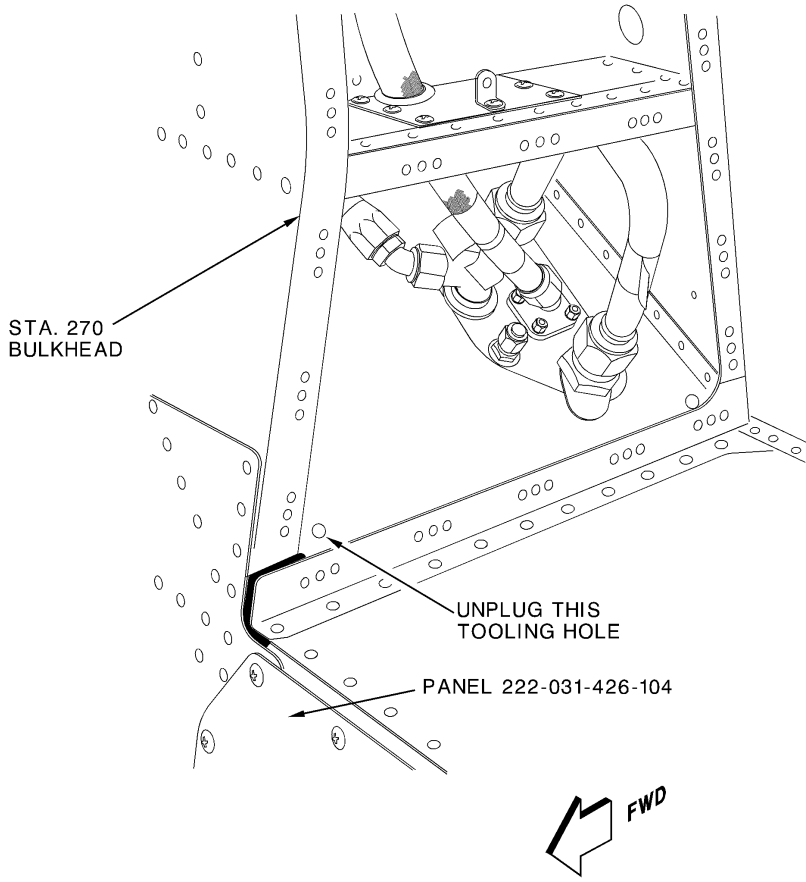
FIGURE 1

Bell Helicopter Textron has determined that a condition exists that could result in an accumulation of fuel or water in the right hand upper fuel enclosure area located at approximate STA 268.03 to STA 281.87 and W.L. 53.50.

Tooling hole is located at approximate STA 271.00, B.L. 22.25, W.L. 54.00 in panel assembly P/N 222-031-470-103

This bulletin provides the procedures to remove the sealant from the existing forward tooling hole located in panel assembly P/N 222-031-470-103 to provide enclosure drainage provision.

5. Locate forward tooling hole in panel assembly P/N 222-031-470-103 and unplug hole using a plastic scrapper and a pin punch or a similar object. Refer to Figure 1.
6. Reposition fuel cell upper right hand side in airframe cavity.
7. Install access panel P/N 222-031-426-104 with sealant MIL-S-8784CLB2. Refer to BHT-430-MM-5, chapter 53.
8. Install the seat cushions and seat backs on the rear passenger seats. Refer to BHT-430-MM-3, chapter 25.
9. Annotate helicopter records to reflect compliance with this bulletin.
