ALERT SERVICE BULLETIN

NO. 430-02-26

MODEL AFFECTED: 430

SUBJECT: WHEEL GEAR HYDRAULIC TUBE ASSEMBLY
P/N 430-080-459-101 AND WHEEL BRAKE
HYDRAULIC TUBE ASSEMBLY 430-080-460-101
AND 430-080-467-101 REPLACEMENT OF

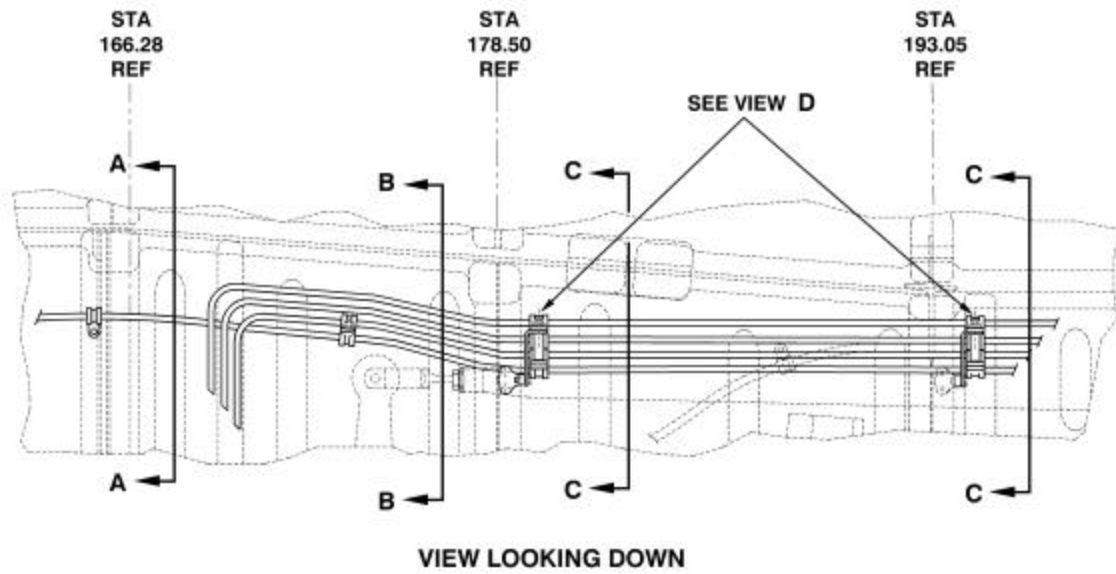
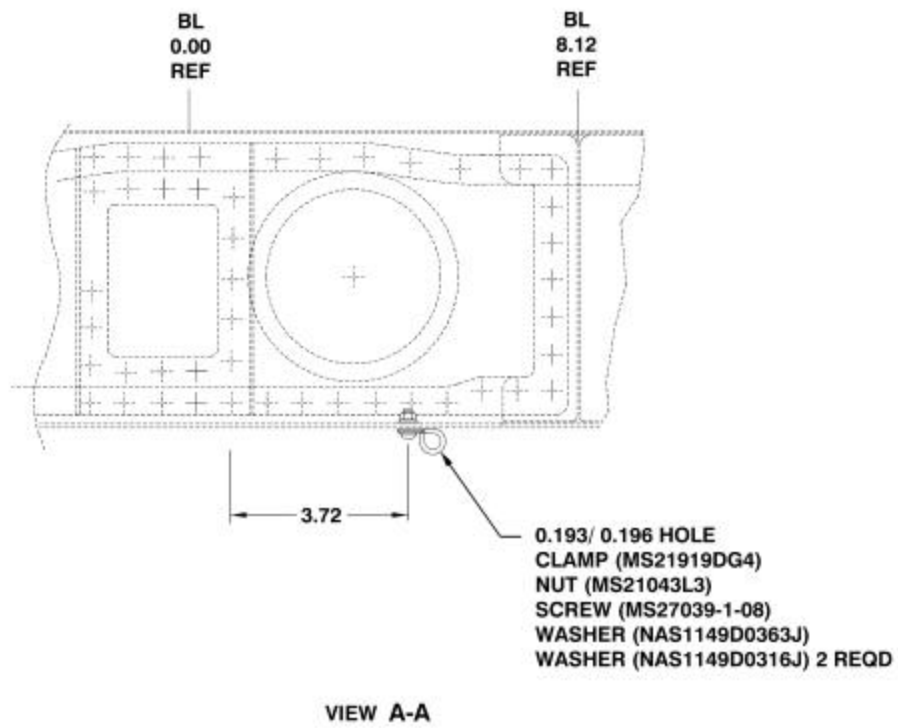
Figure 1
Cargo hook release cable clamping modifications

In addition if the cargo hook kit P/N 430-706-905-101 or -105 is installed the mechanical release cable P/N 222-320-925-103 will require additional clamping with the new tubes.

10. If cargo hook kit P/N 430-706-905-101 or -105 is installed you will need to modify the clamping for the cargo hook release cable P/N 222-320-925-103 as per figure 1 and 2.
