ALERT SERVICE BULLETIN

NO. 430-99-12

MODEL AFFECTED: 430

SUBJECT: TAIL ROTOR PITCH CHANGE BEARINGS P/N 222-312-753-103, INSPECTION OF; AND TAIL ROTOR BLADE ATTACHING HARDWARE, REPLACEMENT OF

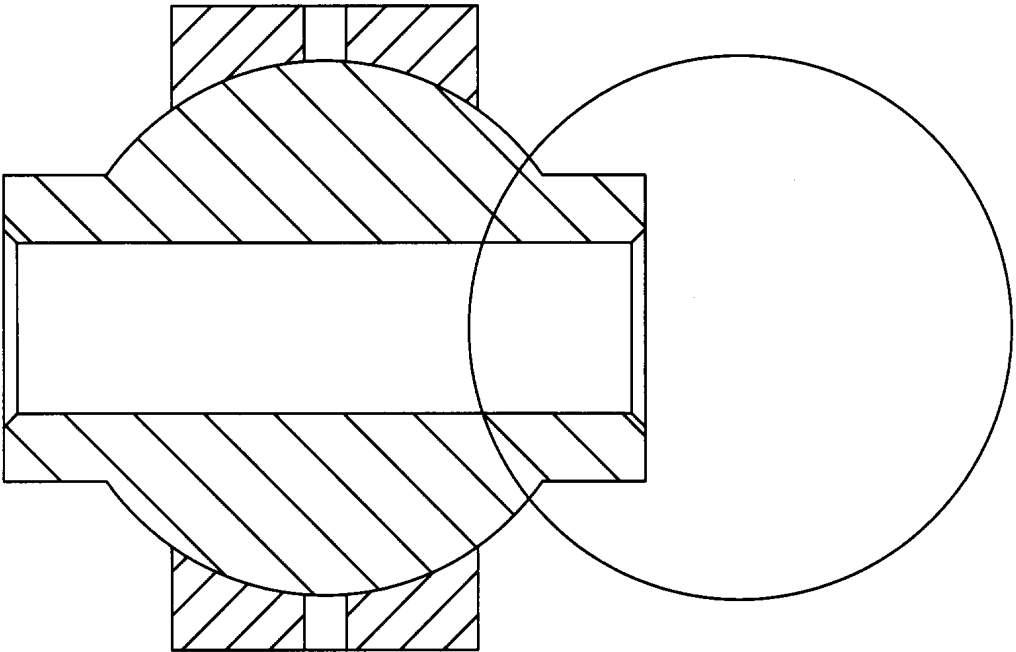
FIGURE 1

Bell Helicopter has received reports of cracked bearings, P/N 222-312-753-103, installed in tail rotor blade assemblies. Investigation revealed that the cracks in the pitch change bearings were the result of stress corrosion cracking caused by loss of torque of the tail rotor blade attaching bolts/nuts.

INSPECT THIS AREA
BOTH ENDS OF BEARING

BEARING
222-312-753-103

3. Visually inspect each bearing inner member neck area (full 360 degrees) for cracks. Refer to figure 1. If crack(s) are found in a bearing, the replacement of both bearings in that blade are required. Refer to BHT-430-CR&O-3.
