ALERT SERVICE BULLETIN
Bell Helicopter **TEXTRON**

NO. 206-05-105

MODEL AFFECTED: 206A/B-SERIES and TH-67

SUBJECT: TAIL ROTOR TRUNNION HOUSING SEAL 535642
INSTALLATION, ONE-TIME INSPECTION OF

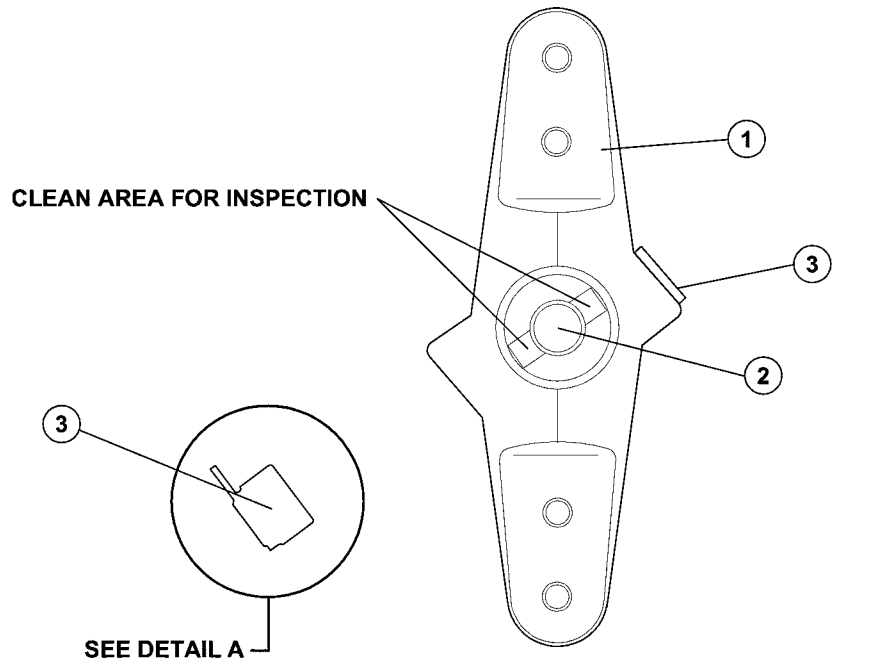
Figure 1. Correct orientation of seal in housing assembly

Bell Helicopter found that some 206-011-814-113 tail rotor trunnion housing assemblies sold as spares may have been assembled with the 26001-7027 seal installed backward. Incorrect installation of the seal will prevent the bearing from getting adequate lubrication and may result in the seal being pushed out of the housing assembly during lubrication.

Lip of seal facing toward the tail rotor gearbox output shaft.
Correct installation shown.

1. Inspect new housing assembly (3, Figure 1) not installed in a hub assembly (1) for correct seal (5) installation. If the housing assembly (3) is found with the seal (5) incorrectly installed, return the defective housing assembly (3) to Bell Helicopter and order a new housing assembly (3).
2. Inspect new housing assembly (3) installed in tail rotor hub assembly (1) for correct seal (5) installation. If the housing assembly (3) is found with the seal (5) incorrectly installed, perform PART III a. of this Alert Service Bulletin.
3. Inspect housing assembly (3) installed in a hub assembly (1) with time in service for correct seal (5) installation. If the housing assembly (3) is found with the seal (5) incorrectly installed, perform PART III b. of this Alert Service Bulletin.

1. Replace the housing assembly (3) if the seal is found to be reversed. Refer to the BHT-206B3-CR&O or to the BHT-206A/B-M&O as applicable. Make an entry in the hub assembly historical records to show that the PART III a. of this Alert Service Bulletin has been accomplished.

1. Replace the housing assembly (3) and both trunnion (2) inner races if the seal is found to be reversed. Refer to the BHT-206B3-CR&O or to the BHT-206A/B-CR&O as applicable. Make an entry in the hub assembly historical records to show that the PART III b. of this Alert Service Bulletin has been accomplished.

1. Remove the tail rotor hub and blade assembly from the helicopter. Refer to the BHT-206A/B-SERIES MM.
2. Replace affected housing assembly (3) and both trunnion (2) inner races. Refer to the BHT-206B3-CR&O or to the BHT-206A/B-CR&O as applicable.
3. Re-install the tail rotor hub and blade assembly on the helicopter. Refer to BHT-206A/B-SERIES-MM.
4. Ground-run the helicopter and perform a tail rotor balance check. Refer to BHT206A/B-SERIES-MM or the TB 206-96-163.
5. Make an entry in the Helicopter and the Component Historical Records to show that Part III c. of this Alert Service Bulletin has been accomplished.
