ALERT SERVICE BULLETIN
REVISION NOTICE
Bell Helicopter**TEXTRON**
A Subsidiary of Textron Inc.

SUBJECT: **REVISION "A" TO ALERT SERVICE BULLETIN 206-06-107:
(VERTICAL FIN SUPPORTS 206-031-417-003/-007 AND 206-031-418-
001/-005, INSPECTION OF)**

NO. 206-06-107

SUBJECT: VERTICAL FIN SUPPORTS 206-031-417-003/-007
AND 206-031-418-001/-005, INSPECTION OF

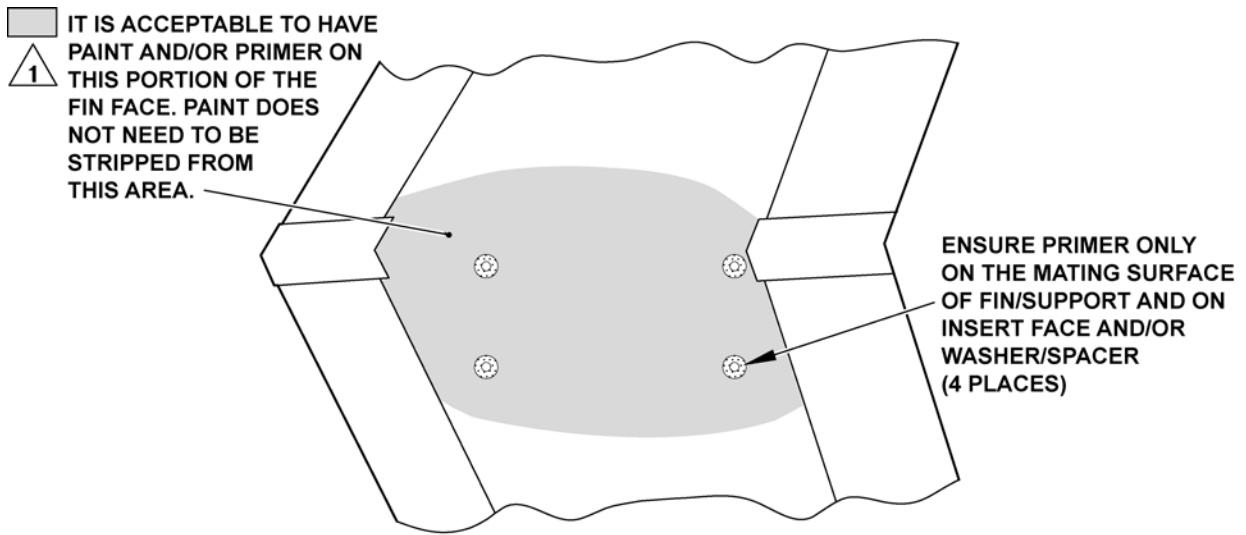
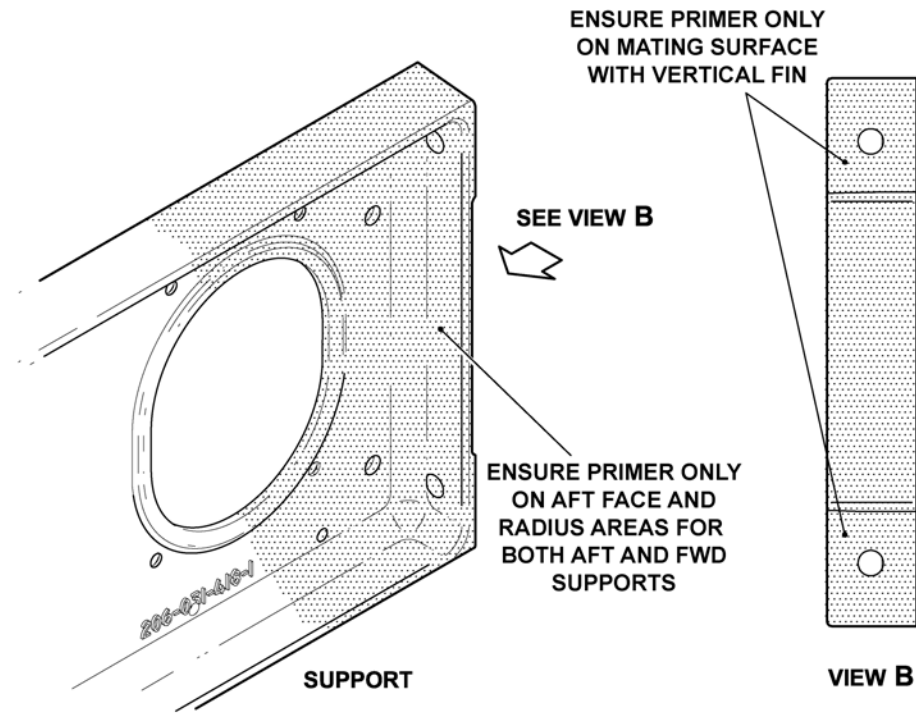
Figure I: Primer Application for Vertical Fin and Support

6. Inspect the supports and fin for the presence of paint coating at the indicated areas on Figure 1. Do not remove paint now, record your findings and proceed with the step 7 (with Type 2 fin only) and 8 or 9 depending on what you have recorded on Table 2 or 3 as applicable.

- b. Remove all organic finish (primer and paint coating) at the areas indicated on the Figure 1. Reference the BHT-ALL-SPM for paint removal and primer application.

- e. Perform a visual inspection with a 10 X power magnifying glass of the supports in the areas shown on the Figure 1, View B:
 - 1) If no crack is visible, NDT FPI Method (ASTM E1417) may be performed immediately or within the next 100 hours or 3 months following the visual inspection as per the BHT-ALL-SPM. Portable kits (Method C) may be employed for inspection of localized areas of components and parts installed on aircraft. If you choose to accomplish the NDT inspection within the next 100 hours or 3 months, apply two coat of Polyamide Epoxy Primer (C-204) or (C-245) now until the time of NDT. If no crack is present following the NDT, apply two coats of Polyamide Epoxy Primer (C-204) or (C-245) on bare metal surfaces and proceed to step f.

1 If paint is present in this area, it is suspected that the washer (spacer) and mating surface has paint coating. In this case, the fin shall be removed for verification.

This surface shall have primer coating only. Remove all paint coating, if present. Refer to BHT-ALL-SPM.

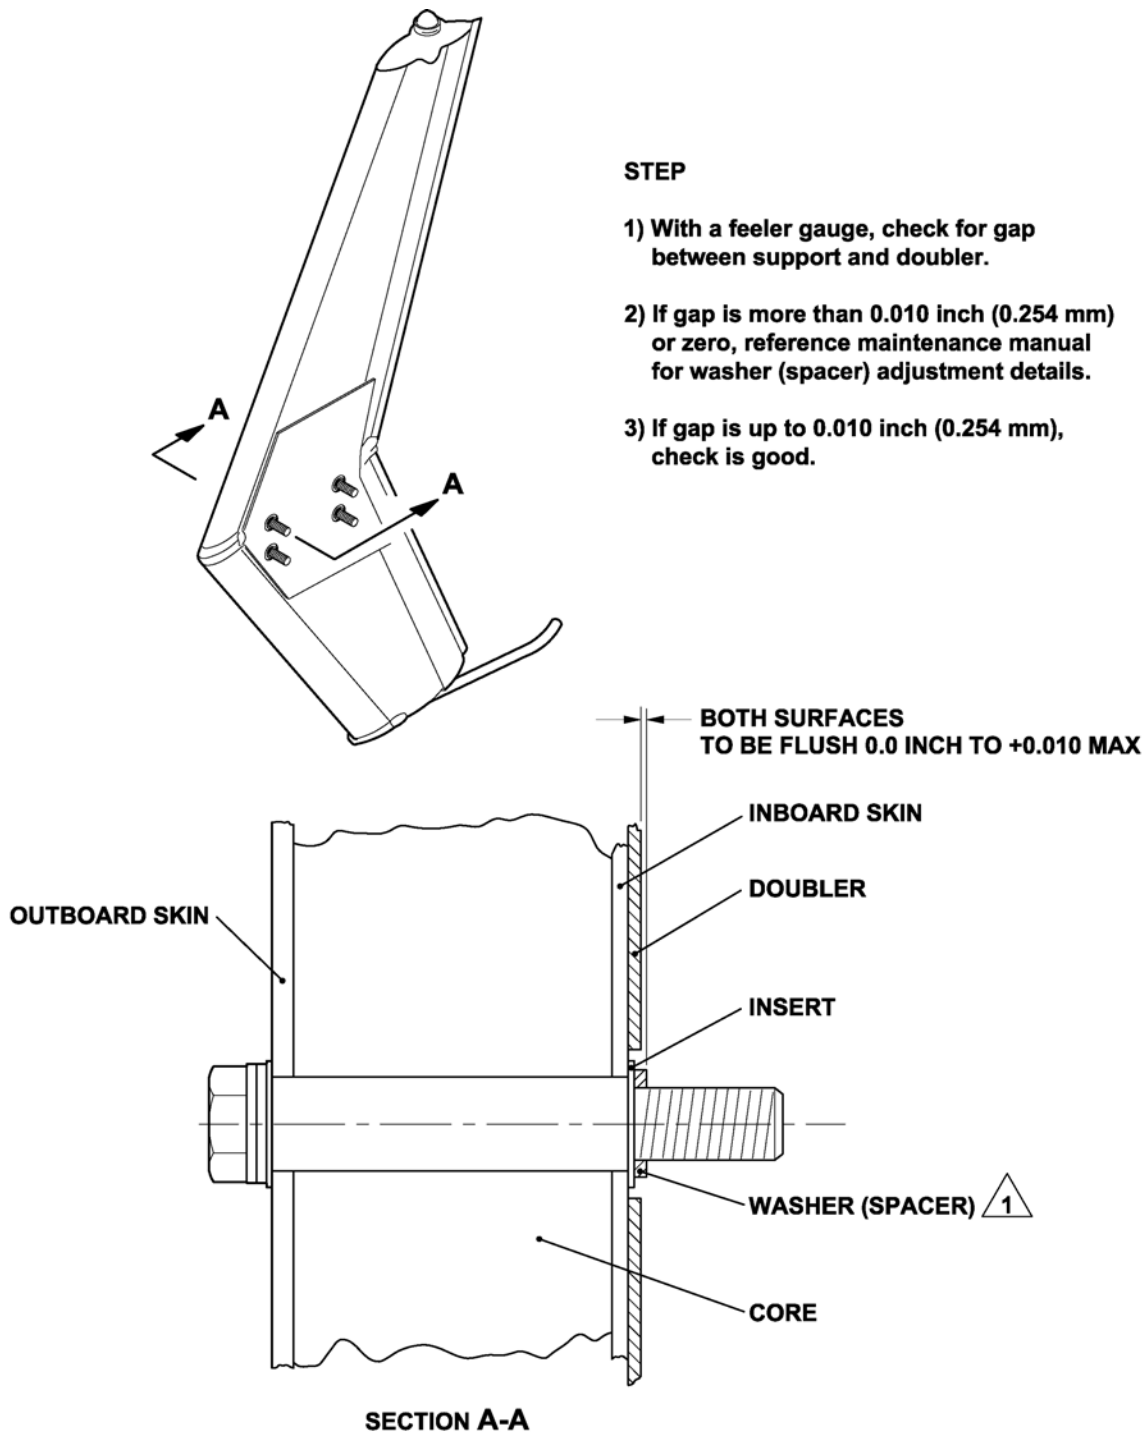
Figure II: Vertical Fin Type 2 Doubler and Washer (Spacer) Stack-Up Gap Check

7. Perform gap check. Reference Figure 2. Record your findings and proceed with step 8 or 9 depending on what you have recorded on Table 3.
8. If the torque was within limits (not below 50 in-lbs (5.65 Nm)), no presence of paint and the gap check (Type 2 fin) was good; perform a 10 X visual inspection of the supports in the area of the fin attaching hardware.

- 1) If no damage is found, proceed to step d.
 - 2) If any damage of the potted insert is detected, contact Product Support Engineering.
 - d. If the fin installed is of Type 2, ensure the correct washers (spacers) are installed between the supports and the fin inner skin. Refer to the Figure 2 Section A-A. For washers (spacers) inspection and installation procedure, refer to the BHT-206A/B-SERIES-MM, chapter 53.

1 FOR WASHER (SPACER) INSTALLATION, REFER TO MAINTENANCE MANUAL.
