ALERT SERVICE BULLETIN
Bell Helicopter **TEXTRON**

NO. 206-06-110

DATE SEP 7, 2006

SUBJECT: UPPER LEFT-HAND TAILBOOM ATTACHMENT
HARDWARE, INSPECTION OF

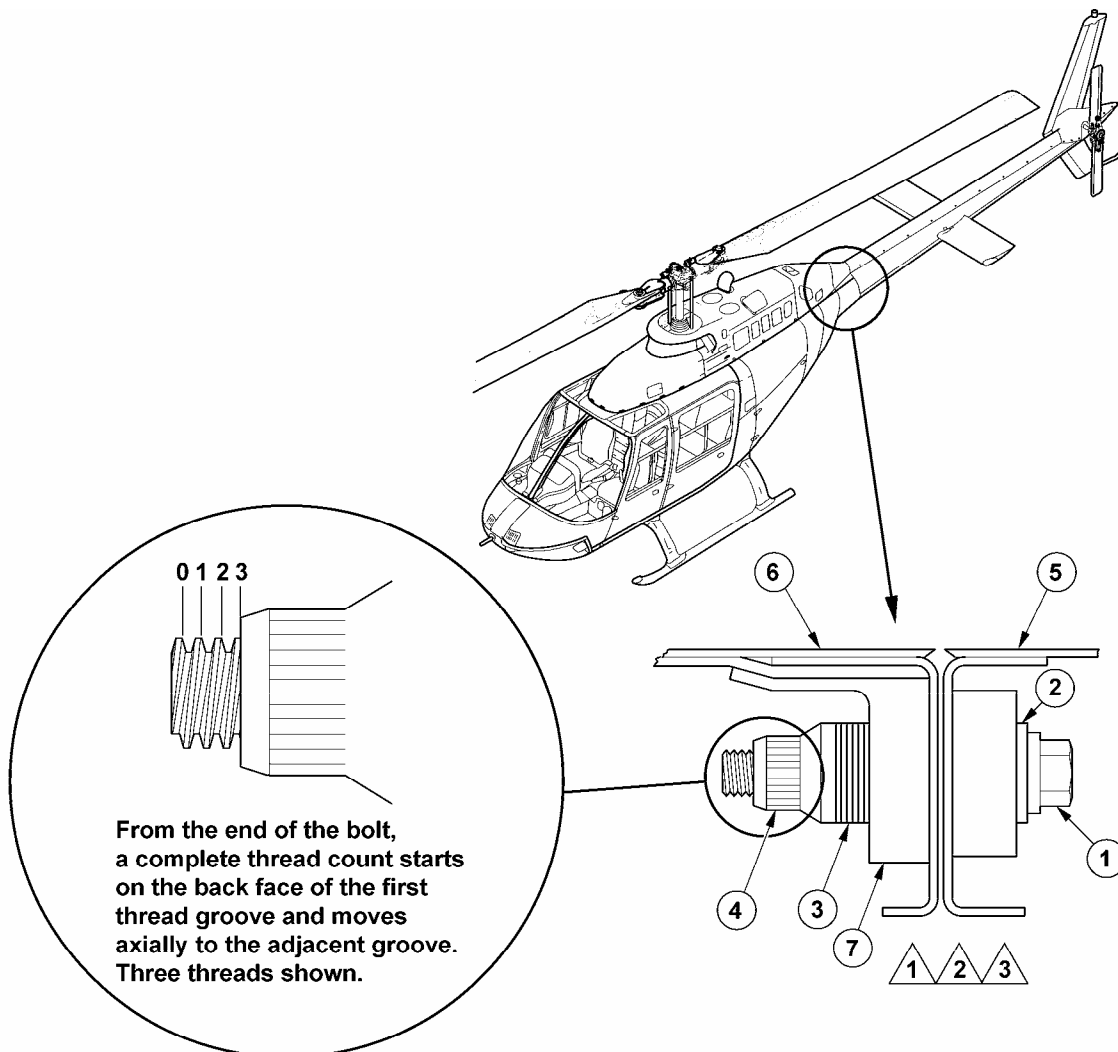
Figure 1: Tailboom Attachment

Bell Helicopter found that on some helicopters having the 407-030-750-103 CRES steel fitting installed at the upper left-hand location, the attachment bolt might not meet the installation requirement.

5. For helicopters affected by this bulletin that have a CRES fitting installed, perform thread count on the upper left hand attachment bolt (1) as per Figure 1.

6. If the correct amount of thread is exposed (between 1 and 3), do a torque check. Refer to the Maintenance Manual. If the torque is correct, make an entry in the helicopter records to indicate that this bulletin has been accomplished. If the torque is found below minimum and a replacement bolt (1) is not available at this time, adjust the washer (3) quantity as required per Figure 1. Refer to the Maintenance Manual and torque as required. Make an entry in the helicopter records to indicate that the PART I of this bulletin have been accomplished and that the PART II of this bulletin will require accomplishment.

7. If less than 1 thread is exposed, adjust the washer (3) quantity as required per Figure 1. Refer to the Maintenance Manual and torque as required. Make an entry in the helicopter records to indicate that this bulletin has been accomplished.

8. If more than 3 threads are exposed and a replacement bolt (1) is not available at this time, adjust the washer (3) quantity as required per Figure 1. Refer to the Maintenance Manual and torque as required. Make an entry in the helicopter records to indicate that the PART I of this bulletin have been accomplished and that the PART II of this bulletin will require accomplishment.

9. If more than 3 threads are exposed and a replacement bolt (1) is available, accomplish PART II of this bulletin.

1. Remove and discard the upper left hand tailboom attachment bolt (1, Figure 1). Install new bolt (1) and adjust the quantity of washer (3) as required to ensure correct installation as shown on Figure 1. If serviceable, the nut (4) does not require replacement. Refer to Maintenance Manual.
2. 100 hours after installation, do a torque check of the upper left hand tailboom attaching hardware (BHT-206A/B-SERIES-MM).
3. Make an entry in the helicopter records to indicate that this bulletin has been accomplished.

- 1 Bolt (1) and chamfered washer (2) are to be installed through tailboom (5) and Aft fuselage (6). Bolt head and chamfered washer are to be installed on the tailboom side. Steel washers (3) are to be installed next to fitting (7) to provide not less than one thread and not more than three threads exposed on threaded end of bolt (1).
- 2 If thread count is less than one, remove washers as required.
- 3 If thread count is more than three, remove and replace bolt, then readjust number of washers to meet requirement of note 1.
