ALERT SERVICE BULLETIN
Bell Helicopter **TEXTRON**

NO. 206-07-112

SUBJECT: AERONAUTICAL ACCESSORIES INC. PC
SAFETY VALVE™ STEM OVER TORQUE STC
SE5511NM

ALERT SERVICE BULLETIN ASB No. AA-06107

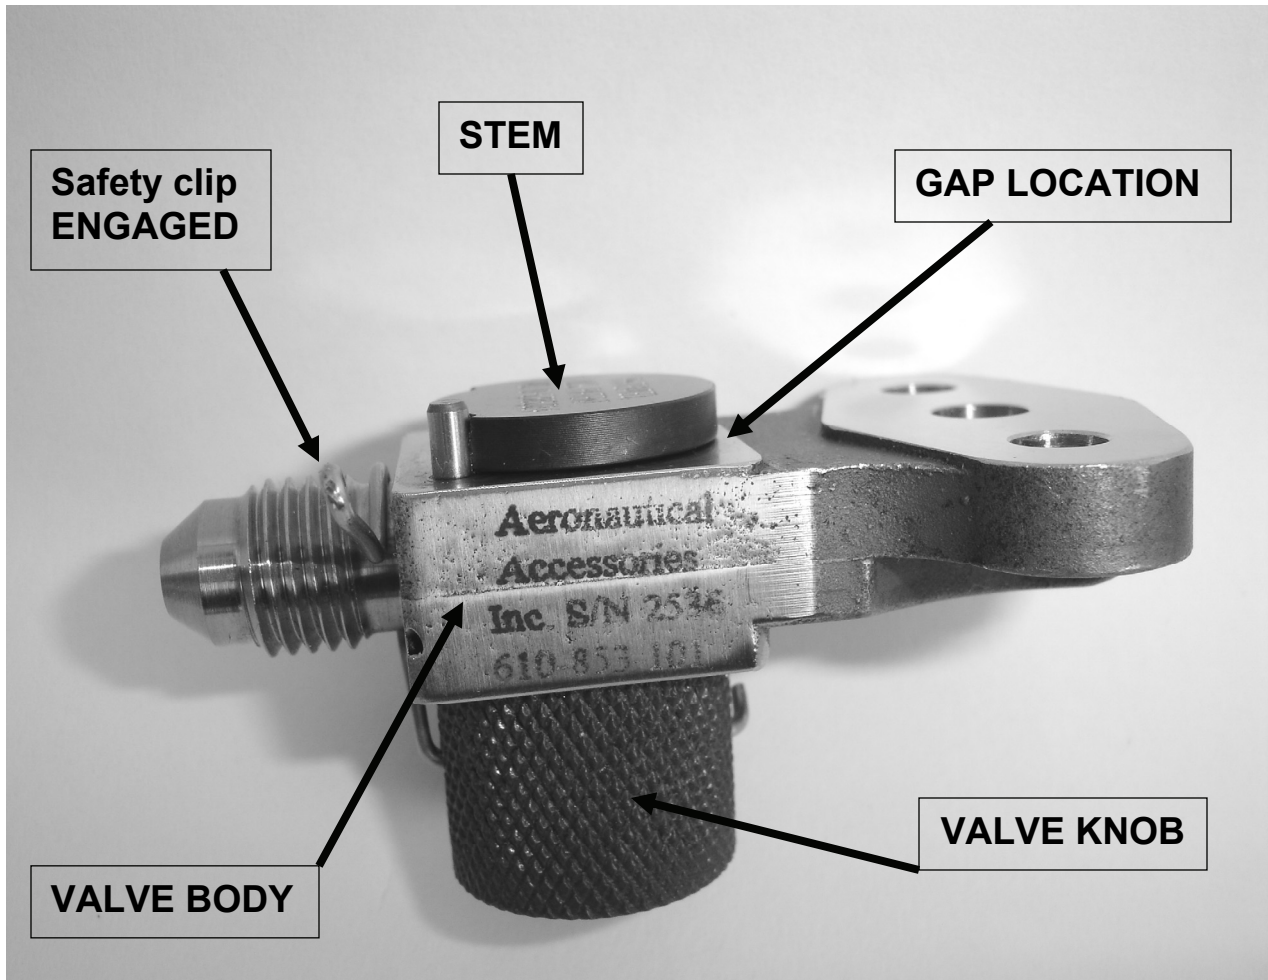
FIGURE 1 – P/N 610-853-101 IN OPEN POSITION

1. Open cowling / panel to gain access to the engine compartment.
2. Locate PC Safety Valve™ assembly on the outside of the engine case.
3. Identify location of the stem. (Reference Figure 1, part removed for clarity)

7. Inspect the gap between the tip of the stem and the valve body opposite the knob (reference Figure 1). The gap between the stem and the valve body should be a maximum of .017 inches. Use a standard feeler gage to determine the actual gap distance (reference Figure 2). Any gap measurement greater than .012 inches warrants closer inspection to determine if the stem has been compromised. If the gap exceeds .017 inches, the valve stem has been compromised and the unit should be immediately returned to Aeronautical Accessories, Inc. for repair.

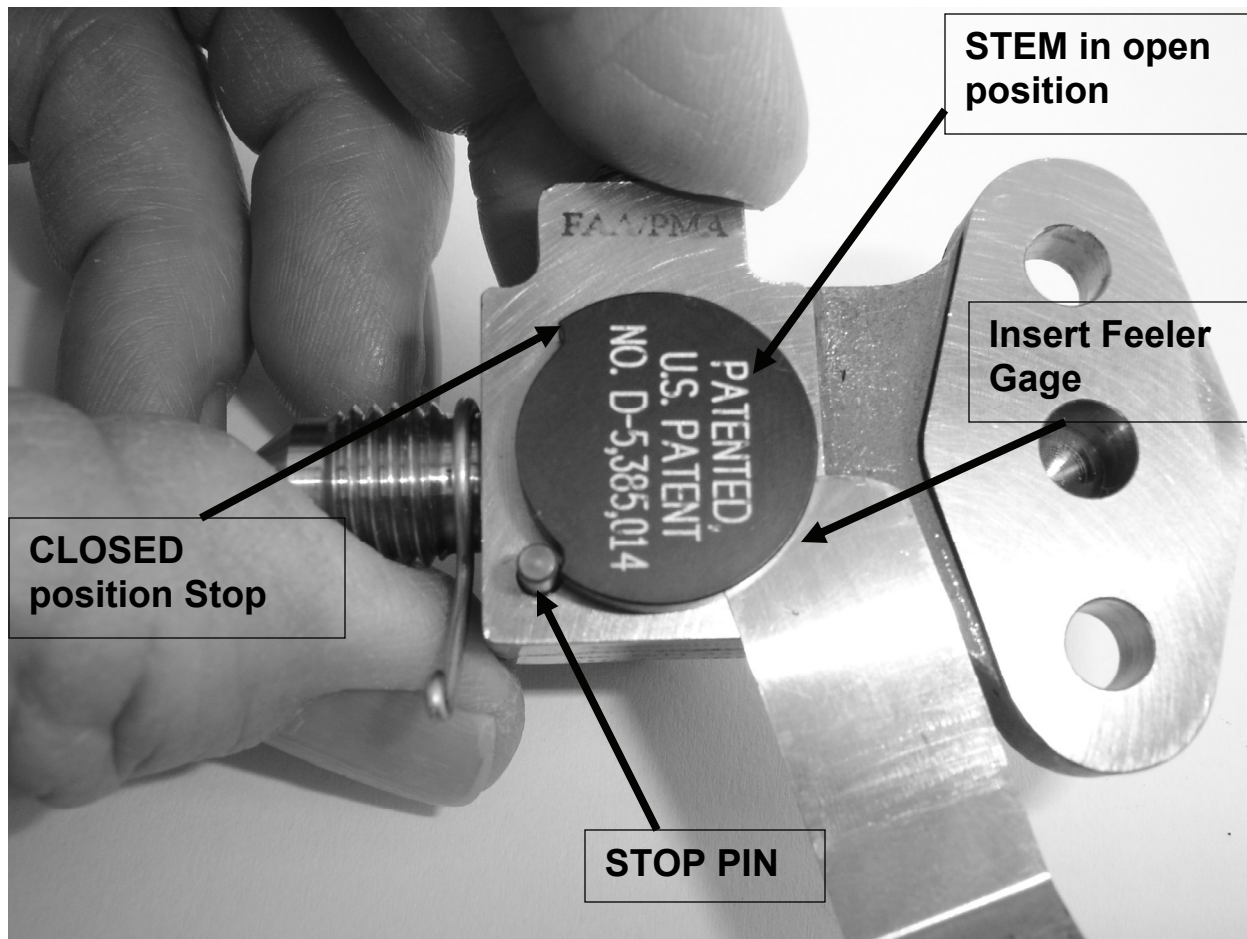
FIGURE 2 – P/N 610-853-101 IN OPEN POSITION (STOPS VISIBLE)

4. Remove safety wire or clip as appropriate.
5. While manually turning the knob from stop to stop, visually or by touch, verify that the opposite end of the stem to which the knob is attached rotates in unison with the knob. There should be distinct stops at both ends of travel (reference Figure 2). If distinct stops at both ends of travel are not detected, the valve stem has been compromised and the unit should be immediately returned to Aeronautical Accessories, Inc. for repair.
