**ALERT SERVICE BULLETIN**  
**Bell Helicopter** **TEXTRON**

NO. 206-07-113

**SUBJECT:** CARGO HOOK STRESS CORROSION CRACKS

Document No. 159-017-00 Rev 0

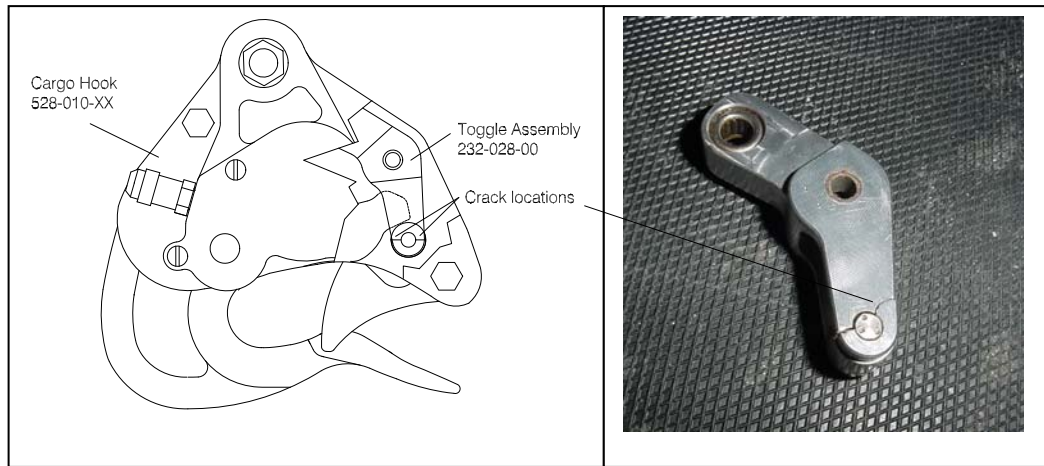
**Figure 1. Crack location**

**Description:** Onboard Systems has had two reported instances of failure of the Toggle Assembly, 232-028-00. The Toggle is an internal component of Cargo Hook 528-010-XX and is a primary element of the Cargo Hook locking mechanism. Figure 1 shows the location of the failure.

**Cause:** Investigation of the failures has suggested that they were caused by Stress Corrosion Cracking (SCC). Specific mechanical, metallurgical, and corrosive conditions must be present in order for SCC to occur.

1. Residual stresses imposed by the press fit of the Load Beam Roller Pin
2. Corrosive salt water environment

1. Visual check to see if cracks are visible in the Toggle. This must be accomplished before further Cargo Hook use and daily prior to external load operations until item 2 is accomplished. If cracks are found, the Cargo Hook must be removed from service and part 2 accomplished before additional use.
2. Replace the original Toggle with a redesigned Toggle, 232-028-01, at the next scheduled overhaul, or within one year from the approval date of this bulletin, whichever comes first.

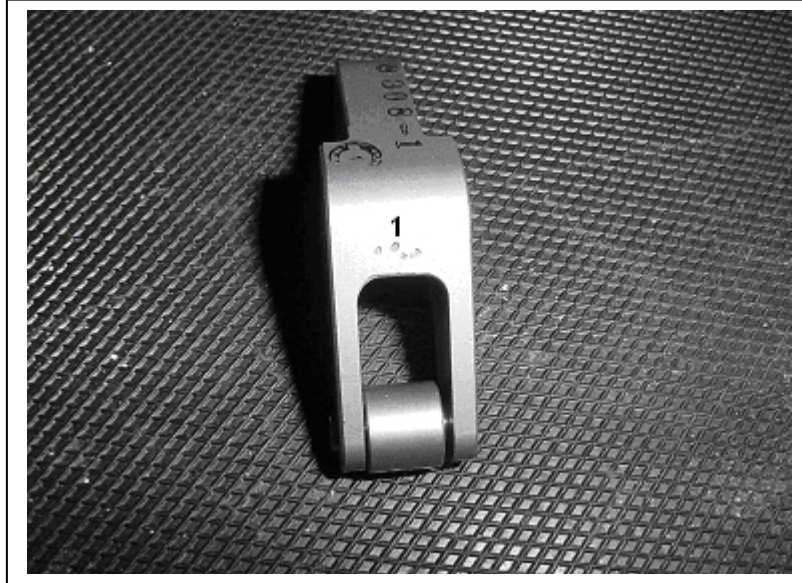
**Figure 3. Stamp location**

3. If part 2 of this bulletin has been complied with, the modified hook can be identified by a 1 stamped on the visible portion of the Toggle. See figure 3. If Part two of this bulletin has been complied with, no further action is required.
