ALERT SERVICE BULLETIN

NO. 206-09-119

MODEL AFFECTED: 206B

SUBJECT: VERTICAL FIN ASSEMBLY 206-020-113-231,
INSPECTION OF

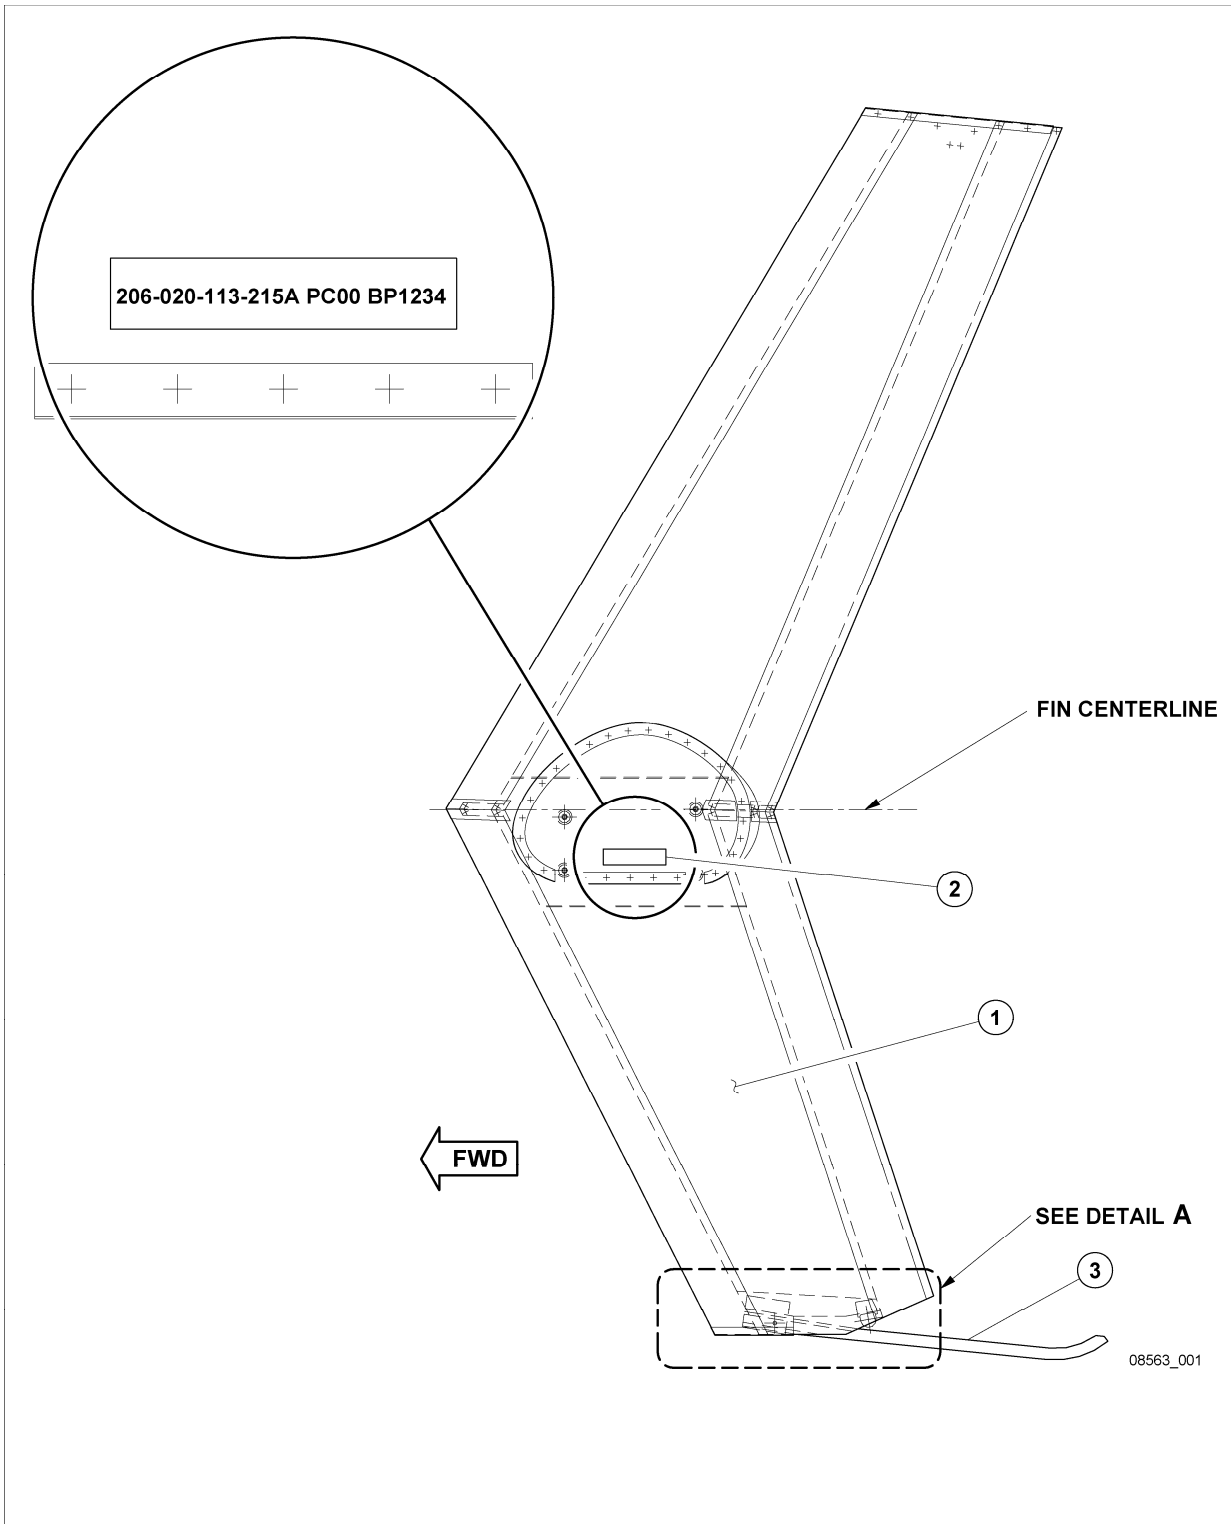
Figure 1 (sheet 1 of 2) – Vertical fin assembly, inspection and repair of

Bell Helicopter has found that some fin assemblies 206-020-113-231 may have been manufactured with a non-conformity in the lower inner doubler area. The non-conformity is defined as a void between the lower skin inner doubler and the core that may progress with time and exceed the maximum repairable limit. The vertical fin assemblies that may be affected are identified using the core assembly serial number. The core assembly serial number can be found on the identification tag bonded on the vertical fin assembly at the location shown on Figure 1.

3. Refer to Figure 1. Determine if you have an affected vertical fin assembly (1) using the serial number of the core 206-020-113-215A as listed in Table 1. An identification tag (2) showing the P/N 206-020-113-215A followed by its serial number is bonded on the fin assy as shown in the Figure 1.
4. If the serial number of the core is not listed in Table 1, reinstall the tail rotor gearbox fairing in accordance with BHT-206A/B-MM and make an entry to indicate that this bulletin has been accomplished.
5. If you have an affected vertical fin assembly, accomplish Part II of this bulletin.
