**ALERT SERVICE BULLETIN**

NO. 206-09-122

**MODEL AFFECTED:** 206A/B SERIES and TH-67

**SUBJECT:** STAKED BEARINGS, ONE-TIME INSPECTION OF.

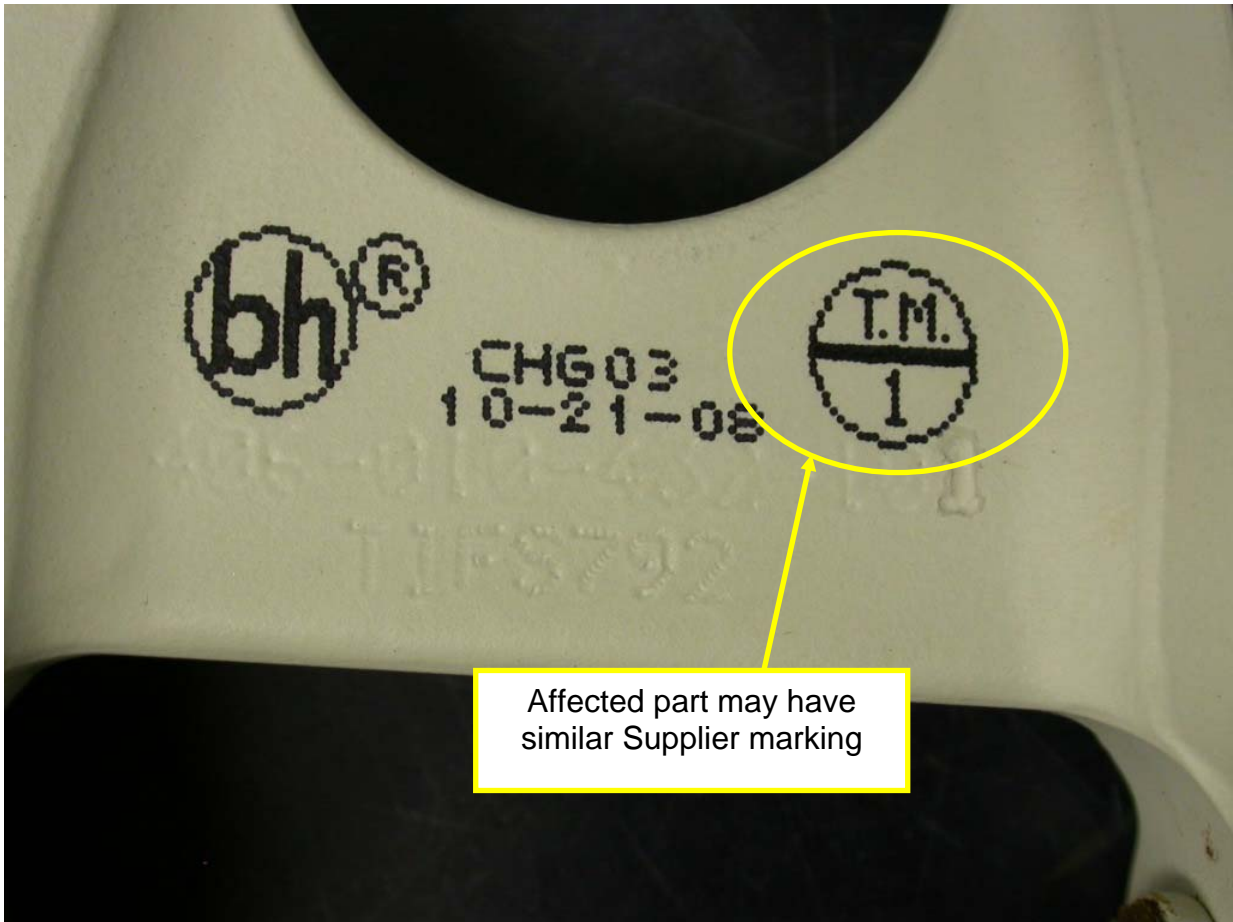
Figure 1. Affected part Supplier marking.

Bell Helicopter issues this bulletin to accomplish a one-time inspection of various parts that could potentially exhibit the same defect. The affected parts are listed in Table 1. Parts in service and all spare parts are affected. When serialized, only parts with serial number prefix TI or TIFS are affected. However, affected part not serialized, may have Supplier marking as shown on Figure 1.

1. Gain access to the affected parts. See Table 1 for a list.
2. Using a 10X magnifying glass or other suitable means such as a boroscope, inspect parts for bearings that have not been staked. Refer to Standard Practices Manual (SPM). If a bearing is not visible, apply hand pressure to the part to detect any axial movement. If still in doubt, remove the part from the aircraft to inspect.
3. Should you find a part with a discrepant bearing, replace the bearing or the assembly and contact Product Support Engineering to report finding.
4. Make an entry in the helicopter historical records indicating compliance with this Alert Service Bulletin.
