ALERT SERVICE BULLETIN

206-11-127

**MODEL AFFECTED:** 206A/B (TH-67)

**SUBJECT:** CONTROL BOX ASSEMBLY P/N 206-375-017-101,  
RECALL OF.

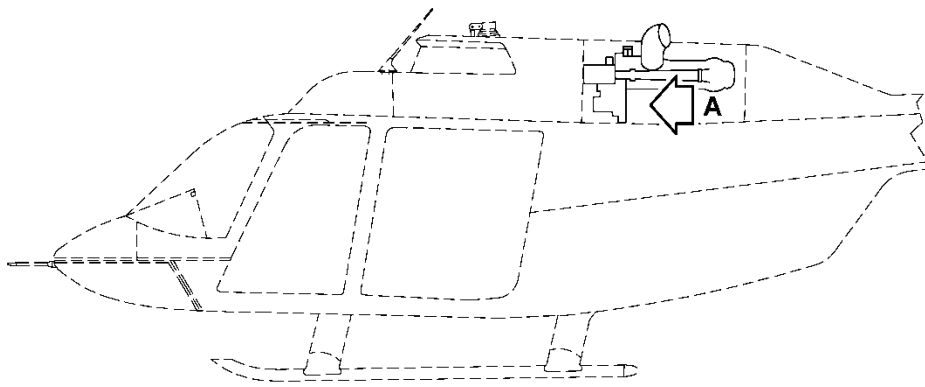
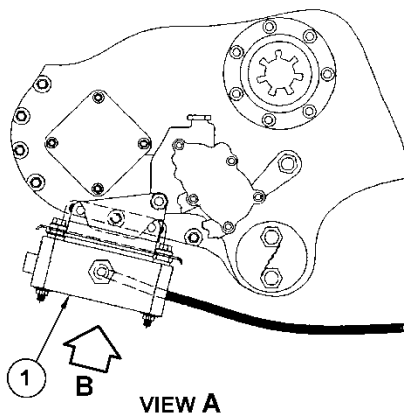
Figure 1. Control Box Assembly Location

1. Auto-reignition control box assembly

1. Prepare helicopter for maintenance.
  - a. Access L/H side of powerplant.
2. Locate control box assembly. Refer to Figure 1 Item 1.
  - a. Verify part number on control box assembly View B. If the part number identified on the unit is P/N 206-375-017-101 (206A/B), then this unit is affected by the intent of this Bulletin. Proceed to step 3.
  - b. If an original Rolls Royce control box assembly P/N 23050521, 23052372, 6877138 or 6877142 is found installed, no further action is required. Proceed to step 5.
3. Install replacement control box assembly P/N 206-375-017-105. Refer to the Installation Instruction BHT-206-SI-92.
4. Test engine auto-relight system for proper functioning. Refer to the Installation Instruction BHT-206-SI-92.
5. Make an entry in helicopter historical service records indicating compliance with this Alert Service Bulletin.
