ALERT SERVICE BULLETIN

222U-17-84  
3 March 2017

**MODEL AFFECTED:** 222U

**SUBJECT:** **MAGNETIC BRAKE ASSEMBLY 204-001-376-105 AND 204-001-376-107, INSPECTION AND REPAIR OF.**

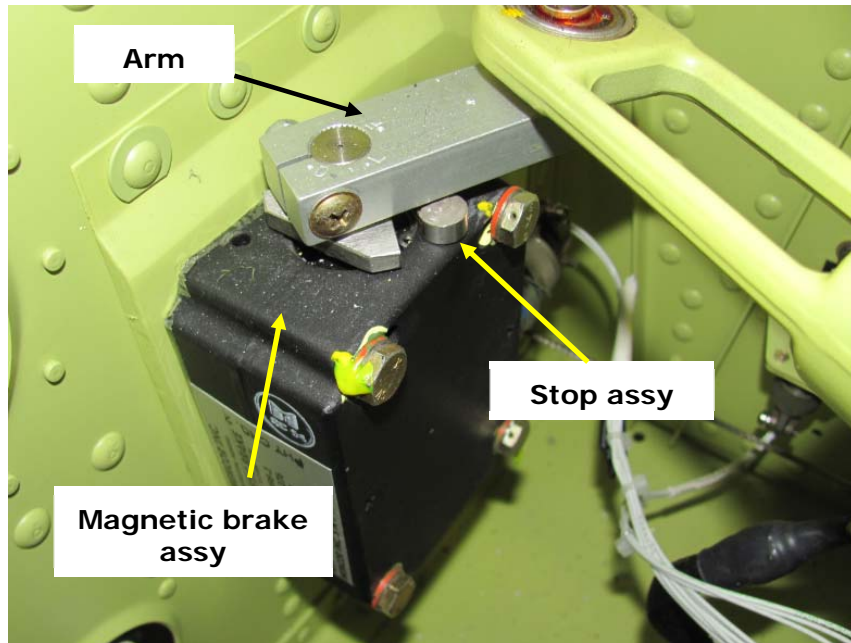
**Figure 1. Magnetic brake assembly.**  
(magnetic brake 204-001-376-003 shown as an example Figures 1 to 4)  
(Magnetic brake 204-001-376-105/-107 installed in 222U)

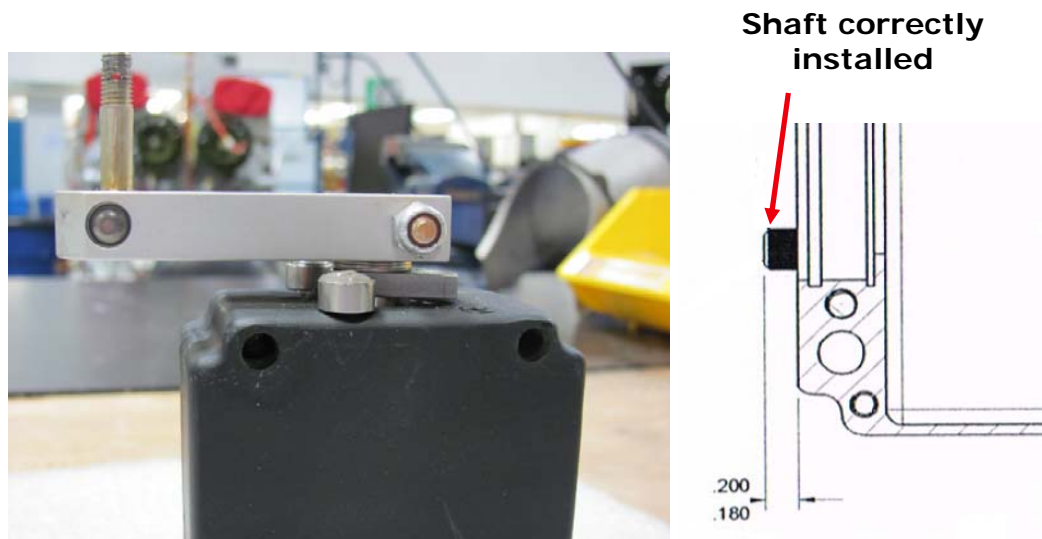
**Figure 2. Magnetic brake assembly with stops properly installed.**

8. The shaft should protrude from the housing surface between 0.180 inch (4.57 mm) and 0.200 inch (5.08 mm). Refer to Figure 2.
9. Allow sufficient time for the adhesive to cure 24 hours at 70 to 95°F (21° to 35°C) and return the magnetic brake assembly to service.

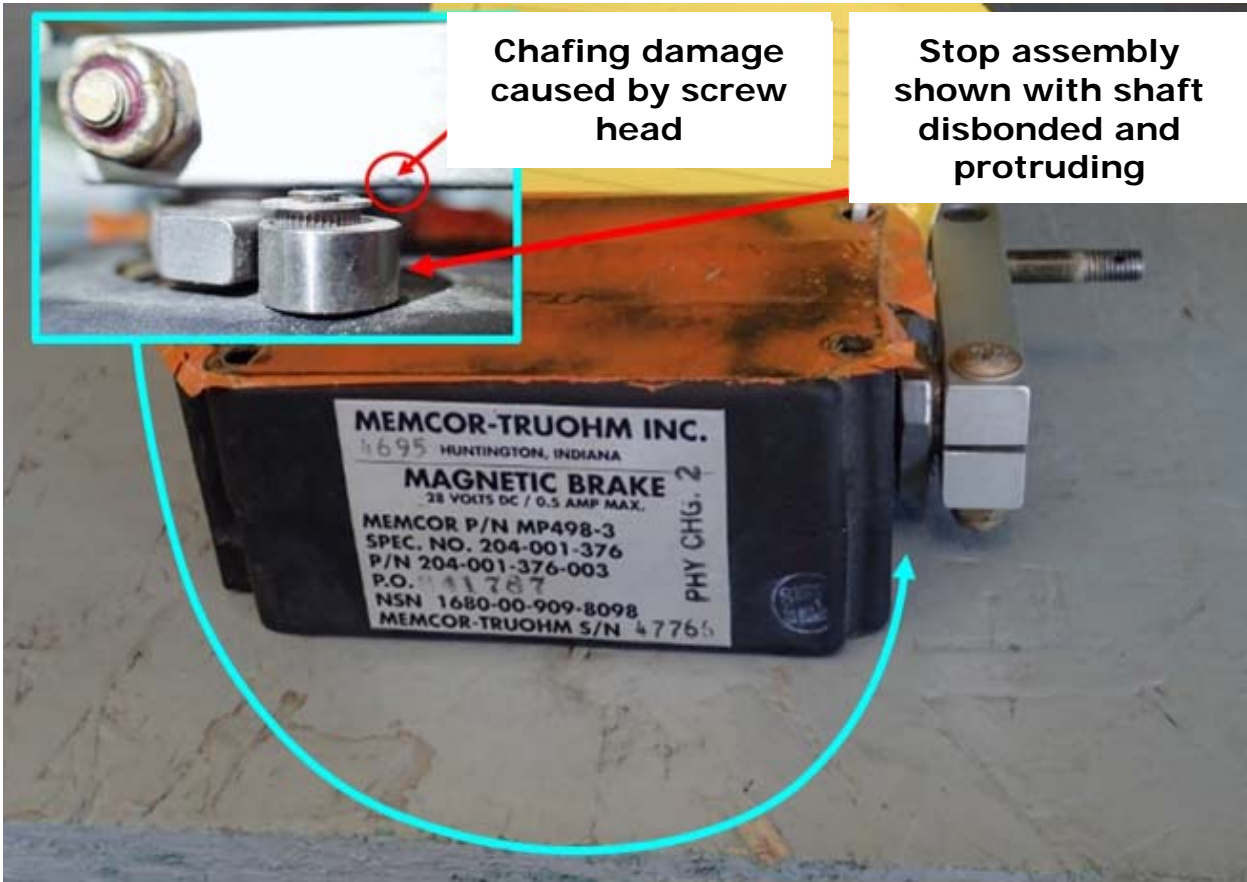
Bell Helicopter has received reports of a magnetic brake P/N 204-001-376-003 (Memcor-Truohm P/N MP498-3) adjustable stop assembly contacting the magnetic brake arm. With time in service, the stop assembly shaft may disbond from the housing, back out and cause interference or limit the magnetic brake arm range of motion. This condition, although not desirable, will not affect the proper function of the cyclic controls.

Figure 3. Stop assembly with disbonded shaft.

5. Thoroughly clean adhesive residue from the shaft and the housing bore. If the splined stop requires removal from the shaft, index mark the stop, the shaft and the housing to ensure installation at the same location. If the screw is removed from the shaft, reinstall with Loctite (C-320) and torque 5 to 10 inch-pounds (0.56 to 1.13 Newton-meters).

6. Apply adhesive (C-317) to the mating surfaces of the housing and the shaft.
7. Install the stop assembly in the housing bore and remove excess of adhesive.

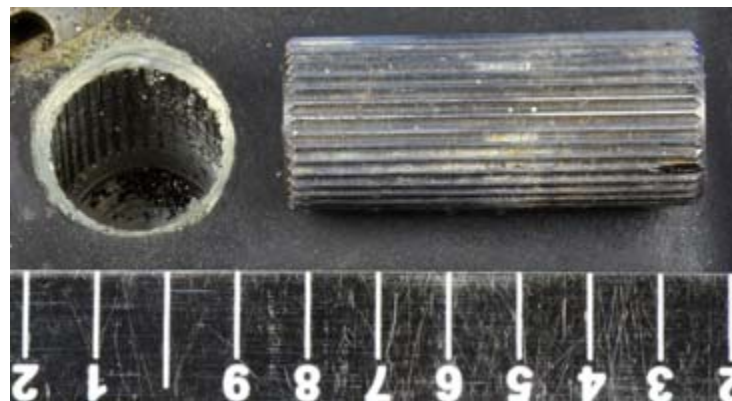
Figure 4. Shaft removed from housing.

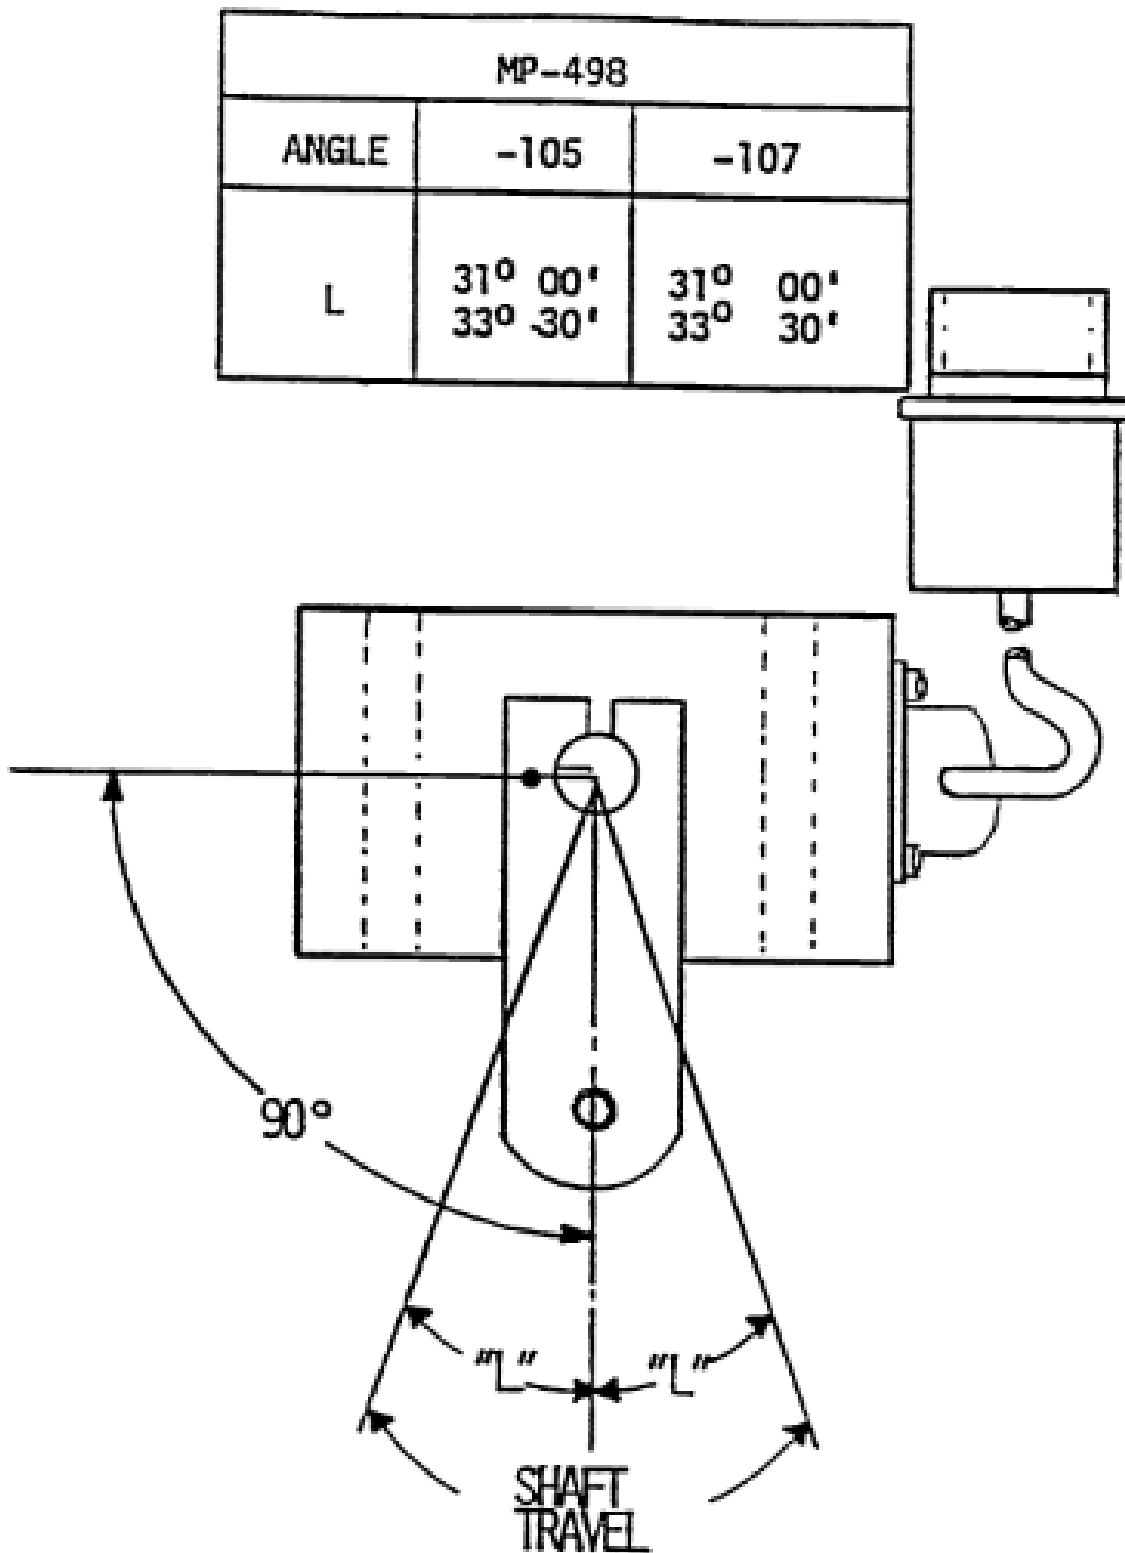
Figure 5. Angle of Arm on magnetic brake 204-001-376-105/ -107

10. Allow sufficient time for the adhesive to cure and return the magnetic brake assembly to service. Verify/adjust stop limits to achieve the arm assembly shaft travel. (Figure 5).
