ALERT SERVICE BULLETIN

412CF-17-62
3 March 2017

MODEL AFFECTED: 412CF

SUBJECT: **MAGNETIC BRAKE ASSEMBLY 204-001-376-003, INSPECTION AND REPAIR OF.**

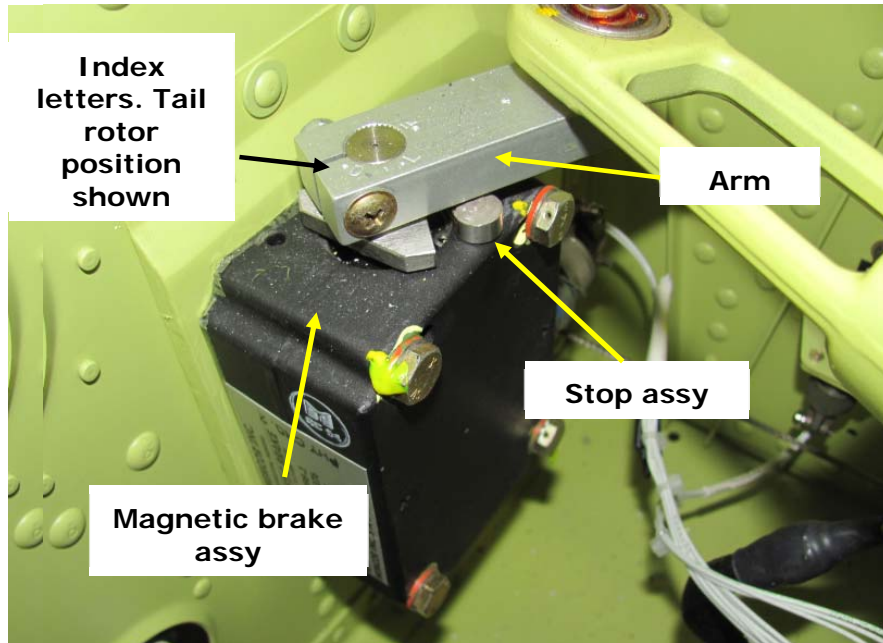
Figure 1. Magnetic brake assembly.

1. Prepare the helicopter for maintenance.
2. Gain access to the tail rotor magnetic brake assembly (C-12-146-000/MF-001).
3. Perform a detailed visual inspection of the stop assemblies (Figures 1 and 2). Figures 3 and 4 show a stop assembly found disbonded.

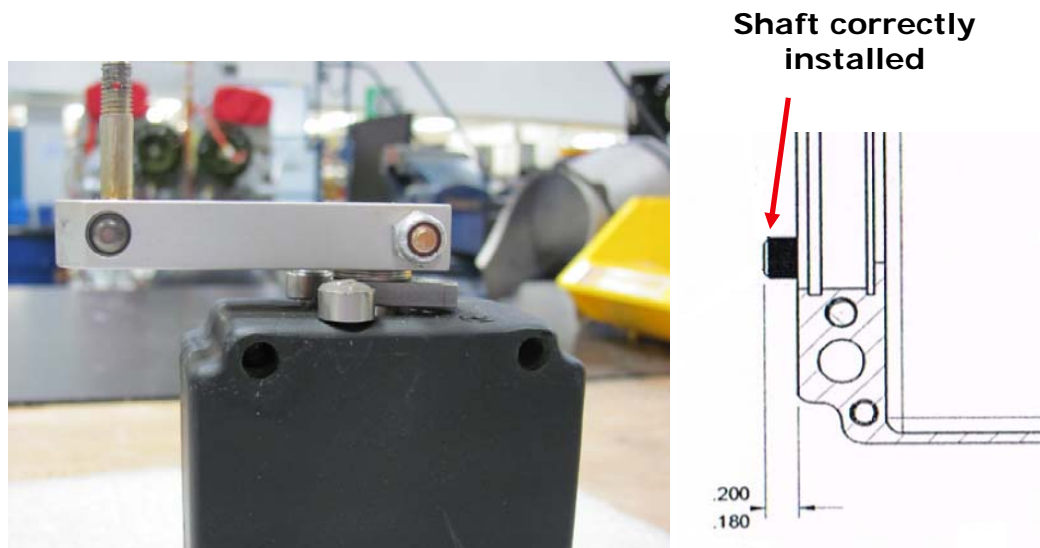
Figure 2. Magnetic brake assembly with stops correctly installed.

8. The shaft should protrude from the housing surface between 0.180 inch (4.57 mm) and 0.200 inch (5.08 mm) (Figure 2).
9. Allow sufficient time for the adhesive (C-317) to cure (24 hours at 21°C to 35°C (70°F to 95°F)) and return the magnetic brake assembly to service.

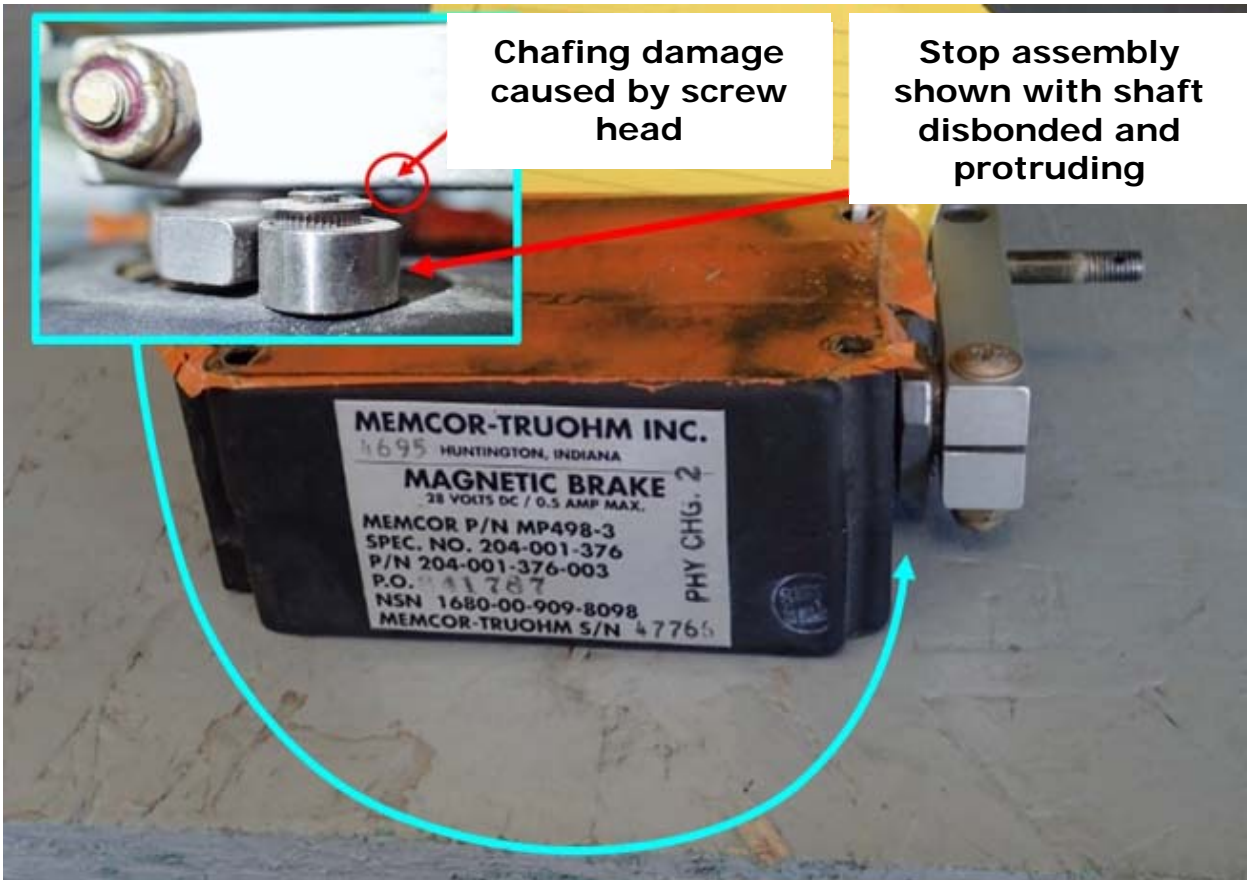
Bell Helicopter has received reports of magnetic brake assembly P/N 204-001-376-003 (Memcor-Truohm P/N MP498-3) adjustable stop assembly contacting the magnetic brake arm. With time in service, the stop assembly shaft may disbond from the housing, back out and cause interference or limit the magnetic brake arm range of motion. This condition, although not desirable, will not affect the proper function of the flight controls.

Figure 3. Stop assembly with disbonded shaft.

4. By hand, pull on the stop assembly to verify if the stop shaft is disbonded from the housing assembly.
5. If the shaft shows evidence of disbond, inspect the lower side of the arm for possible chafing damage and accomplish Part II. The maximum allowable mechanical damage is 0.030 inch. (0.762 mm).

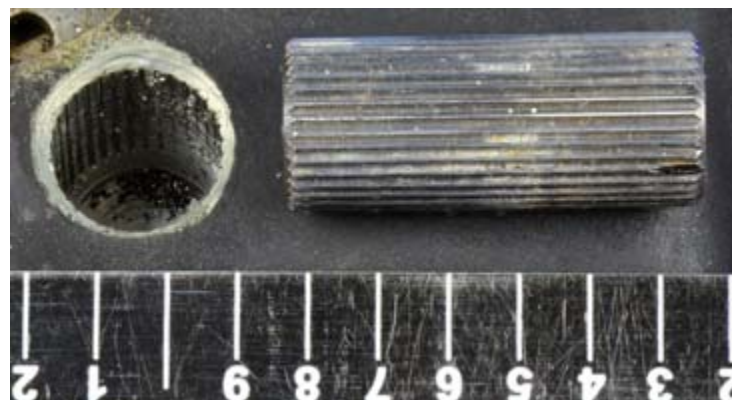
Figure 4. Shaft removed from housing.

5. Thoroughly clean adhesive residue from the shaft and the housing bore (BHT-ALL-SPM). If the splined stop requires removal from the shaft, index mark the stop, the shaft and the housing to ensure installation at the same location. If the screw is removed from the shaft, reinstall with adhesive (C-320) and torque to 5 to 10 inch-pounds (0.56 to 1.13 Newton-meters).

6. Apply adhesive (C-317) to the mating surfaces of the housing and the shaft.
7. Install the stop assembly in the housing bore and remove excess of adhesive (C-317).

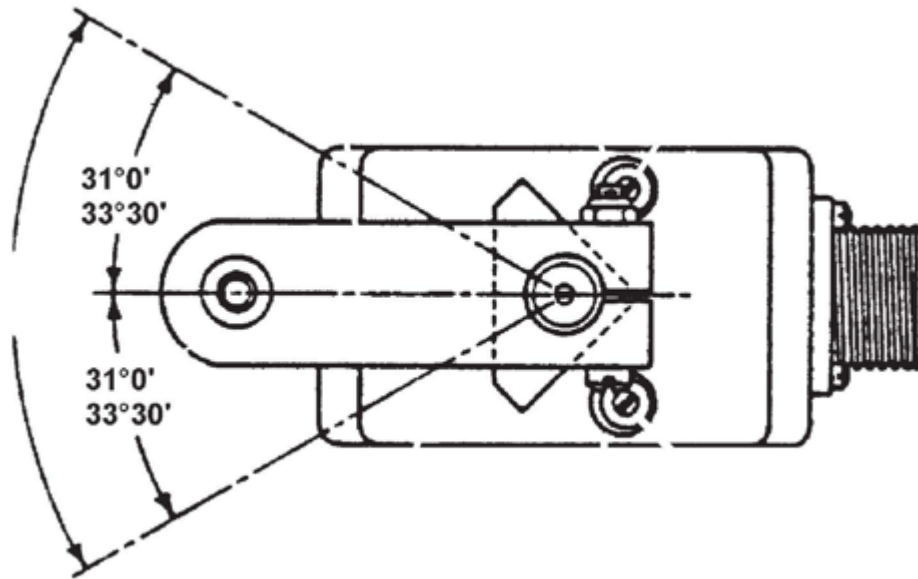
Regardless of arm letter indexing, total travel of the arm in relation to the stops is the same.

Figure 5. Arm total travel.

Regardless of arm letter indexing, in case the stop assemblies require adjustment for proper arm travel, refer to the Figure 5.
