ALERT SERVICE BULLETIN

429-14-15

MODEL AFFECTED: 429

SUBJECT: GOODRICH EXTERNAL HOIST

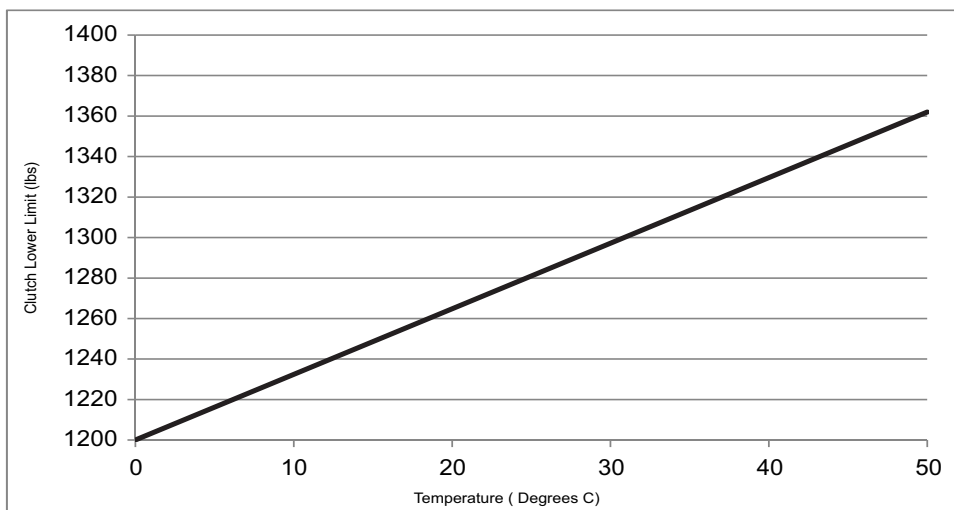
Figure 1. Lower limit for the 600 lb capacity hoists

- a. If the test results indicate a value above the acceptable lower limits per Table 2, Figure 1 of the Goodrich ASB 44301-10-18, Revision 6, proceed with step 3.

- b. If the test results indicate a value below the acceptable lower limit per Table 2, Figure 1 of the Goodrich ASB 44301-10-18, Revision 6, remove the hoist from service before the next hoist operation.
