ALERT SERVICE BULLETIN

429-17-36  
6 March 2017

**SUBJECT:** CONDENSER FAN MOTOR MOUNT FASTENER,  
INSPECTION OF.

**Title:** SB 429-201-1 Bell 429 Condenser Fan Motor Mount Fastener Inspection

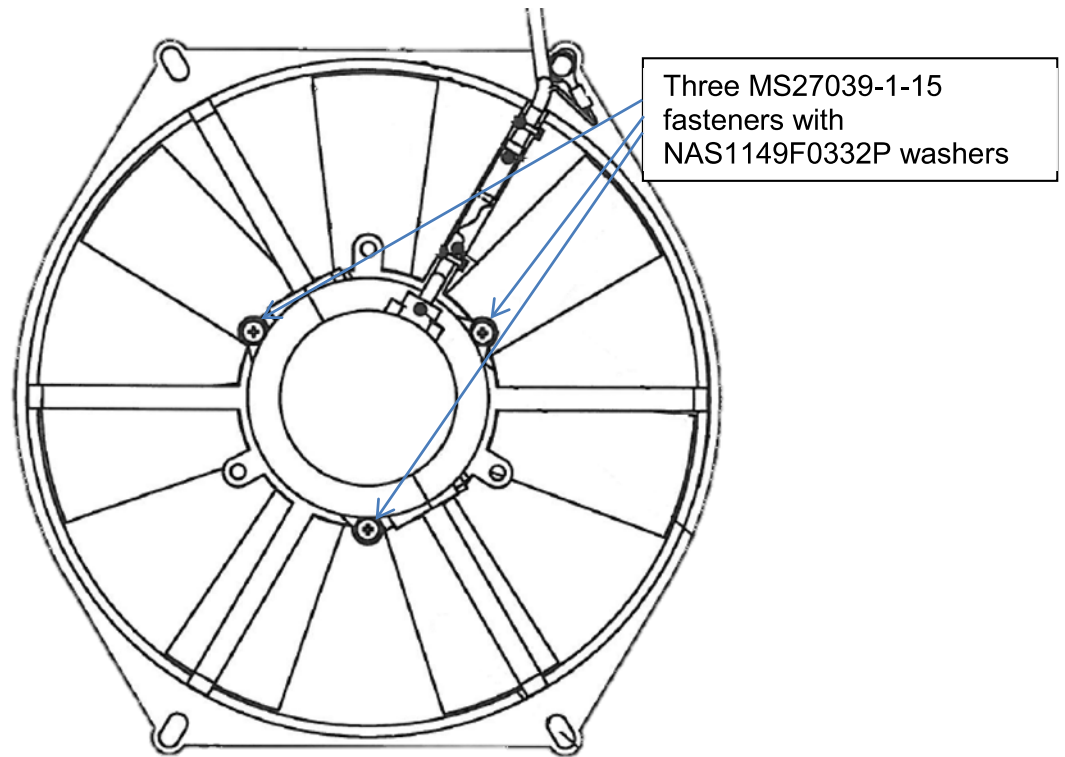
**Figure 1**

During an annual inspection, an operator reported finding the condenser fan motor detached from the condenser blower assembly and resting on the collective control tube. The condenser fan motor is secured to the condenser blower assembly by 3 fasteners with thread locker applied. Evidence suggests that some motor mount fasteners may have had misapplied thread locker.

1. Locate and visually inspect the condenser fan motor securement. Refer to Figure 1 to identify the three MS27039-1-15 fasteners mounting the condenser motor to the condenser blower assembly.

- e) Make log entry that the air-conditioning system is DEACTIVATED per ACC service bulletin SB 429-201-1.
4. Replace missing fasteners and remove and reinstall existing fasteners as follows:

- a. Clean the threads of the fastener of any debris and/or existing thread locker residue.
  - b. If no thread locker is found on existing fasteners, report incident to ACC at: Phone 303-440-4075, Fax 303-440-6355, or E-mail [service@aircommcorp.com](mailto:service@aircommcorp.com)

- c. Apply Loctite 222 to the fastener threads and re-install fastener with 20 to 25 in-lbf torque.
  - d. Once all fasteners are secure, apply torque stripe to the head of each fastener.

- e. Allow a minimum of 6 hours for Loctite to cure prior to aircraft flight operations.
5. Make log entry that this service bulletin SB 429-201-1 has been performed.
