**ALERT SERVICE BULLETIN
REVISION NOTICE**

**TAIL ROTOR BLADE P/N 222-016-001-123, -123M, -131 AND -139M, INSPECTION
AND REWORK OF**

NO. 430-04-31

MODEL AFFECTED: 430

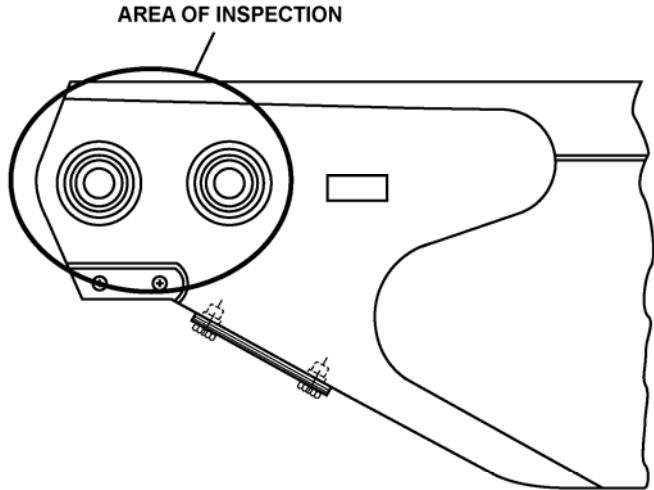
222-016-001-123

Figure 1. Blade Inspection Area

- a. Wipe down both surfaces of each blade around the blade feathering bearings using aliphatic naphtha (C-305) or detergent (C-318) or equivalents. Refer to Figure 1.
 - b. Closely examine the cleaned surface, on both sides of the blade, paying particular attention to the area around both bearings. If no crack is found in the paint, the inspection is complete until next inspection.
 - c. If a crack is found in the paint, maintenance personnel must proceed with step 2.
2. Remove the suspected blade from the helicopter. Refer to BHT-430-MM-7, Chapter 64.

- a. Wipe down both surfaces of each blade around the blade feathering bearings using aliphatic naphtha (C-305) or detergent (C-318) or equivalents. Refer to Figure 1.
 - b. Using a 10X power magnifying glass, closely examine the cleaned surface, on both sides of the blade, paying particular attention to the area around both bearings.
 - c. If no crack is found in the paint the inspection is complete until next inspection.
 - d. If a crack is found in the paint, proceed with step 2.
2. Remove the tail rotor blade from the helicopter. Refer to BHT-430-MM-7, Chapter 64.
