ALERT SERVICE BULLETIN
Bell Helicopter **TEXTRON**

NO. 430-07-39

MODEL AFFECTED: 430

SUBJECT: TAIL ROTOR PITCH CHANGE MECHANISM,
REVISED RIGGING PROCEDURES

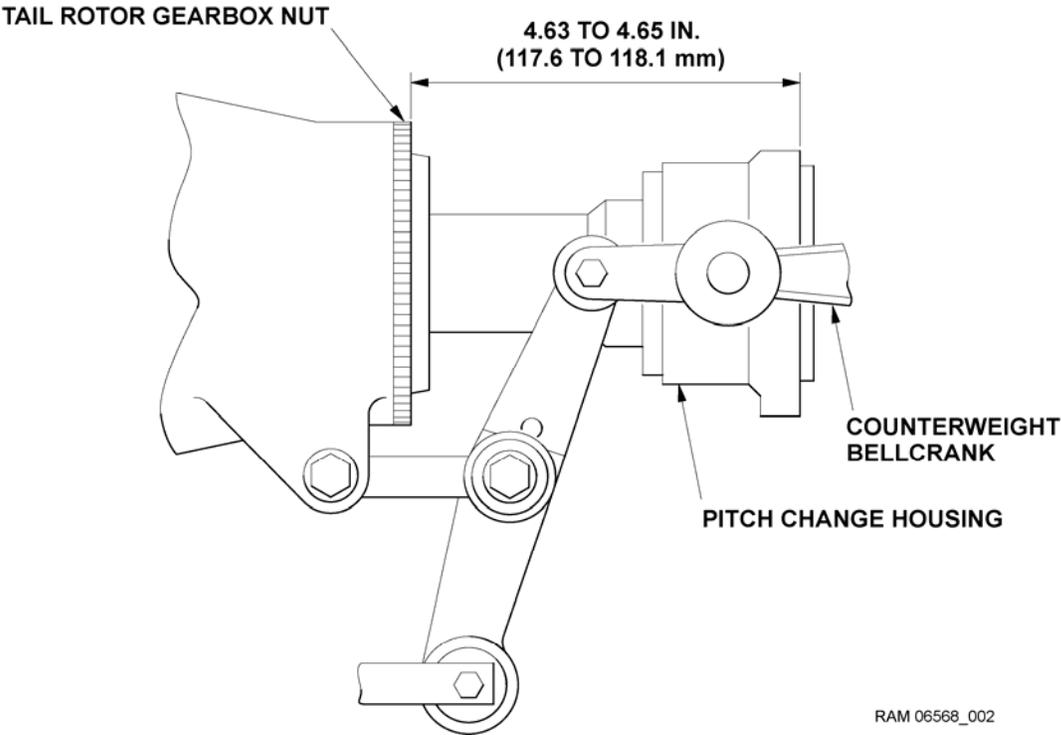
Figure 1. Tail Rotor Pitch Change Mechanism (Position)

It has come to the attention of Bell Helicopter Textron that due to parts tolerance buildup, the existing rigging procedures for the tail rotor pitch change mechanism can create a condition in which the position of the tail rotor counterweight bellcranks may not be at their optimized position to assist the flight crew with the tail rotor pedal forces in an emergency type operation with # 1 hydraulic system inoperative.

1. Move the tail rotor pedals as required and set the pitch change housing to obtain a 4.63 to 4.65 inches (117.6 to 118.1 mm) dimension as shown in Figure 1. Maintain this position.
