ALERT SERVICE BULLETIN

NO. 430-09-42

MODEL AFFECTED: 430

SUBJECT: STAKED BEARINGS, ONE-TIME INSPECTION OF.

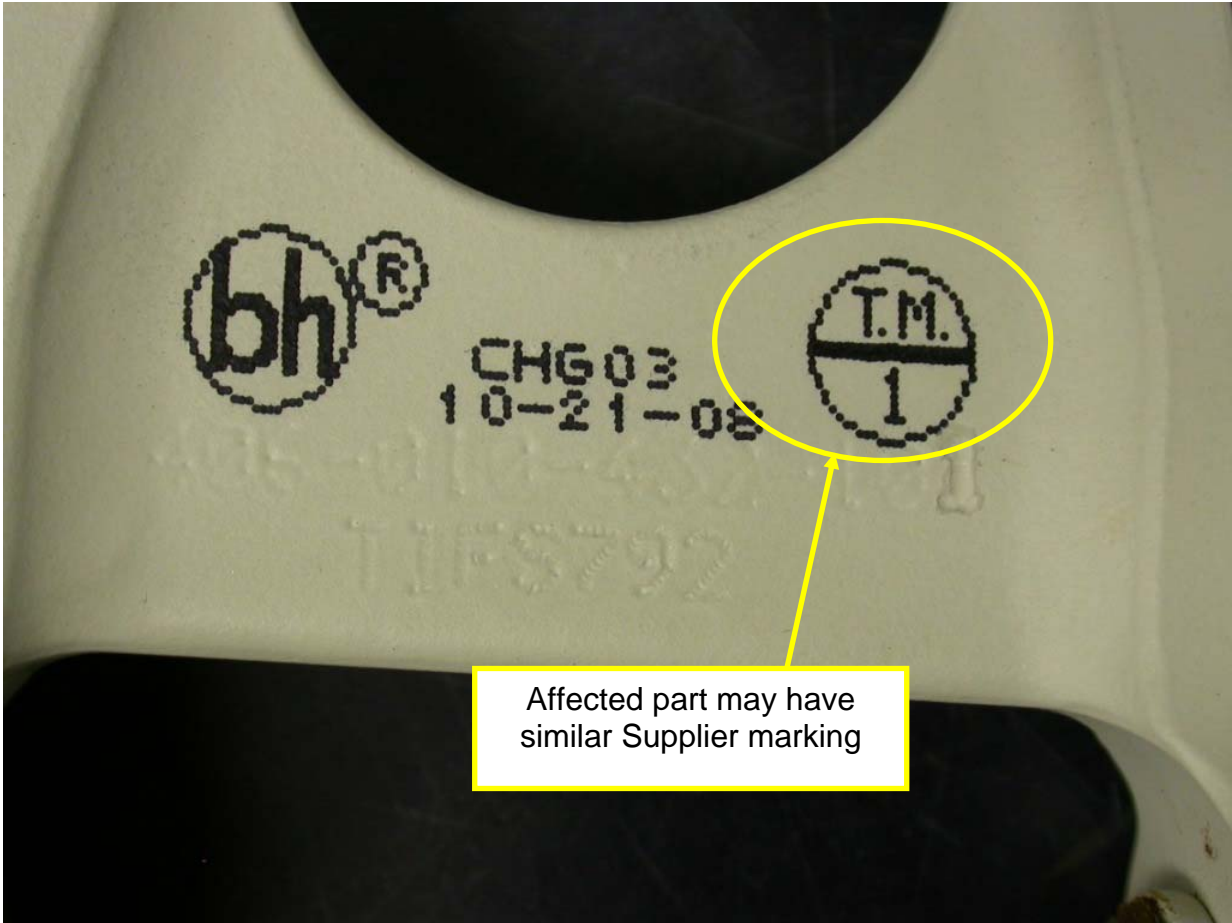
Bell Helicopter issues this bulletin to accomplish a one-time inspection of various parts that could potentially exhibit the same defect. The affected parts are separated in Table 1 and Table 2 based on installation characteristics and criticality. Parts in service and all spare parts are affected. When serialized, only parts with serial number prefix TI or TIFS are affected. However, affected part not serialized, may have Supplier marking as shown on Figure 1.

Figure 1. Affected part Supplier marking.
