**TO: All Owners/Operators of Bell 430 Helicopters**

**SUBJECT: REVISION A TO ALERT SERVICE BULLETIN 430-10-45:  
DIRECTIONAL FLIGHT CONTROL BEARING P/N MS27643-4;  
INSPECTION AND REPLACEMENT OF.**

NO. 430-10-45

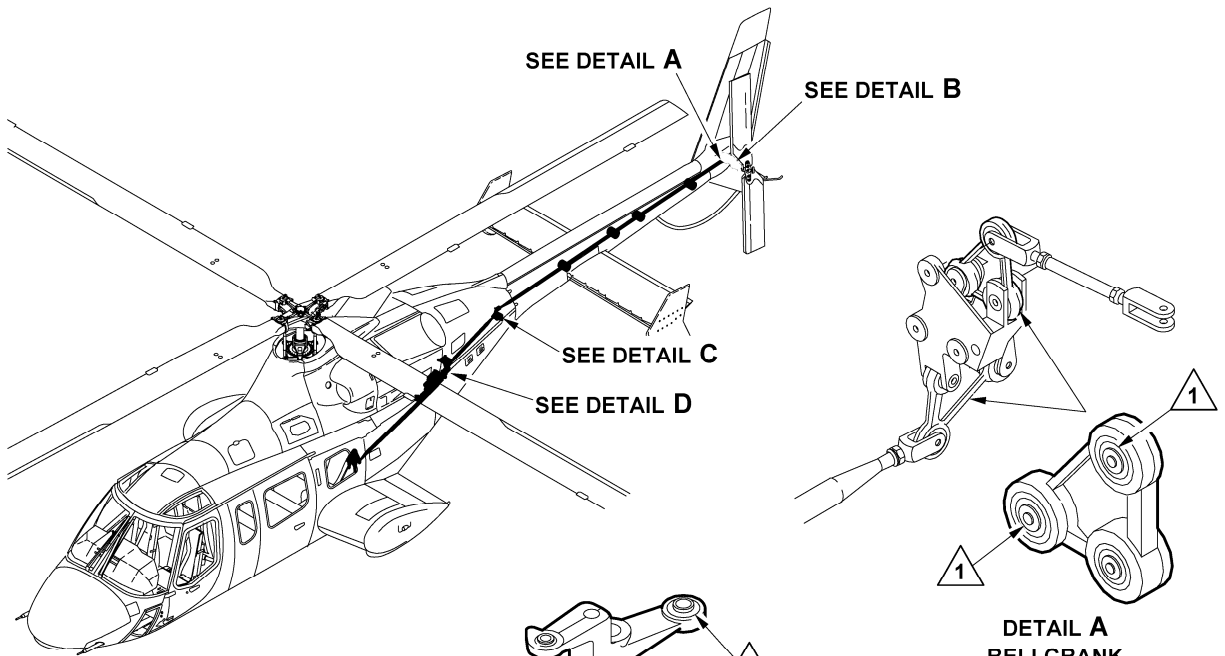
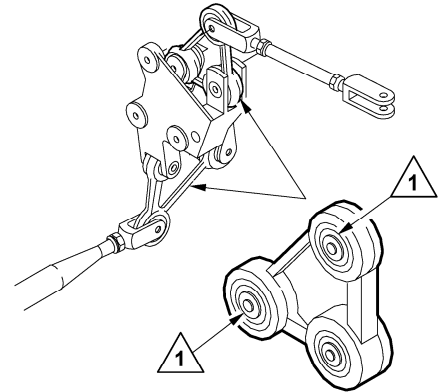
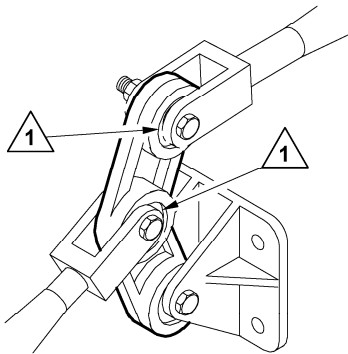
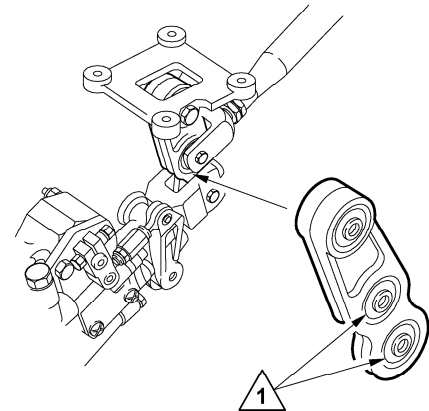
Figure 1

1. On the model 430, Bell Helicopter has identified 4 locations in the boosted directional flight controls where a degraded P/N MS27643-4 bearing can affect proper control operation.

Input lever Assembly P/N 222-012-715-101 contains 1 P/N MS27643-4 Bearing (Figure 1).

Bellcrank Assembly P/N 222-001-736-005 (QTY2) contains 2 P/N MS27643-4 Bearings (Figure 1).

Bellcrank Assembly P/N 222-001-734-001 contains 2 P/N MS27643-4 Bearing (Figure 1).

Bellcrank Assembly P/N 222-001-727-005 contains 2 P/N MS27643-4 Bearing (Figure 1).

- a. Disconnect directional control tubes at each location to be inspected. Specific bearings to be inspected are identified on Figure 1. Refer to BHT-430-MM as necessary.

- 1) Bearings found to be rough, binding, or otherwise not meeting serviceability criteria must be replaced immediately. Refer to BHT-430-MM and BHT-ALL-SPM, as applicable, for replacement procedures.

- 2) Schatz manufactured bearings installed after Sep 2006 and found serviceable remain susceptible to degradation and therefore must be replaced at the next 150 hour inspection but no later than one year after release date of this bulletin, which ever occurs first.

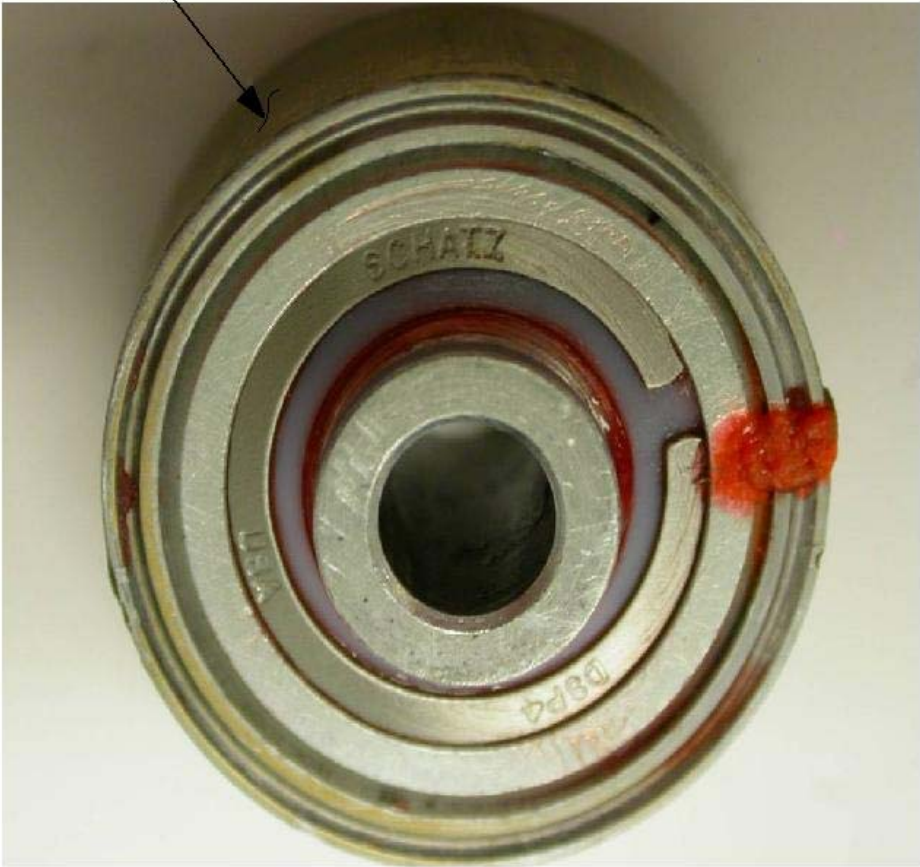
Figure 2

2. Installed MS27643-4 bearings manufactured by Schatz Bearing Corporation can be identified by the word **SCHATZ** and **DSP4** imprinted on the bearing seal retainer on at least one side of the bearing (Figure 2).
3. Uninstalled MS27643-4 bearings will expose a Schatz manufacturing lot number marked on the outer race, with MS27643-4 and DSP4-H or (L) identified on the packaging (Figure 2).

LOT NUMBER MARKED ON OUTER RACE
