# **Bell Helicopter** **TEXTRON**

## **INFORMATION LETTER 407-05-87**

**TO: All Owners/Operators of Bell 407 Helicopters**

**SUBJECT: FILTER 50-075-1, INSPECTION AND RECALL OF**

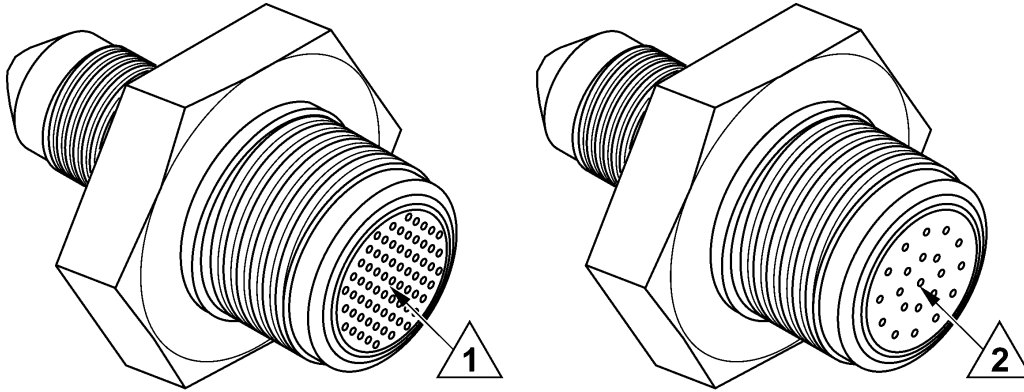
Figure 1. Filter 50-075-1 Physical Difference

This information letter is issued to report that in some filter units 50-075-1, the screen portion of the filter was not manufactured with the correct number of holes. Testing has confirmed this condition is not detrimental to the normal operation of the transmission and freewheel oil system. However, Bell Helicopter recommends that filter units with an incorrect hole pattern be identified and replaced.

- 1** Acceptable hole pattern. A minimum of 65 holes are required.
- 2** Unacceptable hole pattern to be removed from service.

To identify the configuration to be removed from service, examine the screen hole pattern (refer to Figure 1). Replace any unacceptable filter unit at your earliest convenience.
