OPERATION SAFETY NOTICE

407-17-21
28 June 2017

SUBJECT: TAIL ROTOR BLADE PREFLIGHT CHECK

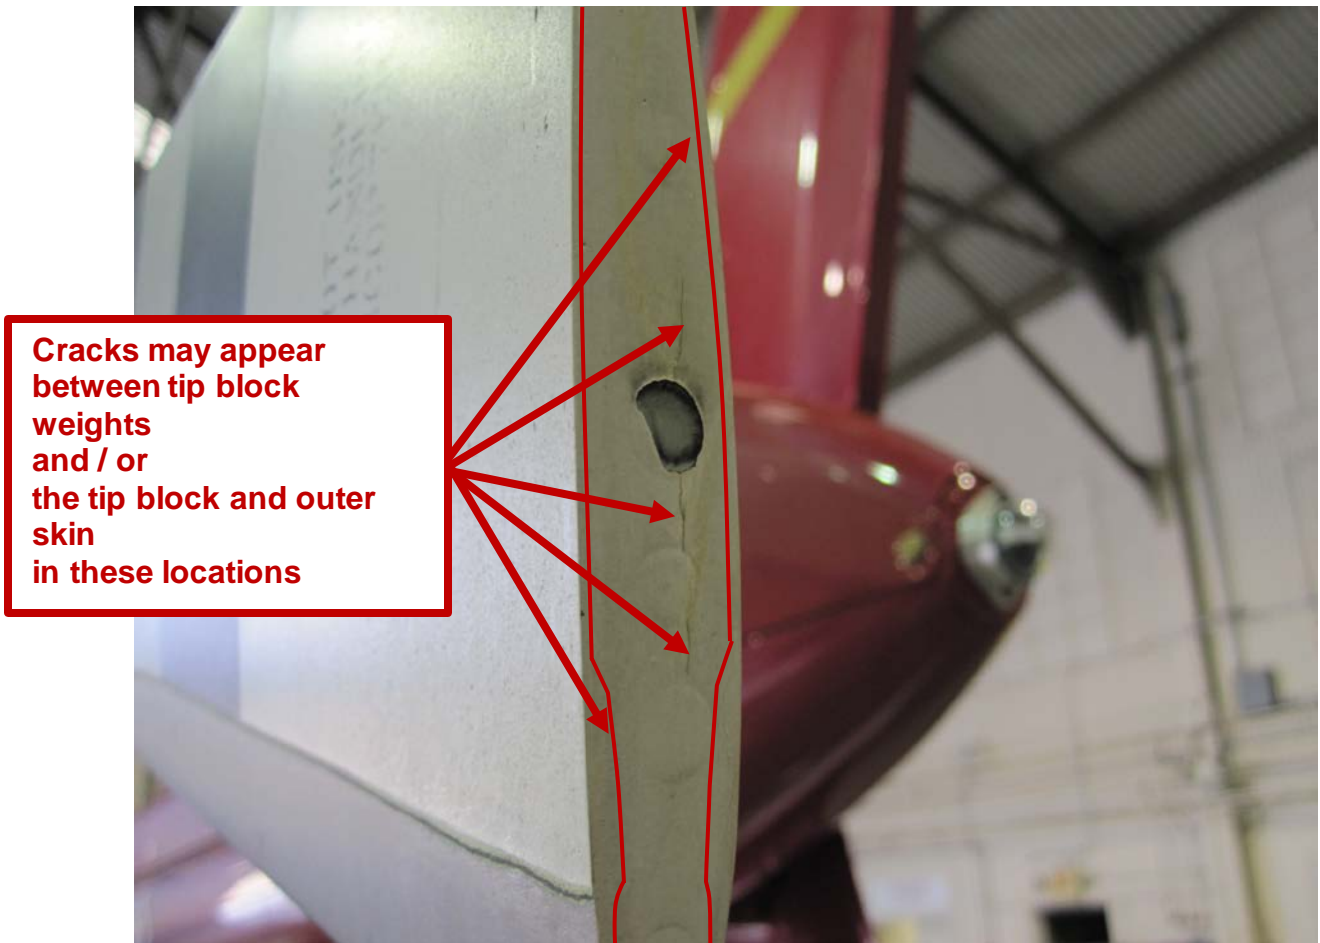
Figure 1 – Tail Rotor Blade Type Block Area

Following a recent event on a model 407 where a tail rotor tip block departed the tail rotor blade assembly in flight, Bell Helicopter is publishing this Operation Safety Notice (OSN) to emphasize the importance of the PREFLIGHT CHECK requirements contained in the BHT-407-FM-1 and BHT-407-FM-2 Flight Manuals, specifically the Section 2 for FUSELAGE – FULL AFT, and the tail rotor blades. For clarification, “tip block seal integrity” referenced in this procedure is explained as any anomalies (i.e. cracks, dents, damage, etc...), that might indicate degradation of the tip block bond.

Please note that wiping dirt and soot from the blade tip will increase visibility of cracks and other conditions in the area.

If any cracks are suspected in the bond lines, or anywhere else, on the tail rotor blade assembly it should be investigated further prior to flight. If a crack exists in any location, the blade is not acceptable and must be removed from service. Detailed tail rotor blade assembly inspection criteria can be found in the BHT-407-MM Maintenance Manual in Chapter 5 and 64. Refer to the Figure 1 below and the Figure 64-10 (extracted from the BHT-407-MM-7) of this OSN, to identify the areas to pay particular attention.
