TECHNICAL BULLETIN

407-14-109

MODEL AFFECTED: 407

SUBJECT: AFT ENGINE FIREWALL ASSEMBLY,
INSPECTION, REPAIR, AND MODIFICATION OF,
FOR ENHANCED STIFFNESS.

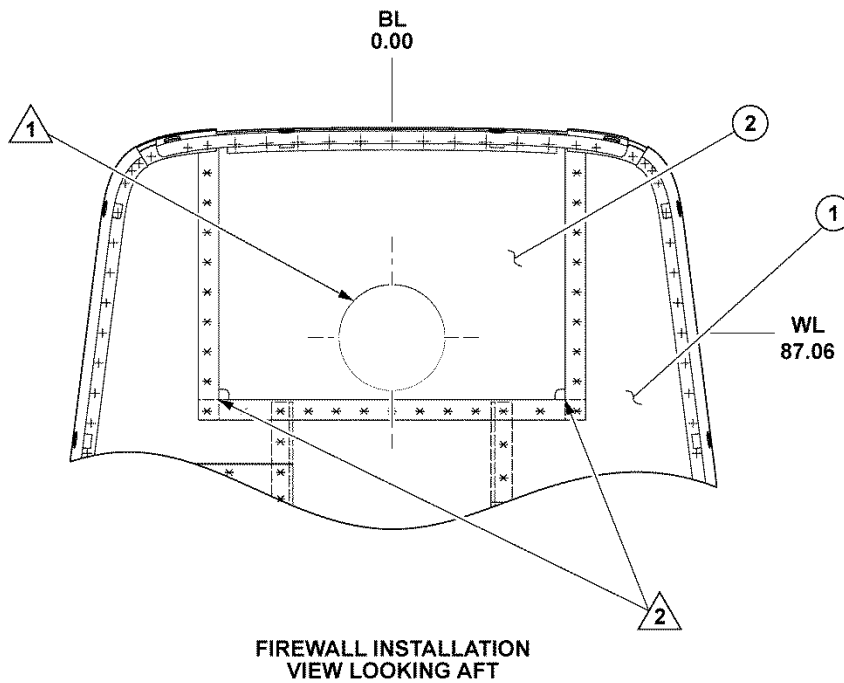
Figure 1: Firewall, Inspection of

Bell Helicopter Textron has received field reports of cracks and fretting marks found on the aft engine firewall assembly. Both of these conditions have been determined to be associated to differential pressure on both sides of the firewall caused by varying ram air pressure in the oil cooler blower compartment. This bulletin provides instructions to inspect, repair as necessary, and modify the aft engine firewall assembly in order to increase clearance between the fuel nozzle hose clamp and the firewall assembly. Compliance with this bulletin will also enhance stiffness and restrict fore and aft movement of the firewall web during dynamic flights.

1. Prepare the helicopter for maintenance.
2. Open the engine doors and inspect the aft firewall assembly. Pay attention to the recessed section (2, Figure 1) for any signs of fretting with the fuel nozzle hose and/or the shield clamp.

- 1. Inspect this region in recessed area for possible fretting marks from fuel nozzle hose clamp.
- 2. Inspect each corner radius of web for possible crack damage.
