ALERT SERVICE BULLETIN

ASB 210-24-19

MODEL AFFECTED: 210

SUBJECT: MAIN BEAM CAP ANGLE, P/N: 205-030-163-093,
INSPECTION OF.

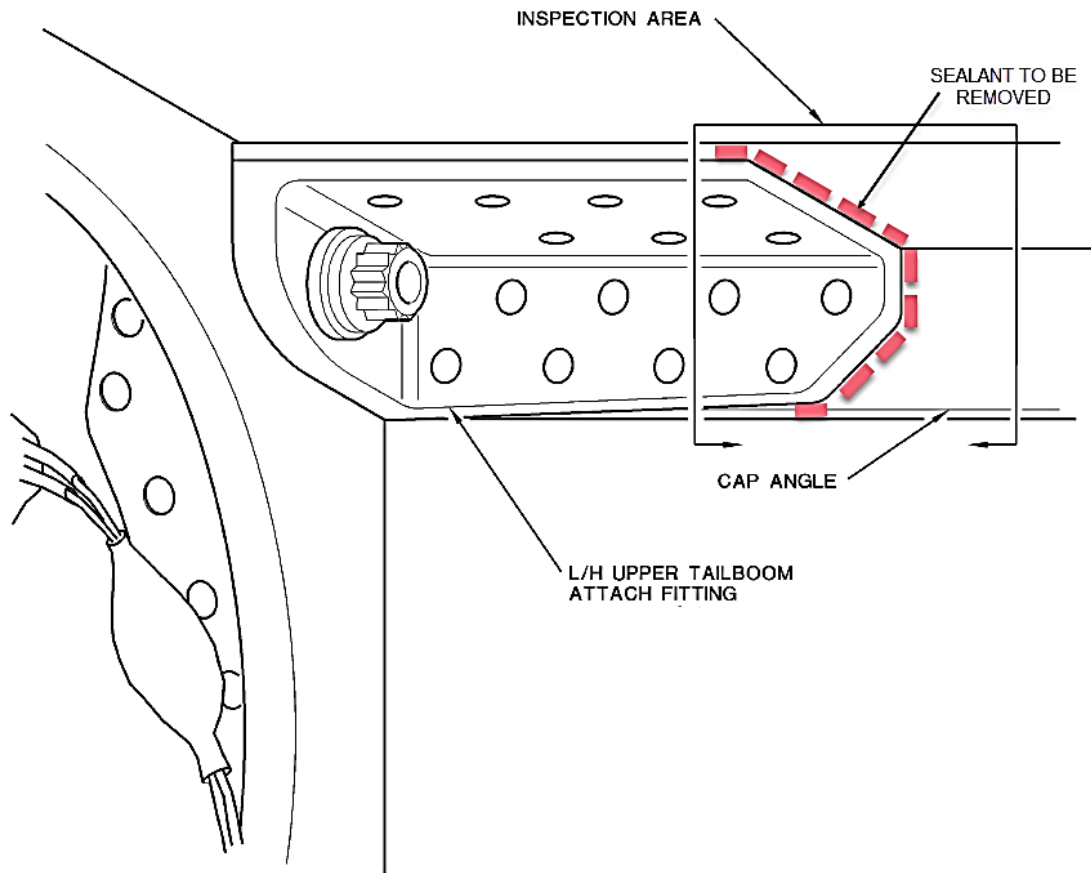
Figure1. Fuselage Tailboom Attachment Inspection.

Bell has investigated reports of fractured tailboom attachment main beam cap angles. Some were found during routine inspection and some during Special Inspections. The investigation indicates that the Special Inspection intervals established for the model helicopters with this cap configuration is not adequate to detect all cracks before possible fracturing of the cap angle. Since the risk of cracking/fracture remains on the 205-030-163-093 cap angle, this ASB introduces a recurring 25 Hour Tailboom Attachment Inspection. Special Inspections publications will be revised to include this 25 Hours Tailboom Attachment Inspection.

2. Remove sealant from edge of fitting (Refer to Figure 1).
3. Inspect the cap angle area shown in Figure 1 with a 10x magnifying glass and bright light.
4. If a crack is found, replace the cap angle before further flight. If no cracks are found, continue with Step 5.
5. Touch up primer and paint, if damaged during sealant removal, and allow to dry. Do not reapply sealant.
6. Ensure work areas are clean and secure. [QA]
7. Make an entry in the helicopter logbook and historical service records indicating findings and compliance with this Alert Service Bulletin.
