ALERT SERVICE BULLETIN

212-24-170

MODEL AFFECTED: 212

SUBJECT: MAIN DRIVE SHAFT ASSEMBLY INNER COUPLING 212-040-687-001, INSPECTION OF

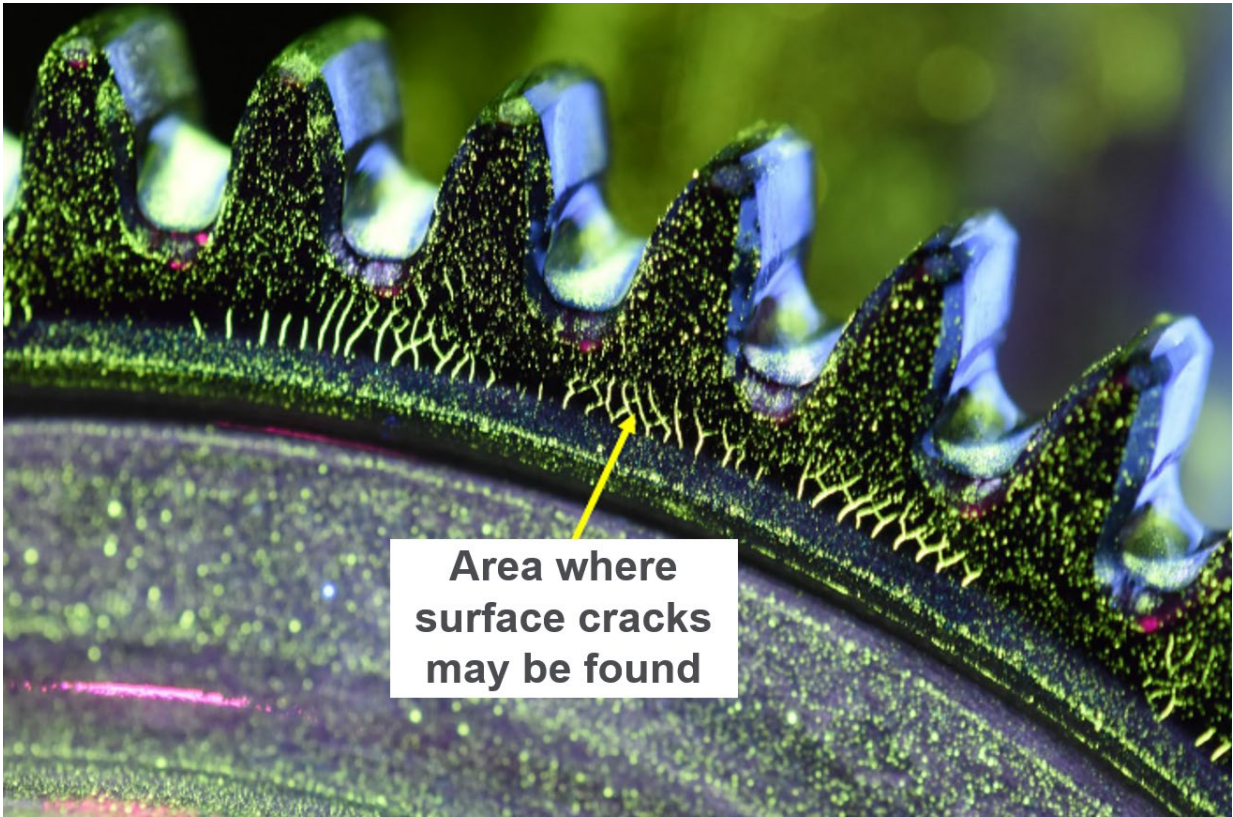
The 212-040-687-001 main drive shaft assembly inner coupling, serial number BH008845, was part of a lot of five inner couplings that may have been produced with a manufacturing defect. This defect, if present, can be detected by Magnetic Particle Inspection (MPI) as surface crack(s) at the tooth roots as shown in Figure 1 of the Accomplishment Instructions. Four of the five affected inner couplings have been retrieved and only one of the four inner couplings was found with the manufacturing defect. The suspected inner couplings were sold through spares in the 2014 timeframe.

NOTE 1: Required only if inner coupling serial number BH008845 is found with the manufacturing defect shown in the Figure 1.

Figure 1. Area where surface cracks may be found.

1. Within the compliance timeframe listed, perform a main drive shaft inner coupling serial number verification.
 - a. If inner coupling serial number BH008845 is not installed, go to step 2.
 - b. If inner coupling serial number BH008845 is installed, perform a MPI of the inner coupling before next flight (BHT-212-CR&O, Chapter 63).
 - (1) If the manufacturing defect shown in Figure 1 is not detected, go to step 2.
 - (2) If the manufacturing defect shown in Figure 1 is detected, contact Product Support Engineering and replace the affected inner coupling before next flight.
2. Make an entry in the helicopter logbook and historical service records indicating findings and compliance with this Alert Service Bulletin.
