## ALERT SERVICE BULLETIN

**407-24-138**

**MODEL AFFECTED:** 407

**SUBJECT:** ROOF BEAM SHIMMING, INSPECTION AND REPAIR OF

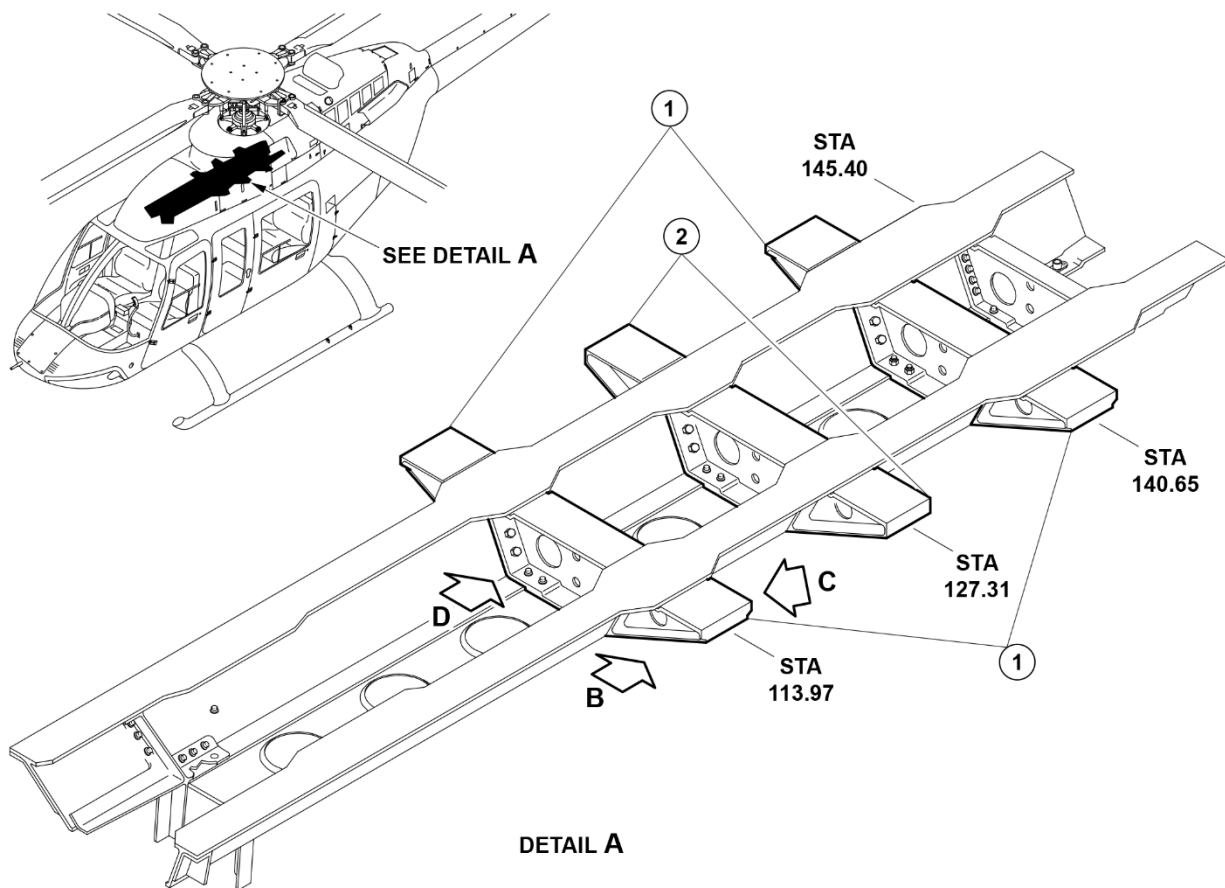
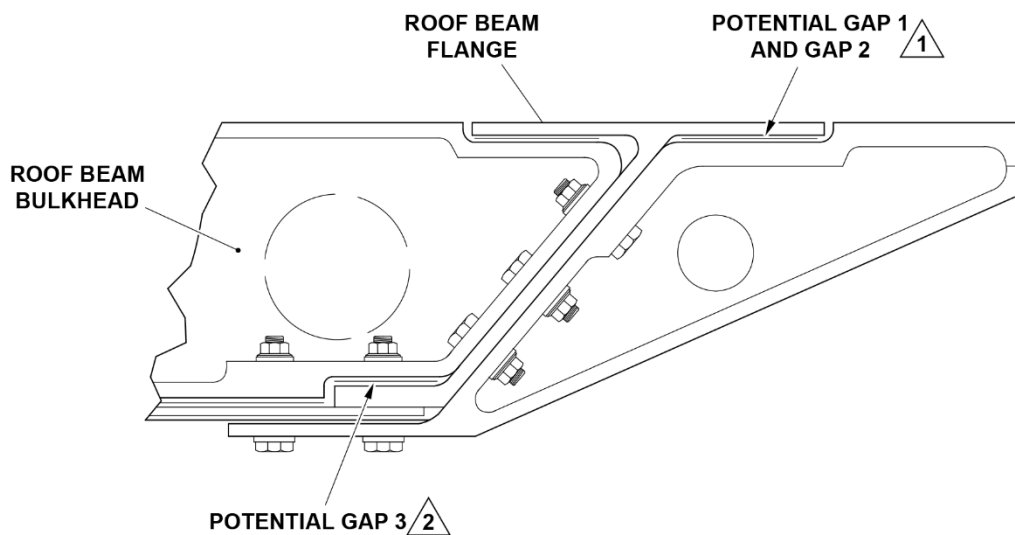
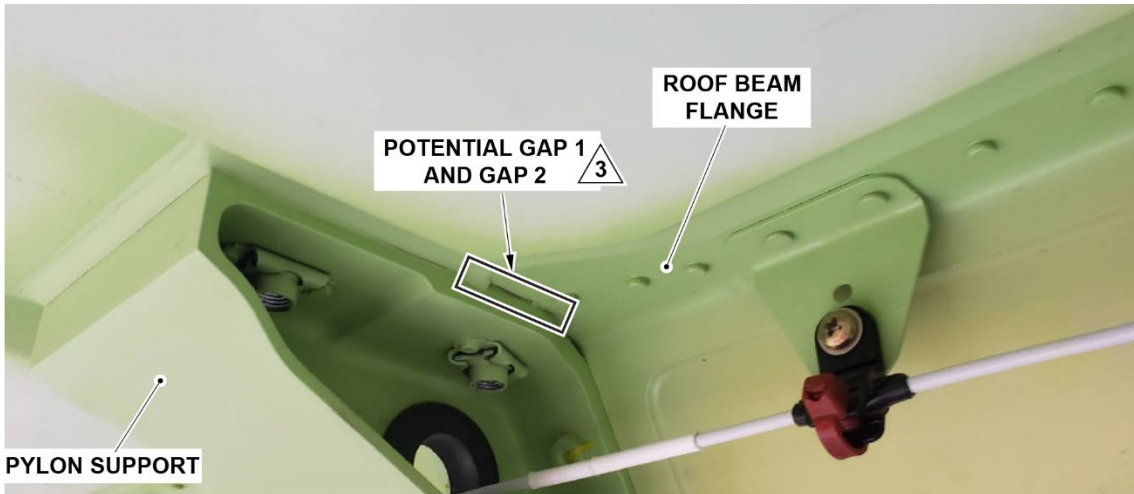
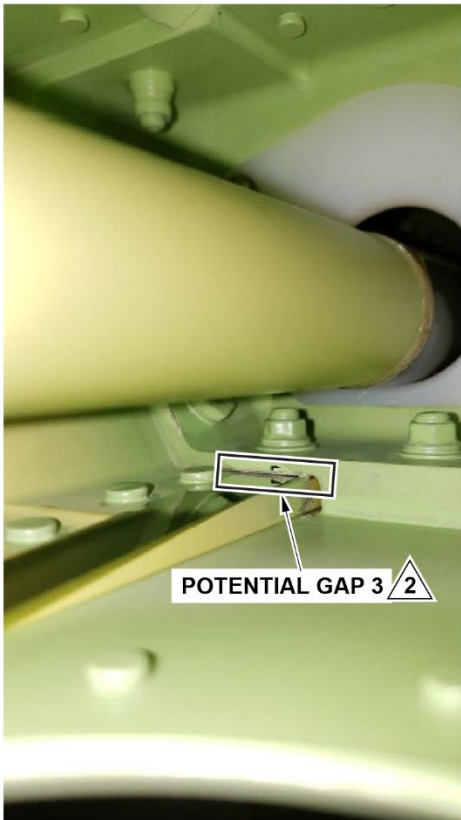
Figure 2: Roof beam potential Gap locations (Sheet 1 of 2)

Bell has been made aware that some operations during the assembly process of the roof beam structure could have been incorrectly performed. The resulting gaps, if not rectified, could affect the airworthiness life of the pylon side beams.

- a. At fuselage STA 113.97 and 140.65: Inspect for Gap 1 (fore and aft) between roof beam flange and pylon support (View B and C, Figure 2). Inspect for Gap 3 inside roof beam (both sides) (View D, Figure 2).

- b. At fuselage STA 127.31: Inspect for Gap 2 (fore and aft) between roof beam flange and stop support (View B and C, Figure 2). Inspect for Gap 3 inside roof beam (both sides) (View D, Figure 2).

- c. At fuselage STA 145.40: Inspect for Gap 3 inside roof beam (both sides) (View B and D, Figure 2).
10. Depending on the measured gap(s) values, roof beam shimming will need to be accomplished within different intervals.

A gap exceeding 0.012 inch (0.305 mm) at the pylon interface (GAP 1) affects the airworthiness life of the Pylon Side Beams. Such gap(s) shall be reported to Product Support Engineering.

Gap 1 located at STA 113.97 and 140.65, Gap 2 is similar to Gap 1 but at STA 127.31.
-

Qty (4) Gaps must be checked at STA 113.97, 127.31 and 140.65 (Fwd / Aft L/H side and Fwd / Aft R/H side). Qty (2) Gaps must be checked at STA 145.40 (Fwd L/H side and Fwd R/H side).
-

- b. If any gap exceeding 0.012 inch (0.305 mm) is detected, the affected pylon side beam shall be replaced and PART II of this ASB must be accomplished before next flight.

- c. For gap(s) exceeding 0.003 inch (0.076 mm) and not exceeding 0.012 inch (0.305 mm), PART II of this ASB must be accomplished within 660 flight hours or 12 months whichever occurs first after the release date of this bulletin .

8. For every gap measured between 0.025 inch (0.635 mm) and 0.060 inch (1.524 mm) at pylon support (GAP 1) or stop support (GAP 2) locations, shimming with the use of a solid shim is required before the laminated or liquid shim. If there is no gap measured between 0.025 inch (0.635 mm) and 0.060 inch (1.524 mm), proceed to step 9.

Liquid shimming must be used to rectify maximum gap(s) of 0.008 inch (0.203 mm).

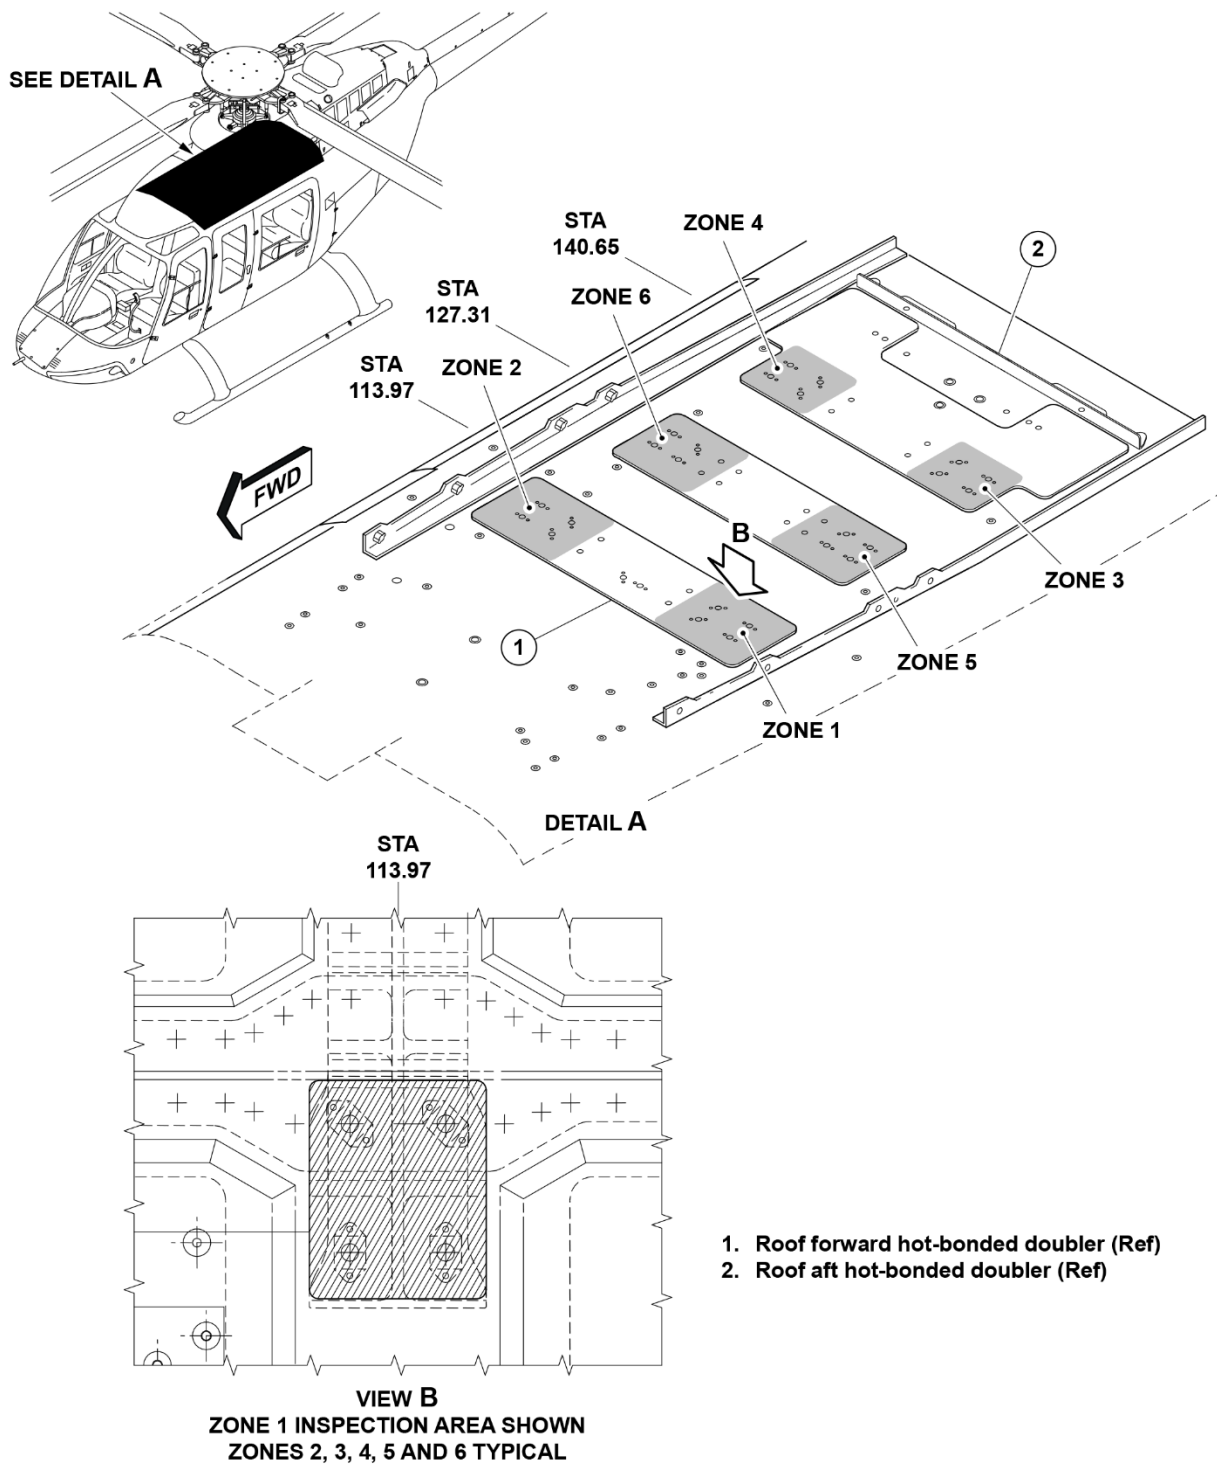
**Figure 3: Roof shell doubler FPI inspection areas**

- c. Remove primer on roof shell doublers in the affected zones (where a gap was found on the roof beam) as shown in Figure 3.
  - d. Perform a Fluorescent Penetrant Inspection (FPI) on the roof shell doublers at the affected pylon beam or stop fitting shim footprint areas (Figure 3). If no crack is found, refinish with primer (C-204) and reinstall affected shim.

- e. If a crack is detected, the roof shell will need to be repaired. Send a duly completed Structural Repair request (Ref: IL GEN-22-154) to Product Support Engineering.

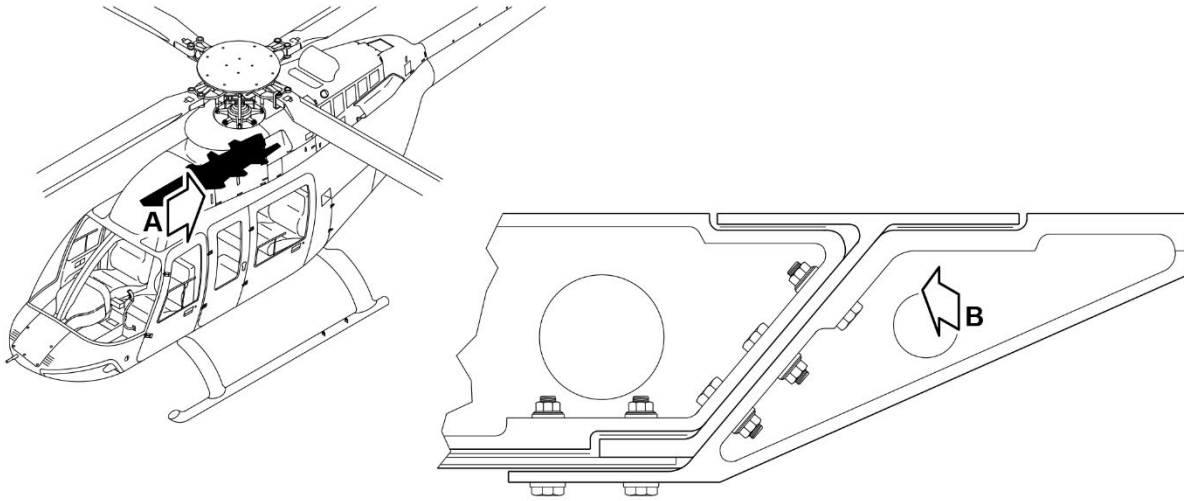
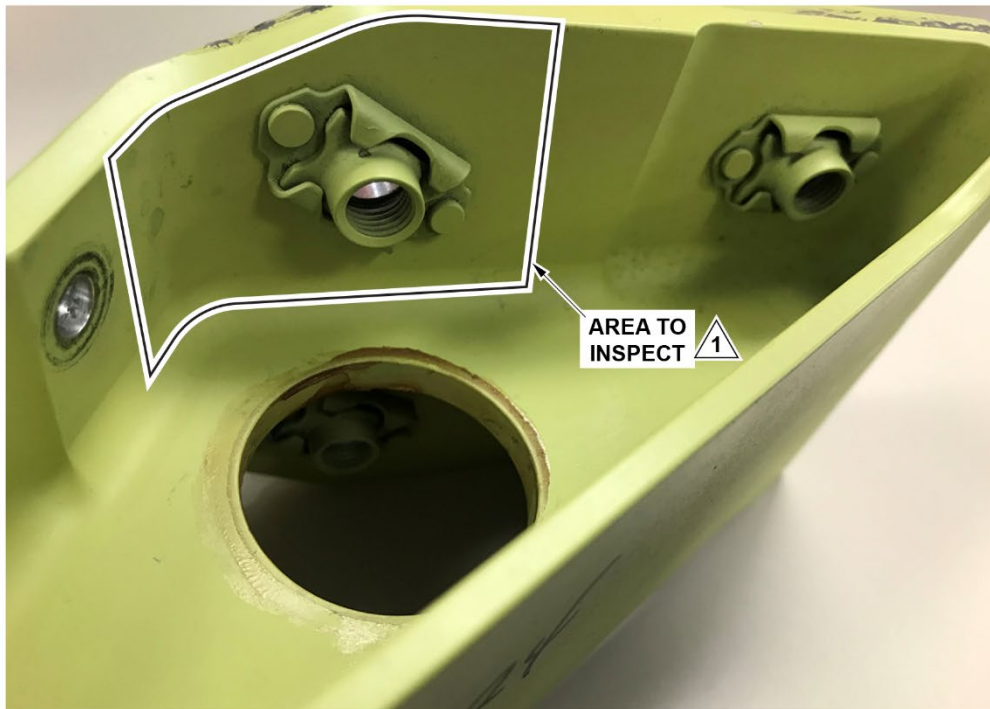
**Figure 4: Pylon support and stop support area to inspect**

- g. Using a 10X magnifying glass, inspect the affected pylon supports or stop supports within the inboard upper radius. Inspect for any signs of crack (Figure 4).

Pylon support and stop support area to inspect using a 10X magnifying glass.

- j. If a crack is detected, the roof beam assembly will need to be replaced in a Bell Approved fuselage fixture. Report any crack to Product Support Engineering.
