ALERT SERVICE BULLETIN

412-24-200

MODEL AFFECTED: 412EP

SUBJECT: ENGINE N1 CONTROL CABLE INSTALLATION, IMPROVEMENT OF.

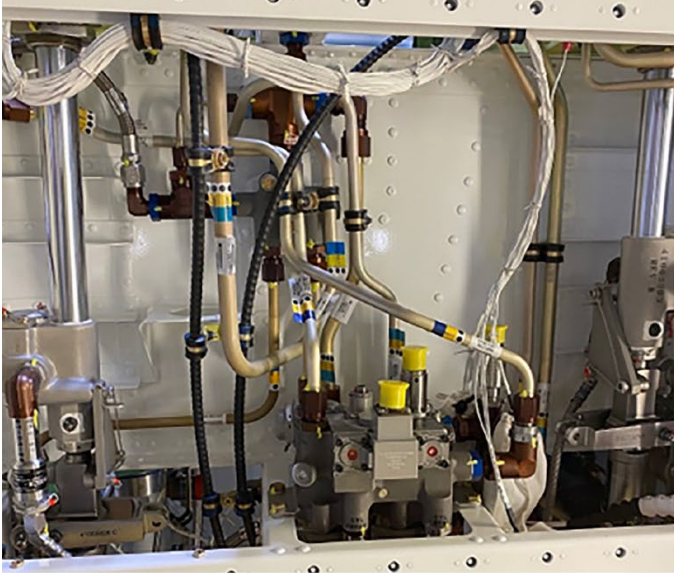
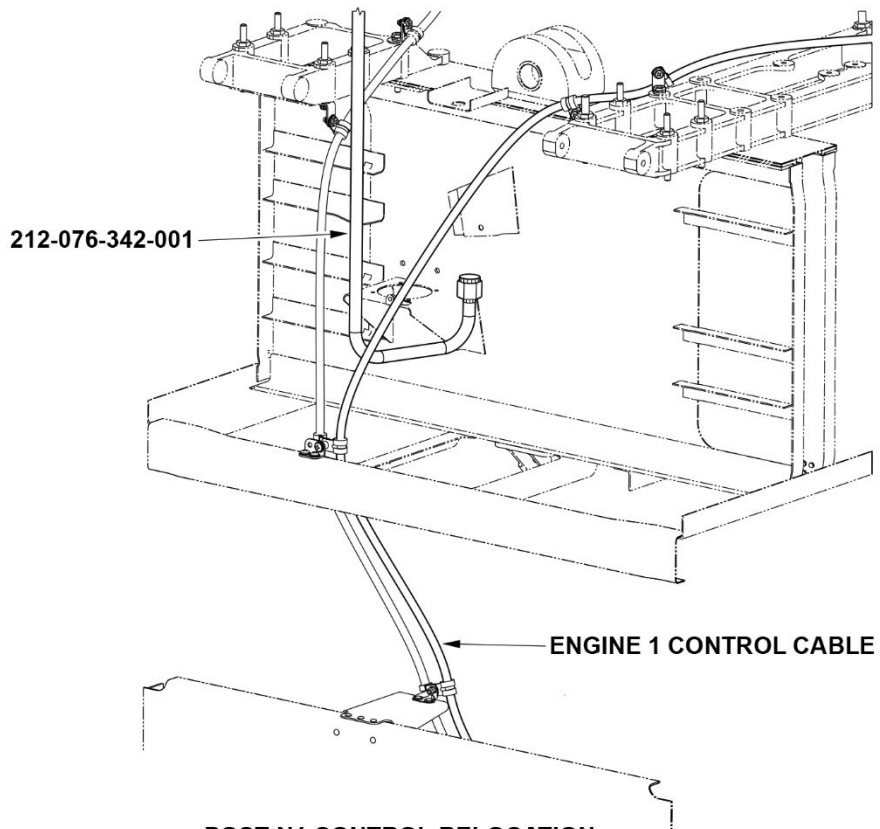
Figure 3. Engine 1 N1 control cable, pre and post relocation.

**PRE N1 CONTROL RELOCATION
VIEW LOOKING AFT**

**POST N1 CONTROL RELOCATION
VIEW LOOKING AFT**

6. Use Figures 5 and 6 to correctly route and secure the N1 control cable installation in the center fuselage area. Detailed instructions are included in the Figures.
7. Install hydraulic tube assembly 212-076-342-001 after relocation of the engine 1 control cable as shown (Figure 3).
8. Once the N1 control cable installation is complete, verify that both throttles operate smoothly over the entire range of operation and that there is no fouling.
9. Install the previously removed center fuselage panels 212-030-276-001 and 412-030-237-101 (Figure 1).
10. Install the previously removed center floor panel 412-030-378-101 (Figure 2).
11. Make an entry in the helicopter logbook and historical service records indicating compliance with this Alert Service Bulletin.

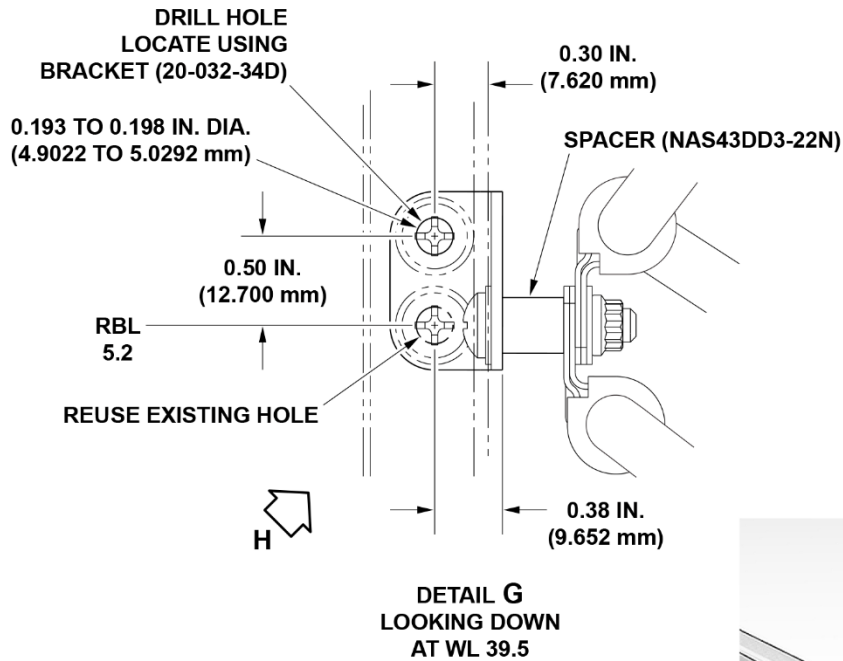
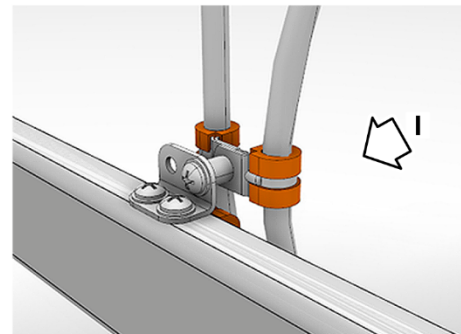
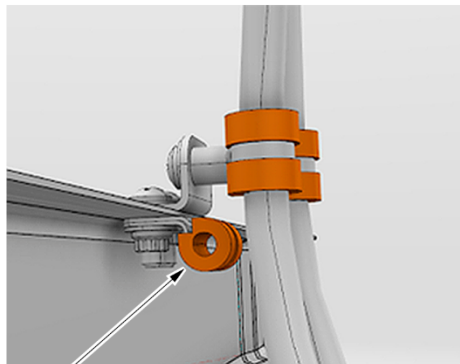
Figure 5 (sheet 6 of 6). Post ASB configuration center fuselage.

Maximum distance between N1 control cables and bulkhead must not exceed indicated value to ensure no fouling exists between the cargo suspension assembly when installed and pushed forward against the bumper assembly.

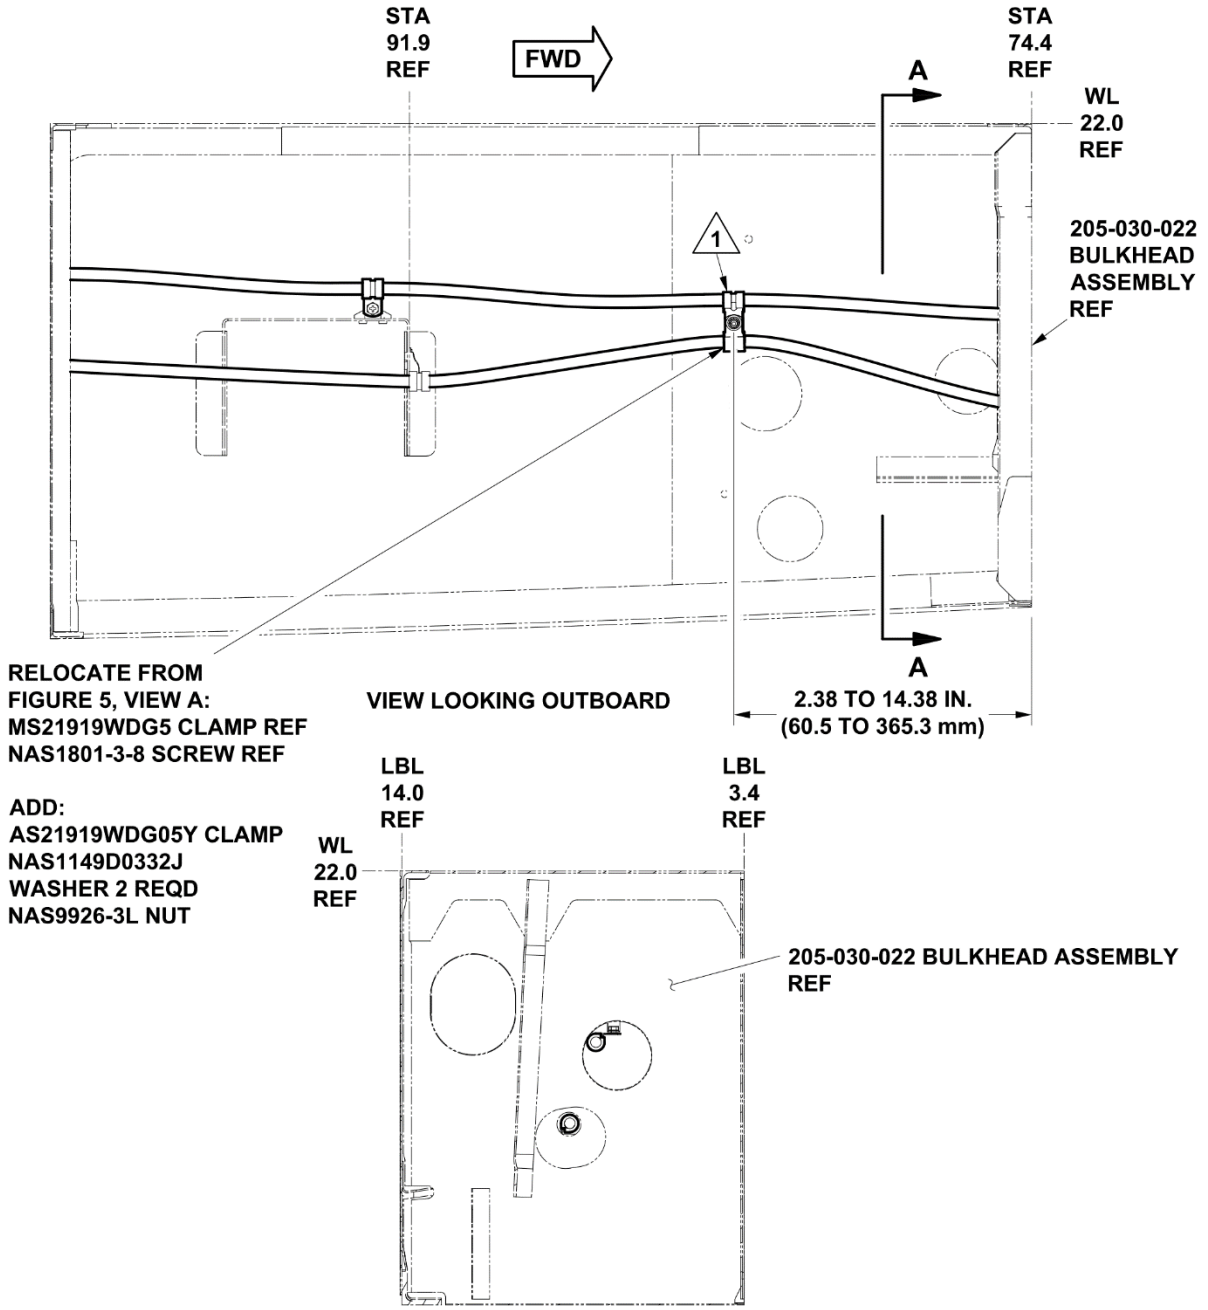
Figure 6. Post ASB configuration center floor.

1 Locate clamping arrangement to avoid fouling between the N1 control cables and the 205-030-022 bulkhead assembly.
