## ALERT SERVICE BULLETIN

**412-24-201**

**MODEL AFFECTED:** 412EP

**SUBJECT:** TRANSMISSION ASSEMBLY 412-040-008-105,  
UPGRADE OF

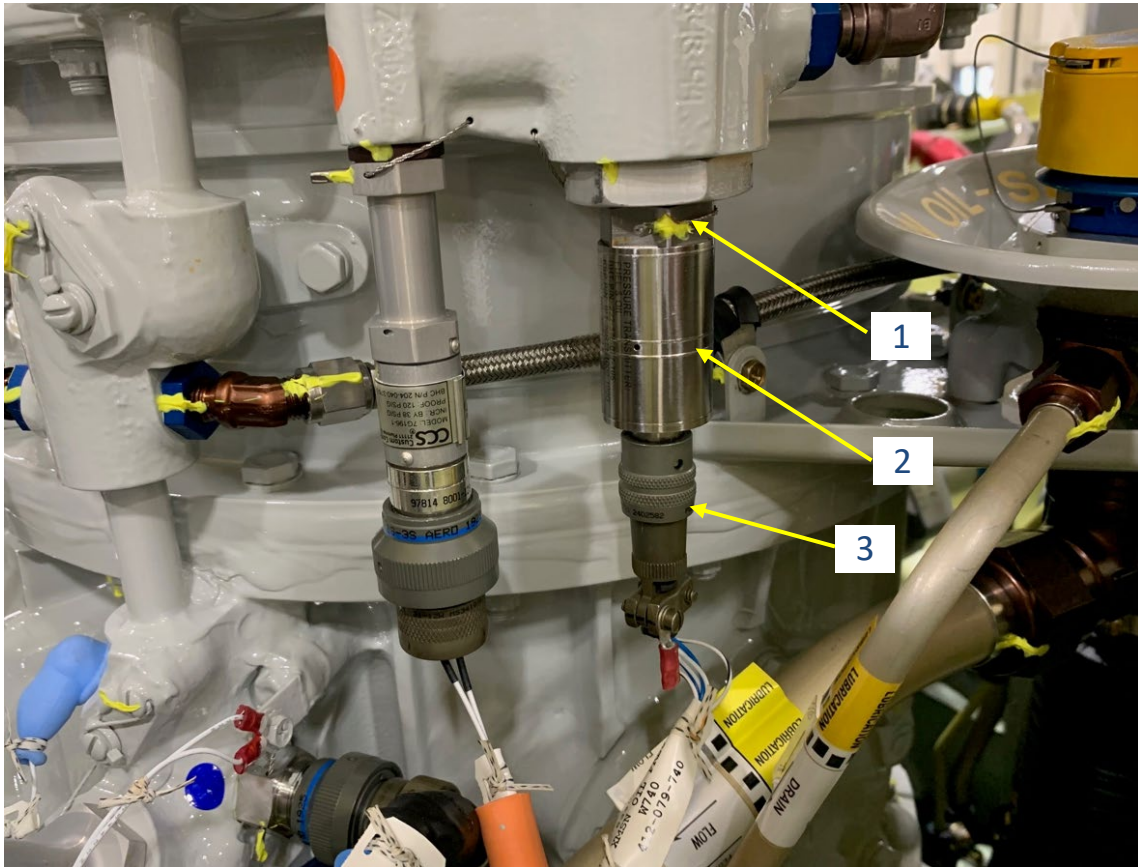
Figure 1, Detail A. Transducer and connector installation.

Bell has received reports of three issues related to the main transmission. The first issue reported, is transmission oil pressure indication fluctuations caused by fretting wear of the oil pressure transducer/connector locking mechanism. The second issue is fretting wear between two oil jets and their respective housings due to loss of torque of the oil jet attaching screw. The third issue reported is contamination of the transmission oil due to fretting of the spring inside the oil filler cap assembly secured to the support case.

**PART I** of this bulletin mandates the replacement of the currently installed 222-375-077-105 transducer and 160-027-508 connector by 222-375-077-121 transducer and D38999/26WA35SN connector having an improved locking mechanism.

1. Prepare helicopter for maintenance and remove necessary cowlings to access the oil pressure transducer (2, Figure 1, Detail A).
2. Disconnect connector (3), remove safety wire (1), transducer (2), and the packing.
3. Install new AS3208-04 packing and 222-375-077-121 transducer (2). Torque 50 to 65 in-lbs (5.65 to 7.35 Nm) and safety wire with AS100028 (C-405).
4. Remove existing terminal lugs from the strain relief.
5. Disconnect strain relief from connector (2).
6. Remove wires listed below from the existing connector (2, Figure 1, Detail B).
