ALERT SERVICE BULLETIN

429-25-64

MODEL AFFECTED: 429

SUBJECT: NON-CONFORMING FUEL PROBES,
REPLACEMENT OF.

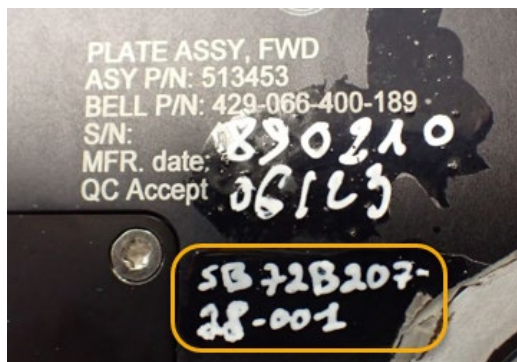
If reference "SB 72B207-28-001" is found written on the plate assembly, this indicates it was repaired at the supplier and is not affected by this Alert Service Bulletin.

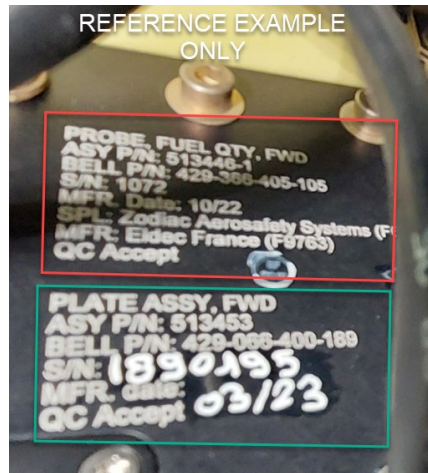
Table 1 lists the individual probes or plate assemblies sold through spares or installed during production. If a plate assembly referenced is found affected, order a replacement plate assembly. If a probe referenced is found to be affected, order a replacement probe. Access to view probe and plate assembly markings as found on the exterior of fuel system beneath the fuselage.

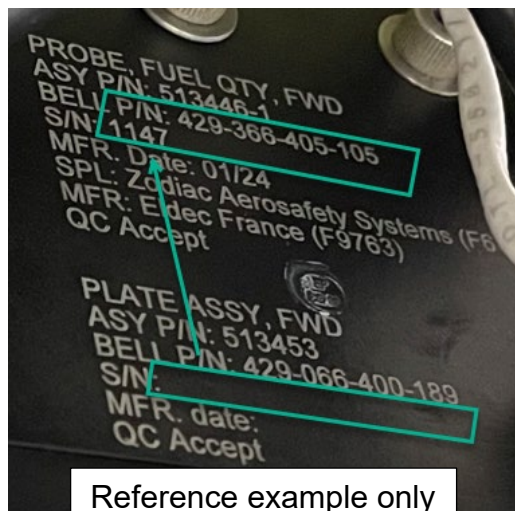
Fuel probes replaced in the field may have a plate assembly identified without a serial number. If no serial number at the plate assembly level is found, this indicates assembly not affected. Subsequently, refer to the fuel probe part number and serial number to determine if affected per Table 1.
