ALERT SERVICE BULLETIN

505-17-02

MODEL AFFECTED: 505

SUBJECT: TRANSMISSION OIL MANIFOLD ASSEMBLY,
INSPECTION AND CLAMP INSTALLATION
MODIFICATION OF.

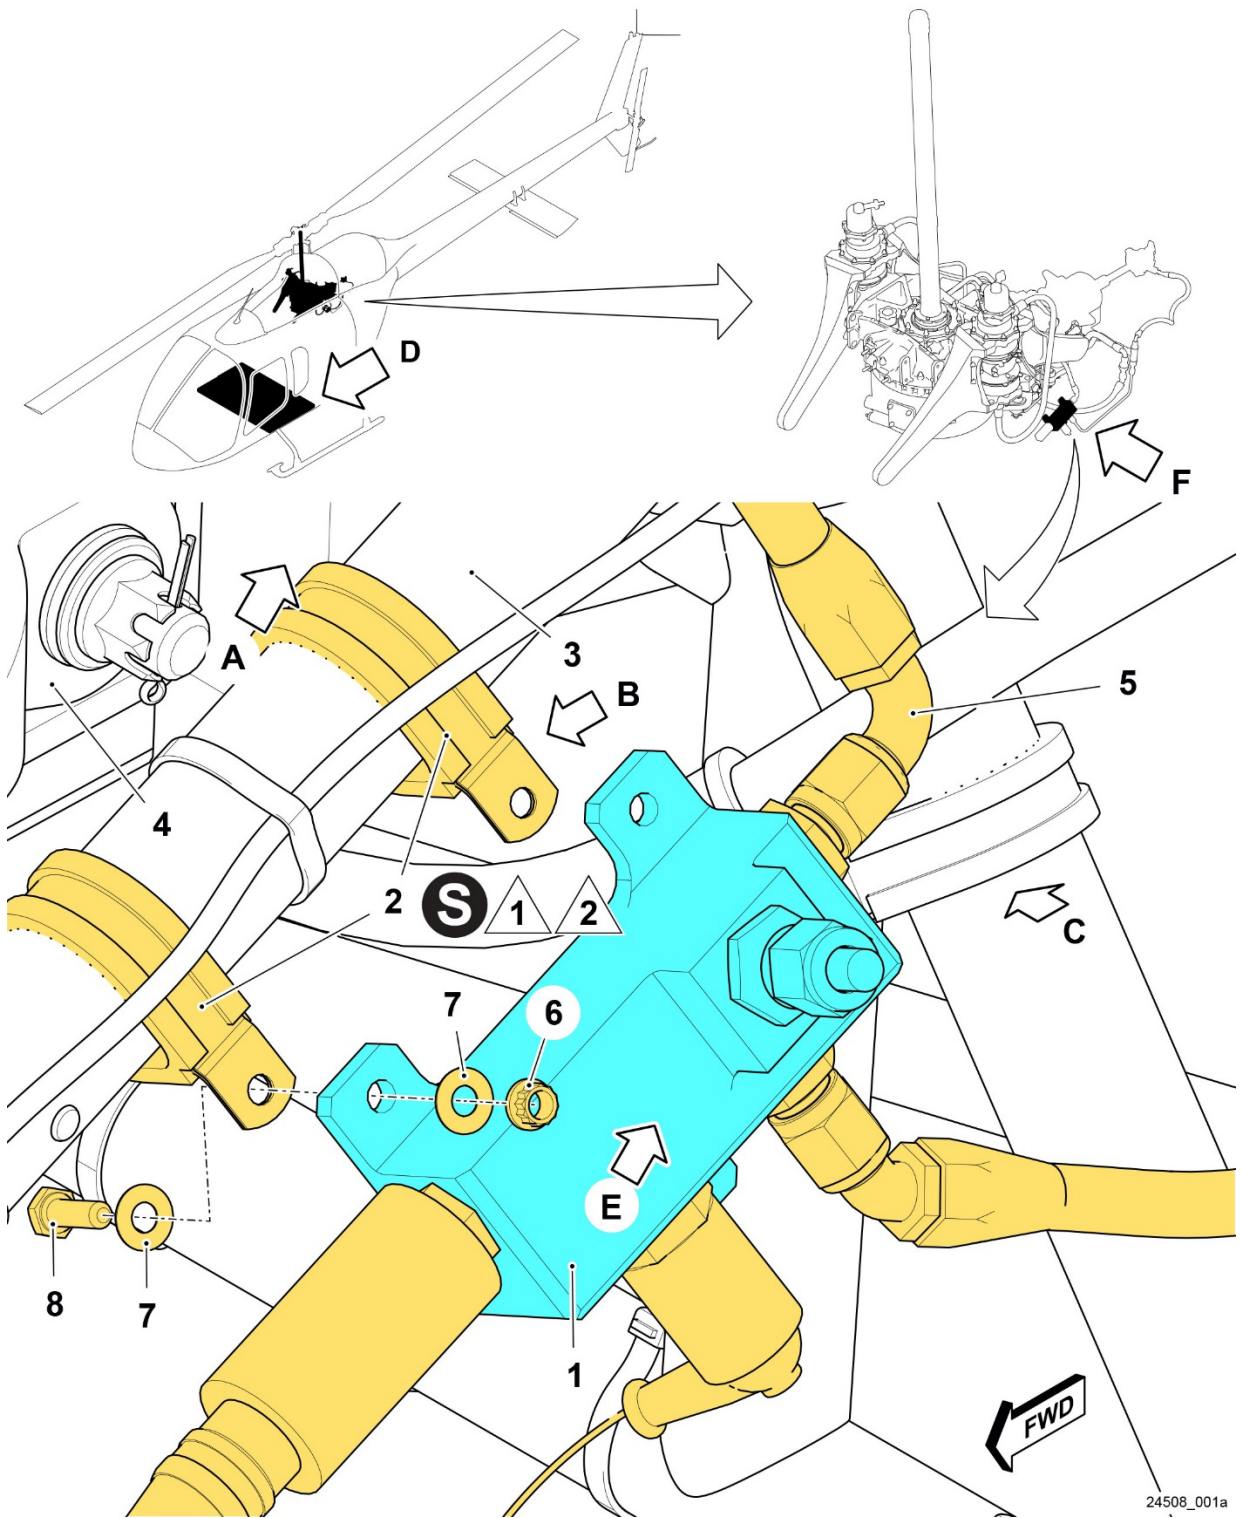
**Figure 1 – Typical Transmission Oil Manifold Assembly Installation
(sheet 1 of 5)**

1. Prepare the helicopter for maintenance.
2. Remove upper-left mid-fuselage access panel ([DMC-505-A-53-40-03-00A-520A-A](#)).
3. Inspect clamps (2, Figure 1, sheet 1 of 5) securing the manifold assembly (1) to make sure they have a tight grip and exhibit no easy movement on the truss tube (3).
 - a. If movement of the oil manifold assembly (1) is not possible without much effort, go to step 4.
 - b. If movement of the oil manifold assembly (1) is possible without much effort, following completion of the **PART I** inspection, comply with **PART II** of this bulletin prior to next flight.
4. Inspect the oil pressure line (5) and transmission restraint assembly (4) for damage.
 - a. If no damage is found, go to step 5.

3. Remove clamps (2, Figure 1, sheet 1 of 5) securing the oil manifold assembly (1) to the truss assembly (3) and discard ([DMC-505-A-63-22-10-00A-520A-A](#)). Retain nuts (6), washers (7), and screws (8) for later steps at installation.

5. Position clamps (2, Figure 1, sheet 1 of 5) and oil manifold assembly (1) on the truss assembly (3) to provide a minimum clearance of 0.300 inch (7.62 mm) between the oil pressure hose (5, Figure 1, sheet 2 of 5) and the transmission restraint assembly (4).
