ALERT SERVICE BULLETIN

505-24-40

MODEL AFFECTED: 505

SUBJECT: TAIL ROTOR SEGMENTED DRIVESHAFT ASSEMBLIES, ONE-TIME INSPECTION OF.

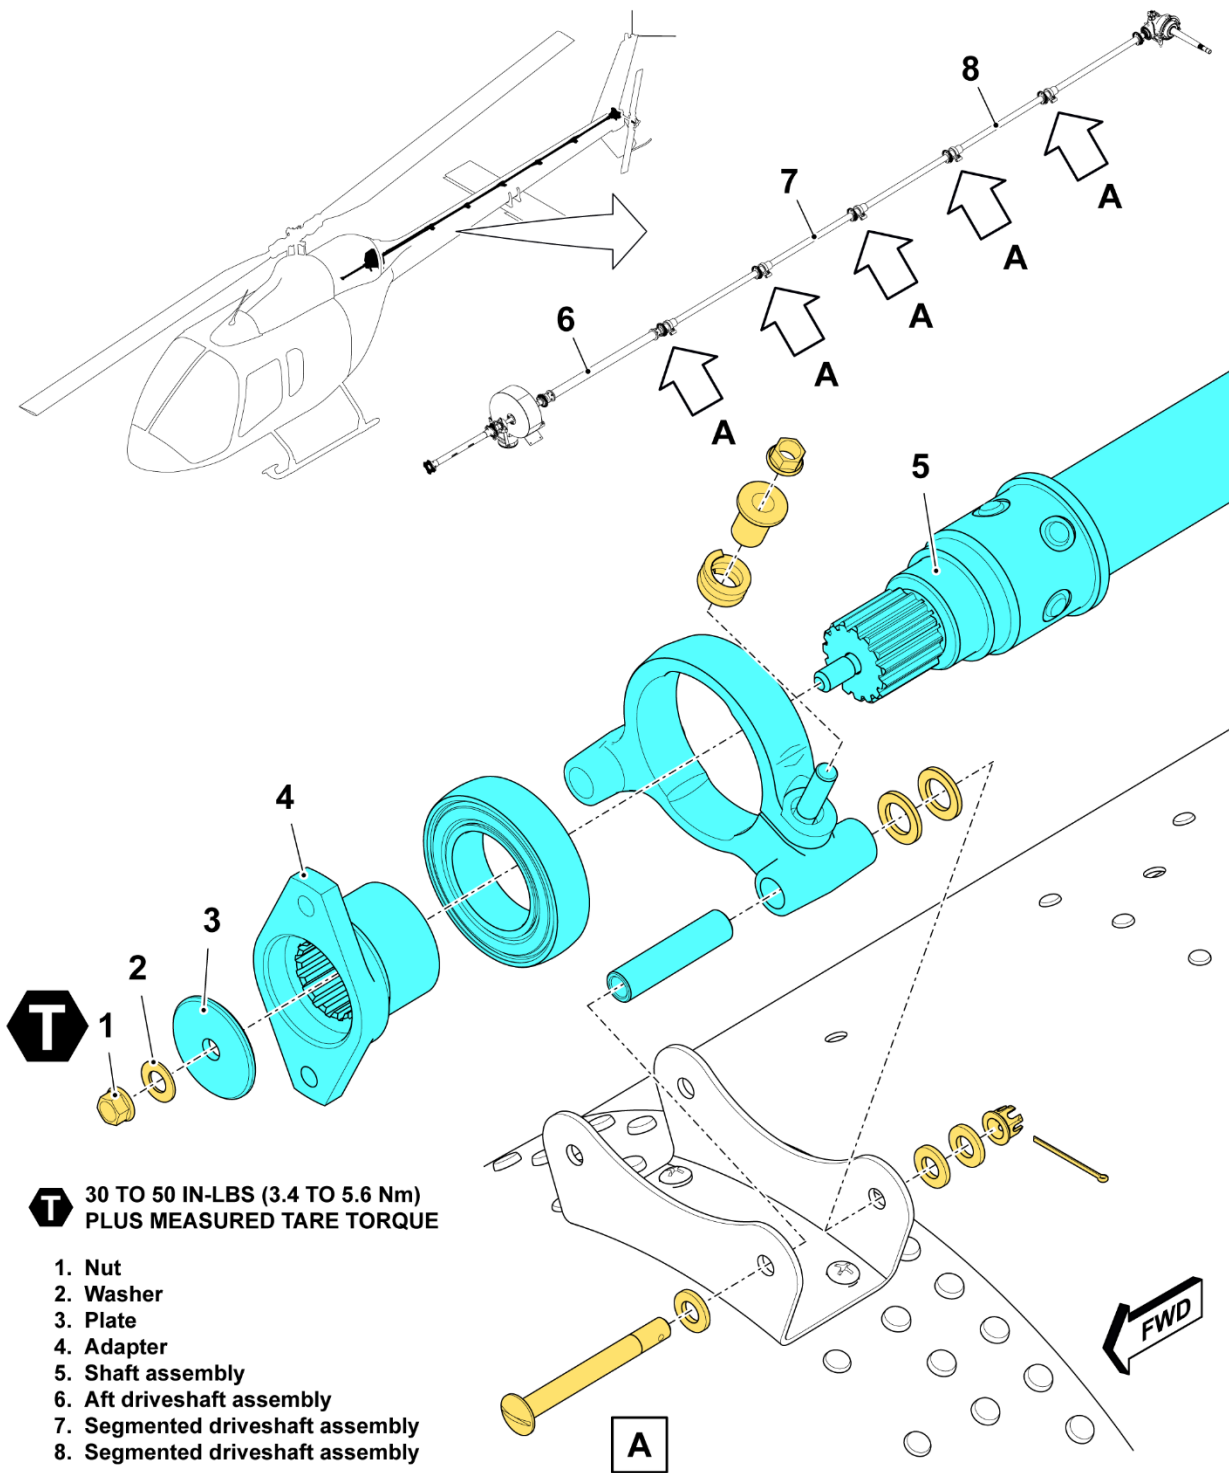
Figure 1 – Tail Rotor Segmented Driveshaft Assembly

Bell has received reports of looseness of the splined adapters on the tail rotor segment driveshaft assembly. The investigation noted that the retaining nut holding the splined adapter to the driveshaft was found with less than the required torque.

8. Check the tail rotor segmented driveshaft assembly splined adapters (4) for any noticeable radial or axial (fore and aft) play between the splined adapter (4) and the driveshaft (5) for all five locations (Figure 1, View A).

- a. If there is no radial or axial play noted, perform the following:
 - (1) Remove any torque seal lacquer (C-049) that may be applied to nut (1) on all five of the tail rotor segmented driveshaft assemblies.

- (2) Unseat the nut (1) by loosening the nut by $\frac{1}{2}$ to 1 turn (BHT-ALL-SPM, Chapter 2) at each of the five tail rotor segmented driveshaft assemblies.

- (3) Measure the tare torque of the nut (1) using a dial indicator torque wrench.
 - (a) If the nut (1) tare torque meets the minimum tare torque of 3.5 inch-pounds (0.4 Nm), go to step 8.a.(4).

- (b) If the nut (1) tare torque is less than 3.5 inch-pounds (0.4 Nm), replace the nut with a serviceable nut and repeat step 8.a.(3).
 - (4) Torque the nut (1) 30 to 50 inch-pounds (3.4 to 5.6 Nm) plus the tare torque measured in step 8.a.(3).

- (5) Apply torque seal lacquer (C-049) across threads of the stud of driveshaft (5), nut (1), washer (2), and plate (3). Go to step 9.
 - b. If radial or axial play is noted, perform the following:

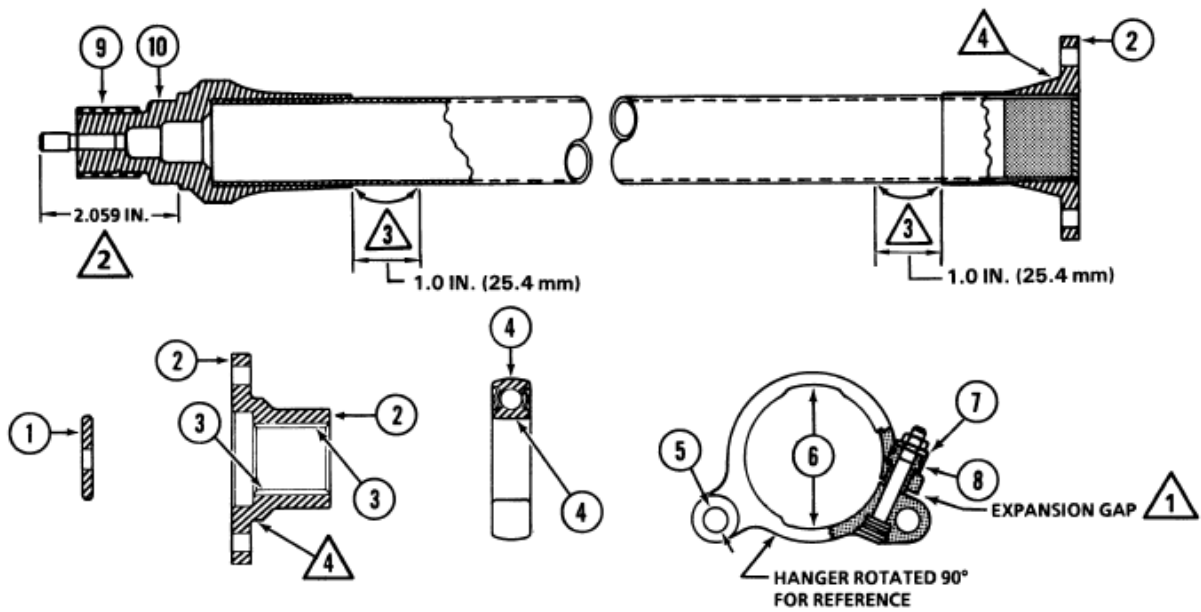
Figure 2 –Tail Rotor Segmented Driveshaft Assembly Wear Limits

- (1) Disassemble the applicable tail rotor segmented driveshaft assembly ([DMC-505-A-65-10-04-00A-530A-A](#)).
 - (a) Inspect splined adapter (4) and driveshaft (5) splines for allowable damage (Figure 2). Replace or repair parts as required.

- (2) Assemble the applicable tail rotor segmented driveshaft assembly with serviceable parts ([DMC-505-A-65-10-04-00A-710A-A](#)).
