ALERT SERVICE BULLETIN

505-24-41

MODEL AFFECTED: 505

SUBJECT: TAILCONE ASSEMBLY SKINS AND FRAMES,
ONE-TIME AND RECURRING INSPECTION OF.

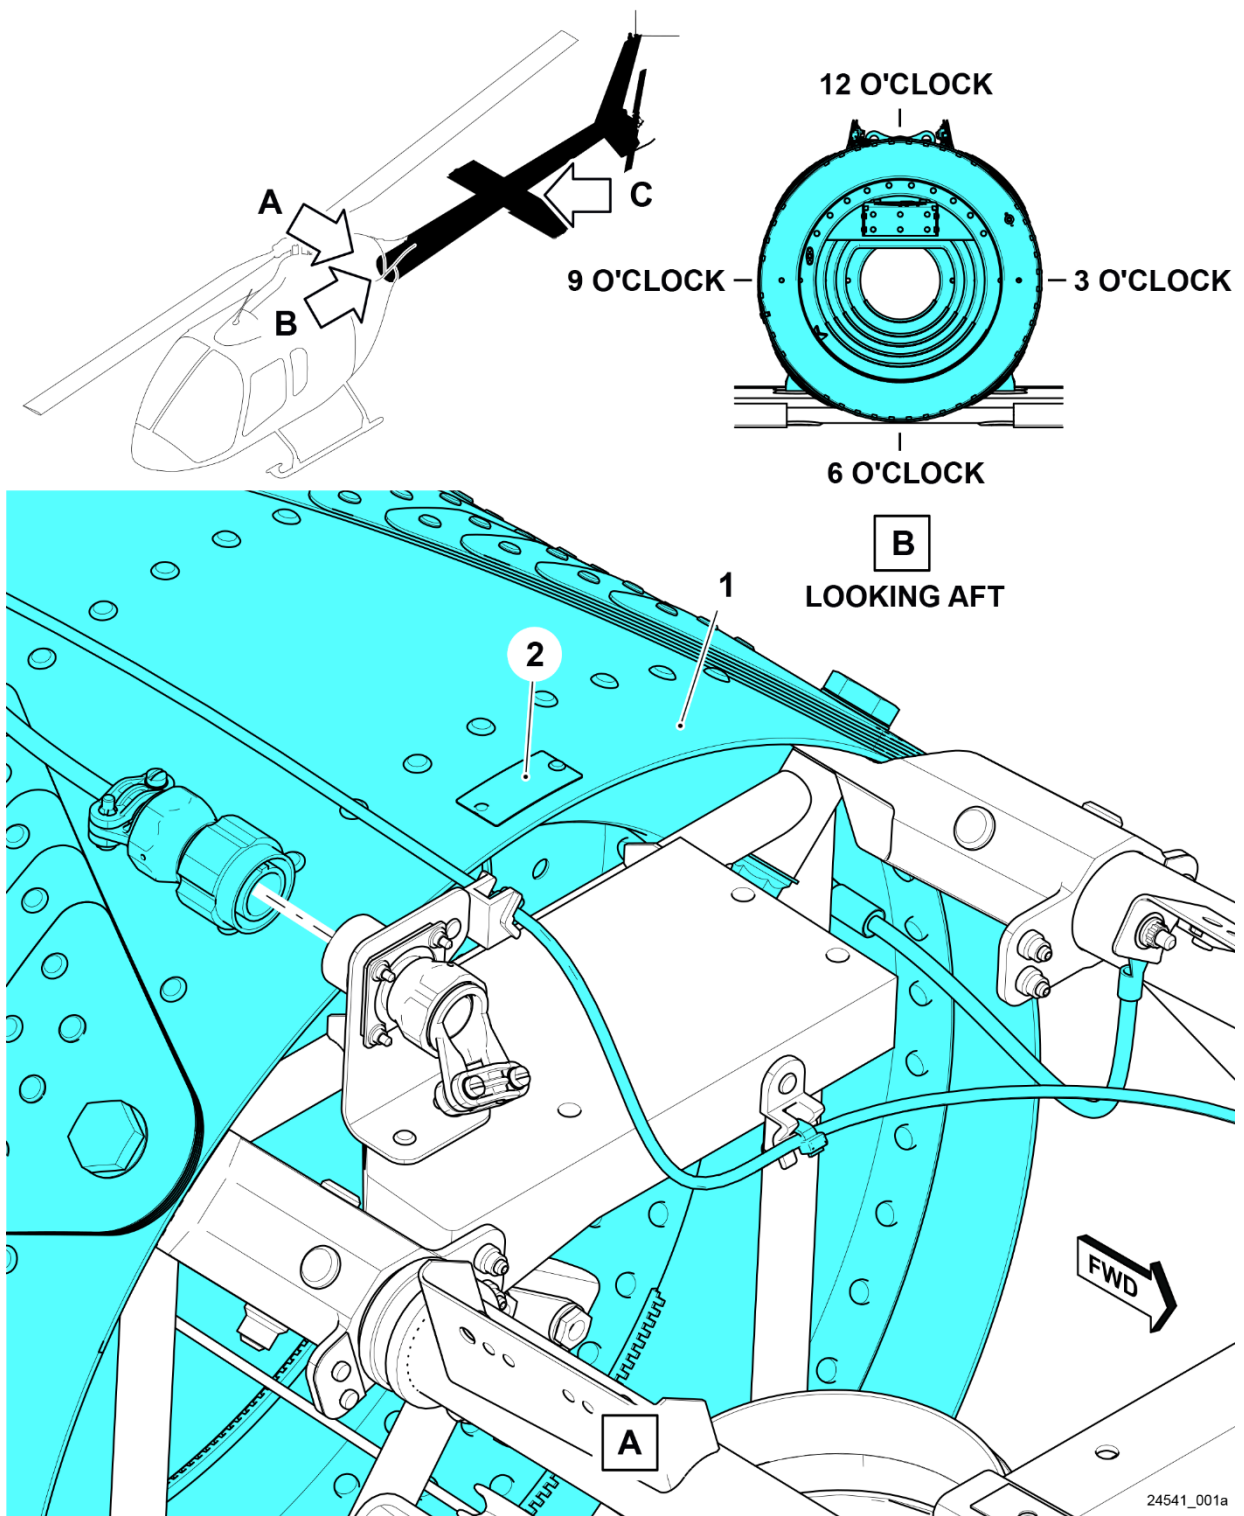
Figure 1 – Location of Tailcone Assembly Identification Plate

2. Remove the exhaust fairing (444AT) ([DMC-505-A-53-40-05-00A-520A-A](#)).
3. Verify serial number of the installed tailcone assembly (1, Figure 1, View A) marked on the identification plate (2).
 - a. If the tailcone assembly (1) serial number identified **is** listed in Table 1, go to step 4.
 - b. If the tailcone assembly (1) serial number identified **is not** listed in Table 1, go to step 10.
4. Remove horizontal stabilizer assembly ([DMC-505-A-55-10-01-00A-520A-A](#)).
5. Remove aft tailboom access panel (310BB) ([DMC-505-A-53-50-07-00A-520A-A](#)).

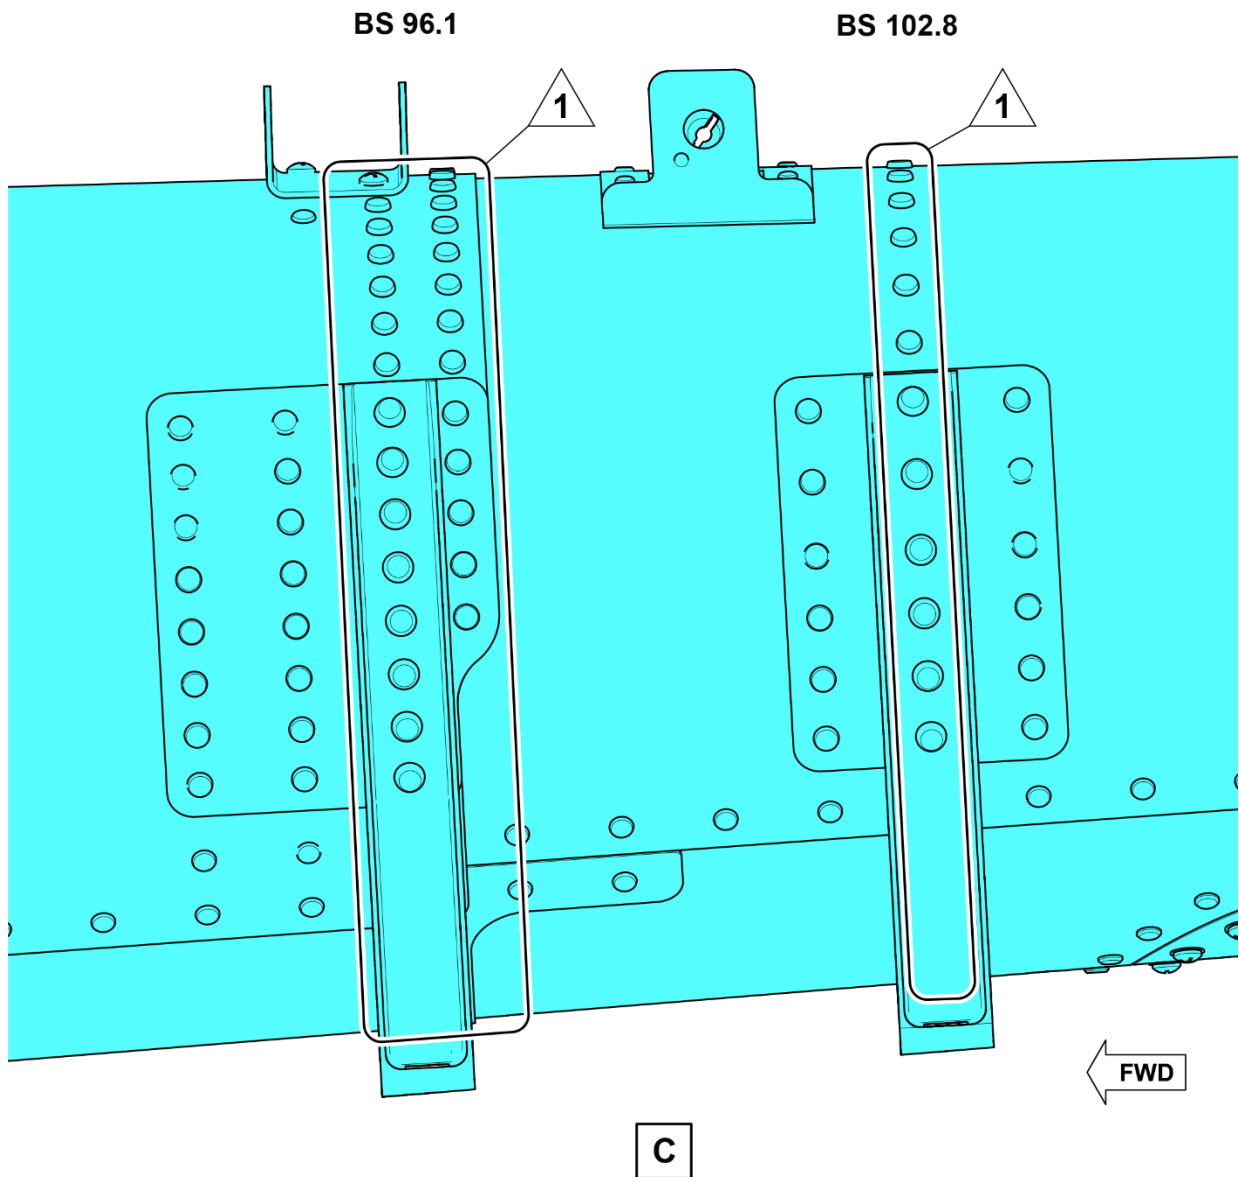
Figure 2 – Location of Tailcone Assembly Inspection

6. Using a feeler gauge, on the whole internal circumference of the tailcone assembly, check for gaps between the skins and frames at stations BS 96.1 and BS 102.8 (Figure 2) at each fastener location up to the shank of all the fasteners.
 - a. If no gaps, or gaps of 0.003 inch (0.076 mm) or less up to the shank of the fasteners are found, go to step 12.
 - b. If gaps greater than 0.003 inch (0.076 mm) up to the shank of the fasteners are found, note the locations and amount of the gap. While looking aft, use the 12 o'clock position at the top of the tailcone assembly, as a reference point, to identify gap locations (Figure 1, View B). Go to step 6.c.

8. Remove the mid driveshaft cover (450BT) ([DMC-505-A-53-50-03-00A-520A-A](#)).
9. On the whole **internal** and **external** circumference at boom stations BS 96.1 and BS 102.8, visually inspect the tailcone assembly skins for cracks and fasteners for looseness (Figure 2).

1 Area to be inspected on each side.

- a. If no cracks are found and fasteners are not found loose, go to step 10.
 - b. If cracks or loose fasteners are found, submit a Structural Repair request to Product Support Engineering (PSE) at productsupport@bellflight.com for a disposition (General Information Letter [GEN-22-154](#)). Once PSE has provided a disposition, go to step 10.

16. For tailcone assemblies that were found with any gaps greater than 0.003 inch (0.076 mm), accomplish **PART II** of this bulletin **every 50 flight hours** until the airworthiness life limitation of the tailcone assembly is reached.
