OPERATION SAFETY NOTICE

GEN-24-54

SUBJECT: NON-CONFORMING NAS9926-4L NUTS

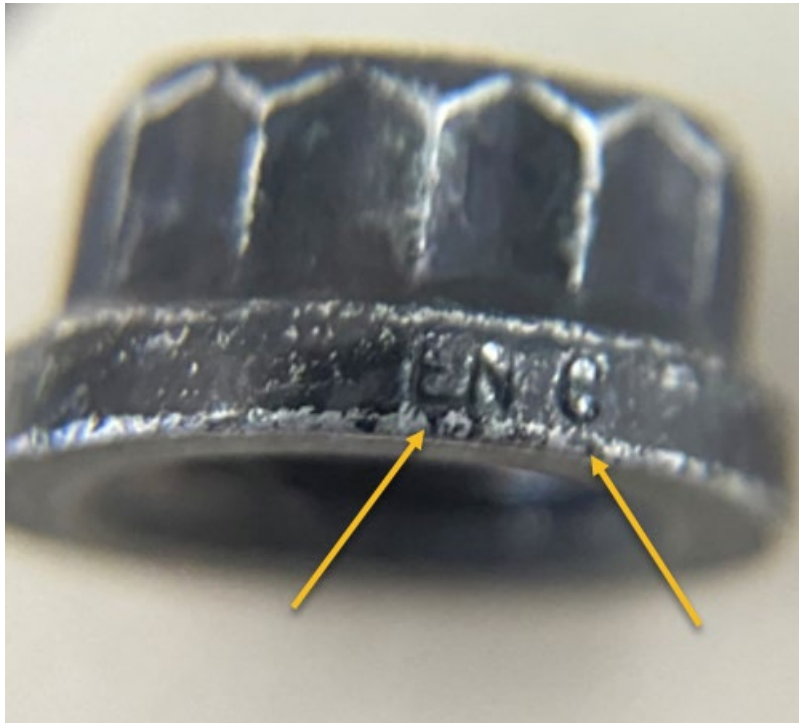
Bell and the Supplier are still investigating the root cause of the non-conformity and evaluating possible field actions. Based on findings, it has been established that only the NAS9926-4L ESNA manufactured nuts with the marking E or EN, as shown below, are suspected. Helicopters on the production assembly line are being inspected for non-conforming nuts that may have been installed. While the issue is still under investigation, Bell emphasizes the importance of measuring the tare torque of self-locking fasteners prior to installation. The criticality of following proper attaching hardware torquing procedures is also highlighted in the recently released General OSN, **GEN-24-53**. As a reminder, some components require a torque check after installation. It is important to ensure that the required torque checks are accomplished as recommended per the applicable Maintenance Manual (MM) Chapter 5, to ensure proper clamp up and security of attachment.

Figure 1. NAS9926 nut manufactured by ESNA

Note: “EN” marking indicates the manufacturer is ESNA and the letter “C” indicates CRES material.
