TECHNICAL BULLETIN
Bell Helicopter

No. 205-09-125

MODEL AFFECTED: 205

SUBJECT: TAIL ROTOR GEARBOX EXCLUDER HOUSING
LEAK: PREVENTION OF

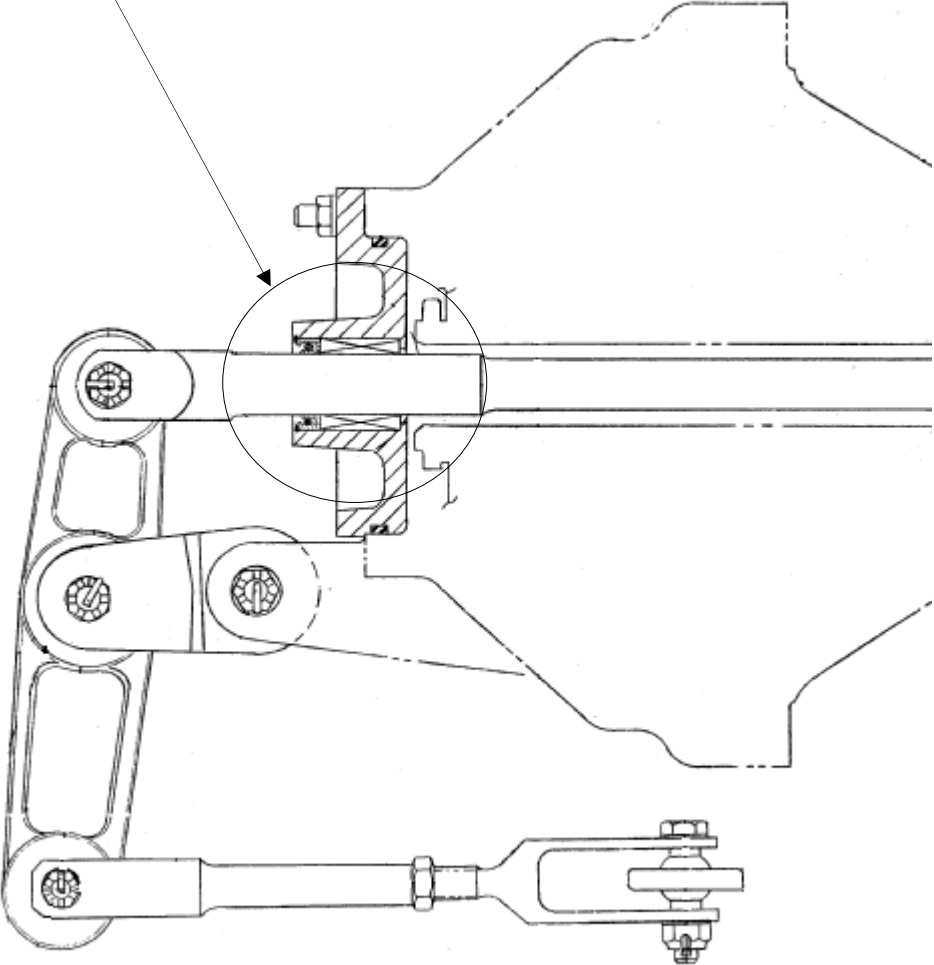
Figure 1

Recently there have been several reported cases of oil leakage from the tail rotor gearbox between the pitch change housing and the excluder housing. These occurrences have been noticed on both new production gearboxes and those with many hours in service. Sealing the metal to metal contact area between the excluder housing and the gearbox pitch change housing will eliminate the oil leakage.

1. Make helicopter ready for maintenance.
2. Refer to Figures 1 and 2. Remove retaining ring (1) and extract excluder housing (2) by applying pressure on the tail rotor controls from full right pedal to full left. (IF excluder and packing need to be replaced refer to BHT-205-MM for disassembly instructions).
3. Using a clean cloth dampened with acetone (C-316) clean inside diameter of pitch change housing (3) where excluder housing (2) will be installed.
4. Using a clean cloth clean outside diameter of excluder housing (2) with acetone (C-316) and coat with sealant (C-328).
5. Install excluder housing (2) in pitch change housing (3).
6. Using a clean cloth dampened with acetone (C-316) remove excessive sealant and reinstall retaining ring (1).
7. Make an entry in helicopter historical records indicating compliance with this technical bulletin.
