## **ALERT SERVICE BULLETIN**

**206L-24-189**

**MODEL AFFECTED:** 206L, 206L-1, 206L-3 and 206L-4

**SUBJECT:** TAIL ROTOR SEGMENTED DRIVESHAFT ASSEMBLY, ONE-TIME INSPECTION OF

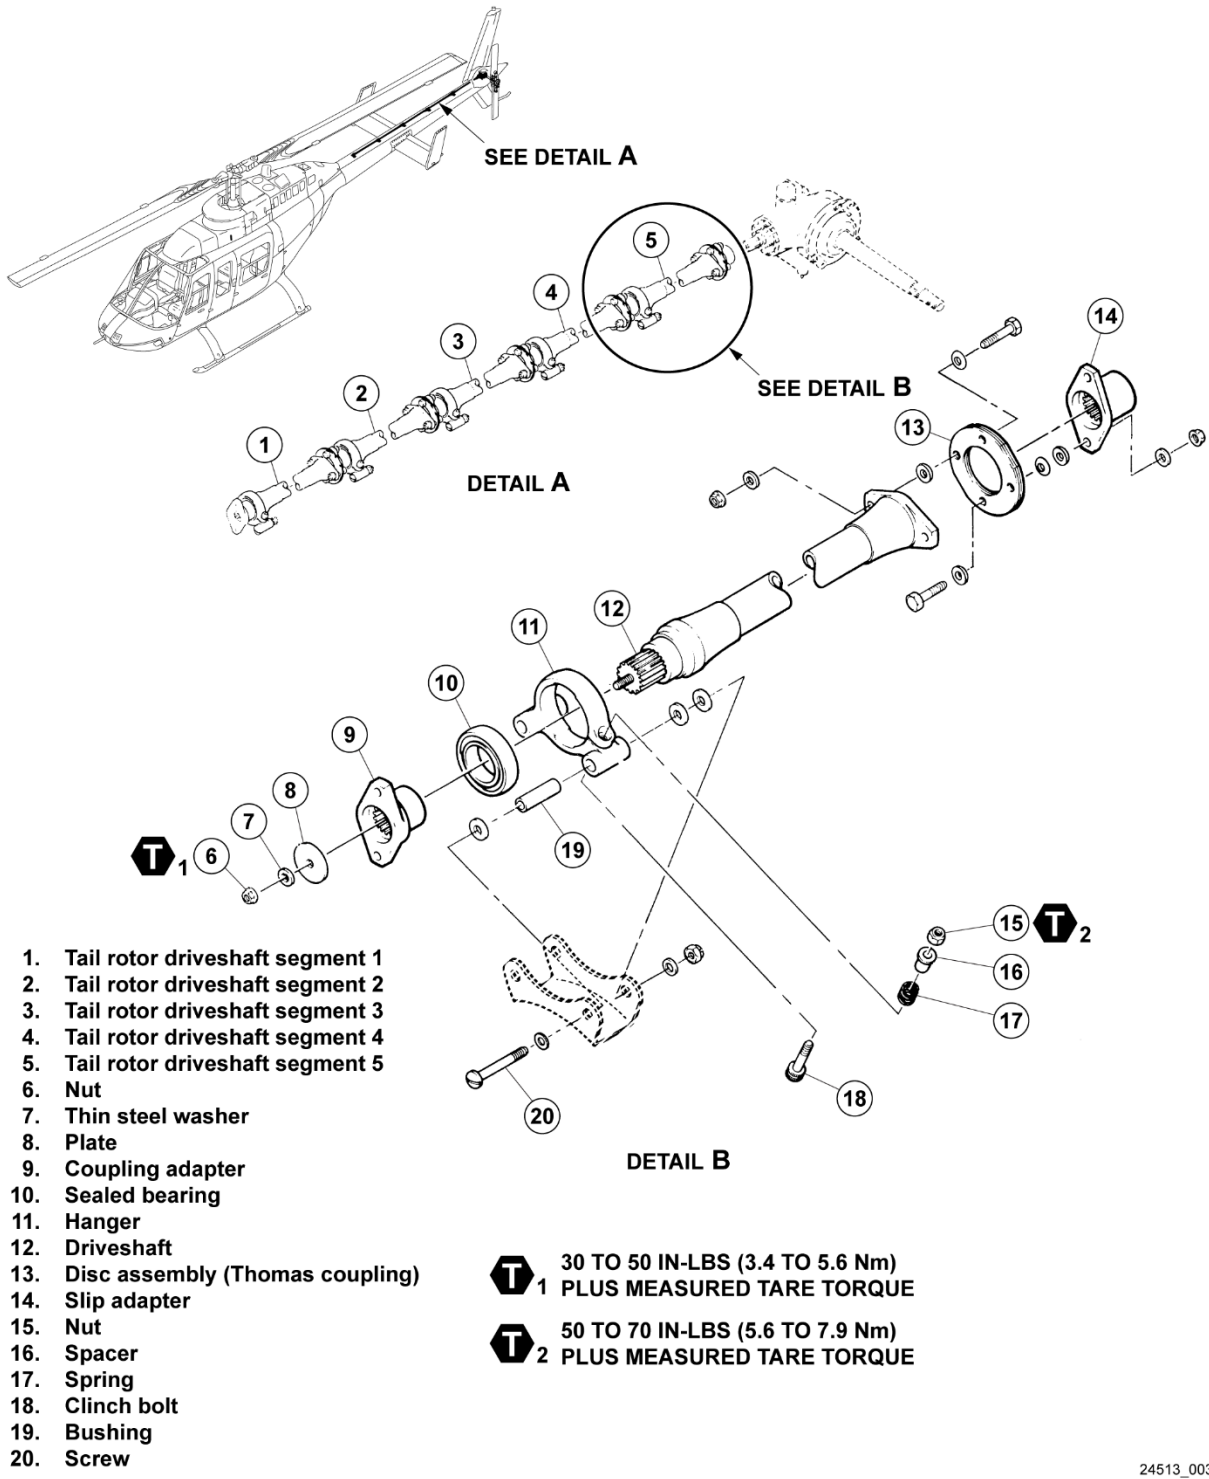
**Figure 1 – Tail Rotor Drive System**

Bell has received reports of looseness of the splined adapters on the tail rotor driveshaft segment assembly. The investigation noted that the retaining nut holding the splined adapter to the driveshaft was found with less than the required torque.

3. Inspect the tail rotor segmented driveshaft assembly splined adapters (9, Figure 1) for any noticeable axial (fore and aft) and radial play between the splined adapter (9) and the driveshaft (12) at all five locations (Figure 1).

- a. If there is no radial or axial play noted, do the following:
    - (1) Remove the aft short shaft directly aft of the fan shaft and the segmented shaft assemblies (2) and (4). Support the aft end of the segmented shaft (1) and (3) (applicable Maintenance Manual, Chapter 65).

- (2) Remove any torque seal lacquer (C-249) that may be applied to nut (6) on all five of the tail rotor segmented driveshaft assemblies.
    - (3) Unseat the nut (6) by loosening the nut by  $\frac{1}{2}$  to 1 turn at each tail rotor segmented driveshaft assemblies.

- (4) Measure the tare torque of the nut (6) using a dial indicator torque wrench.
      - (a) If the tare torque of the nut meets the minimum 3.5 inch-pounds (0.4 Nm), go to step (3.a.(5)).

- (b) If the tare torque of the nut is less than 3.5 (0.4 Nm), replace the nut with a serviceable nut and proceed to step (3.a.(4)(a)).
    - (5) Torque the nut (6) 30 to 50 inch-pounds (3.4 to 5.6 Nm) and add the measured tare torque in steps (3.a.(4)) to the specified torque.

- (6) Apply torque seal lacquer (C-249) across the threads of the stud of the driveshaft (12), the nut (6) and the plate (8). Go to step (4).
  - b. If radial or axial play is noted, perform the following:

- (a) Inspect the splined adapter (9) and splines of the driveshaft (12). Replace or repair parts if required (BHT-206L-CR&O).
- (3) Assemble the applicable tail rotor driveshaft assembly with serviceable parts (BHT-206L-CR&O).

- (a) Measure the tare torque of the nut (6) using a dial indicator torque wrench.
    - 1. If the tare torque of the nut meets the minimum value of 3.5 inch-pounds (0.4 Nm), go to step 3.b.(3)(b).

- 2. If the tare torque of the nut is less than 3.5 inch-pounds (0.4Nm), replace the nut with a serviceable nut and repeat step (3.a(4)).
  - (b) Torque the nut (6) 30 to 50 inch-pounds (3.4 to 5.6 Nm) and add the tare torque measured in step 3.a(4) to the specified torque.

- (c) Apply torque seal lacquer (C-049) across the threads of the driveshaft stud (12), the nut (6) and the plate (8).
- 4. Install the tail rotor segmented driveshaft assemblies 2 and 4 (applicable Maintenance Manual, Chapter 65).
