ALERT SERVICE BULLETIN

SUBJECT: REVISION "B" TO ALERT SERVICE BULLETIN 212-00-106: (MAIN ROTOR MAST 204-011-450-007/-105/-113/-119 INSPECTION AND RETIREMENT INDEX NUMBER RIN REDUCTION)

NO. 212-00-106
DATE 04-24-00
PAGE 1 of 14

SUBJECT: MAIN ROTOR MAST, P/N 204-011-450-007/ -105/ -113/ -119, INSPECTION AND RETIREMENT INDEX NUMBER (RIN) LIFE REDUCTION

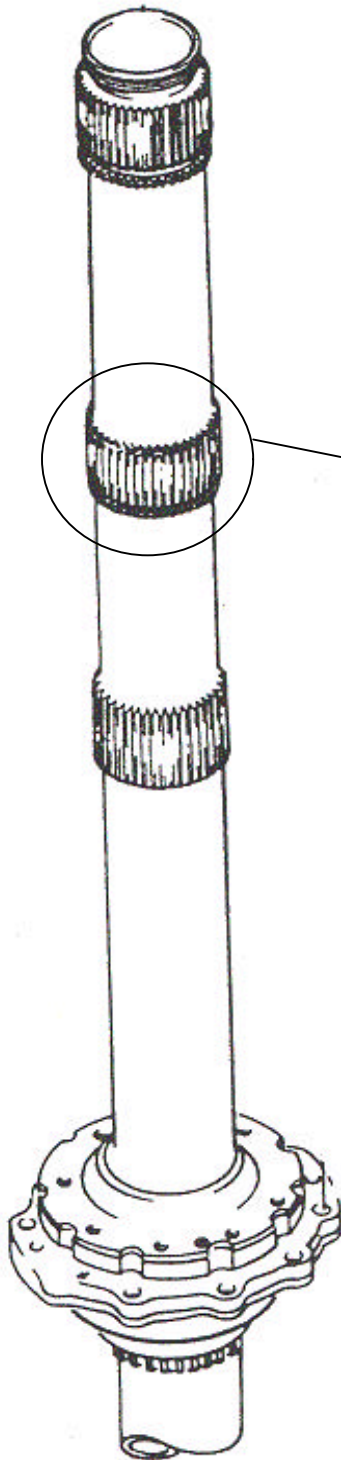
Figure 1

Inspect area for:

- At 100X minimum magnification
Minimum radius of 0.020 in the
upper and lower snap ring groove,
entire circumference
- At 200X minimum magnification
Burr in the snap ring groove/spline
intersection, all places

Main rotor mast 204-011-450-007/-105

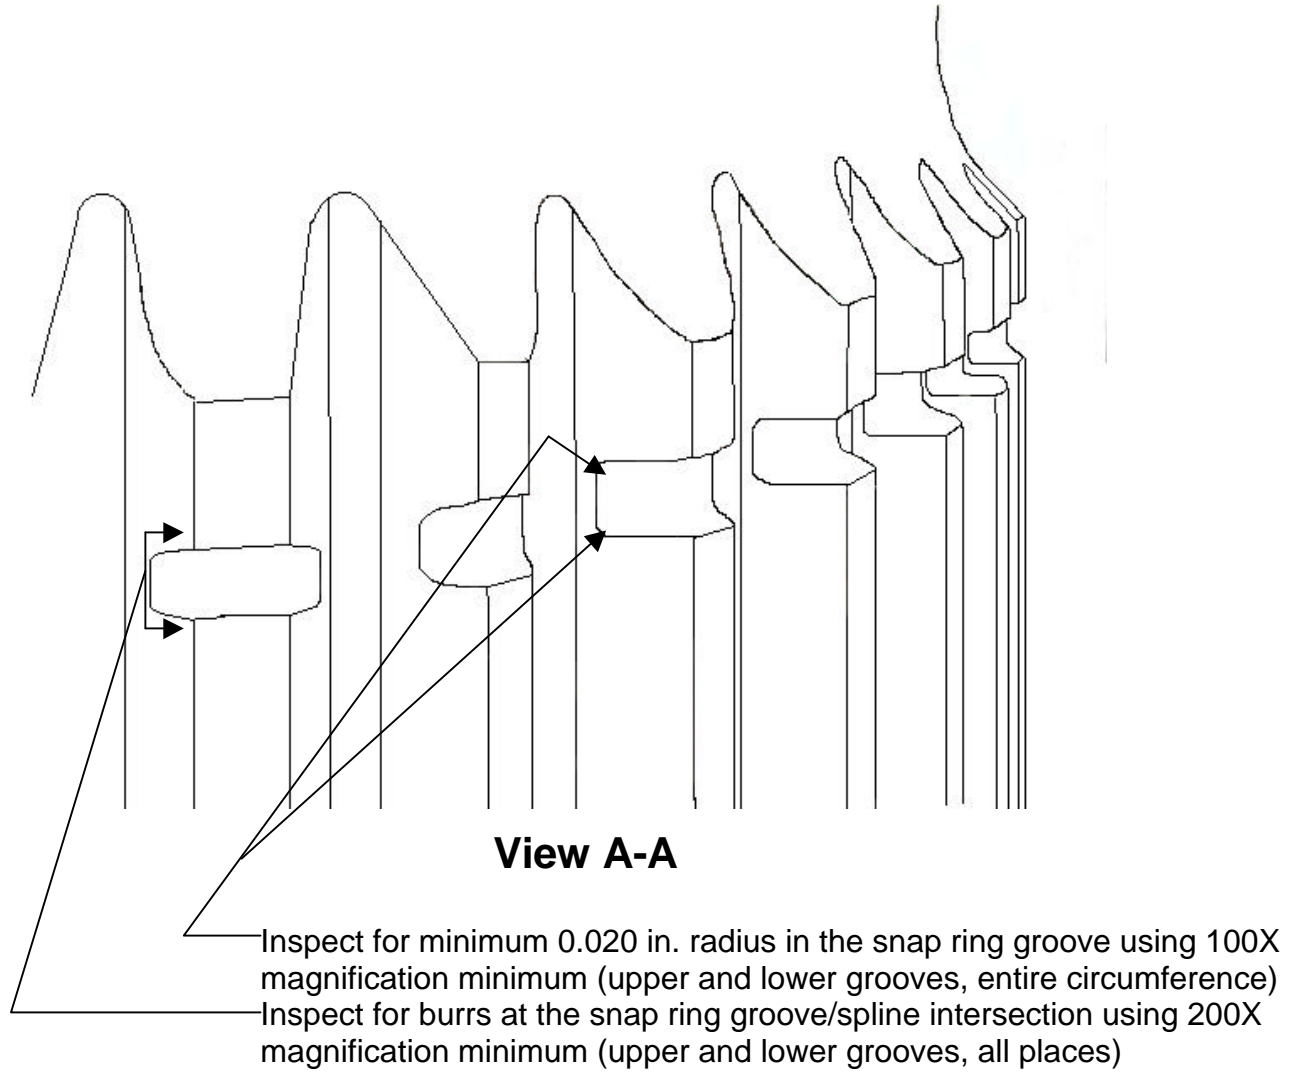
Figure 2
Snap ring groove / spline intersection

- 1. Inspect the mast snap ring upper and lower grooves (entire circumference) for a minimum radius of 0.020 (figure 2, and figure 3 view A-A). Any mast that has indications of a radius less than 0.020 shall apply a 165,000 RIN penalty to the mast.

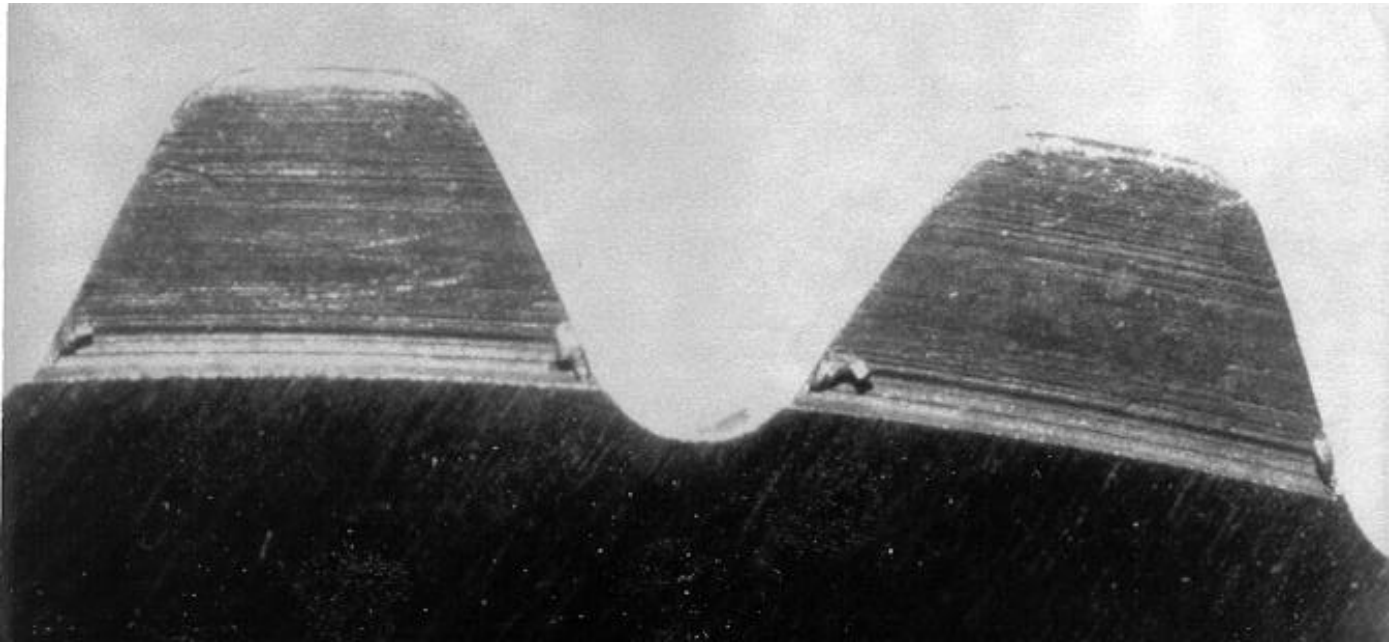
FIGURE 3
Typical Burr at Snap Ring Groove

2. Inspect the mast snap ring upper and lower grooves for indications of burrs at all intersections with splines (see figure 3 view A-A, and figure 4). Any mast that has indications of a burr shall apply a 95,000 RIN penalty to the mast. Burr removal should not be accomplished.
3. Masts not exhibiting insufficient radius or burrs in the snap ring groove may continue in service until reaching the revised retirement of 265,000 RINs / 15,000 hours.
4. Annotate Historical Service Records showing compliance with this bulletin.

Cutaway View looking down from inside snap ring groove
Typical burrs at snap ring groove/spline intersection
Burrs are to be inspected at 200X minimum magnification
