## **ALERT SERVICE BULLETIN**

**205-24-122**

**MODEL AFFECTED:** 205A/205A-1

**SUBJECT:** INSPECTION OF CAP ANGLE, P/N 205-030-207-005, INTRODUCTION, OF.

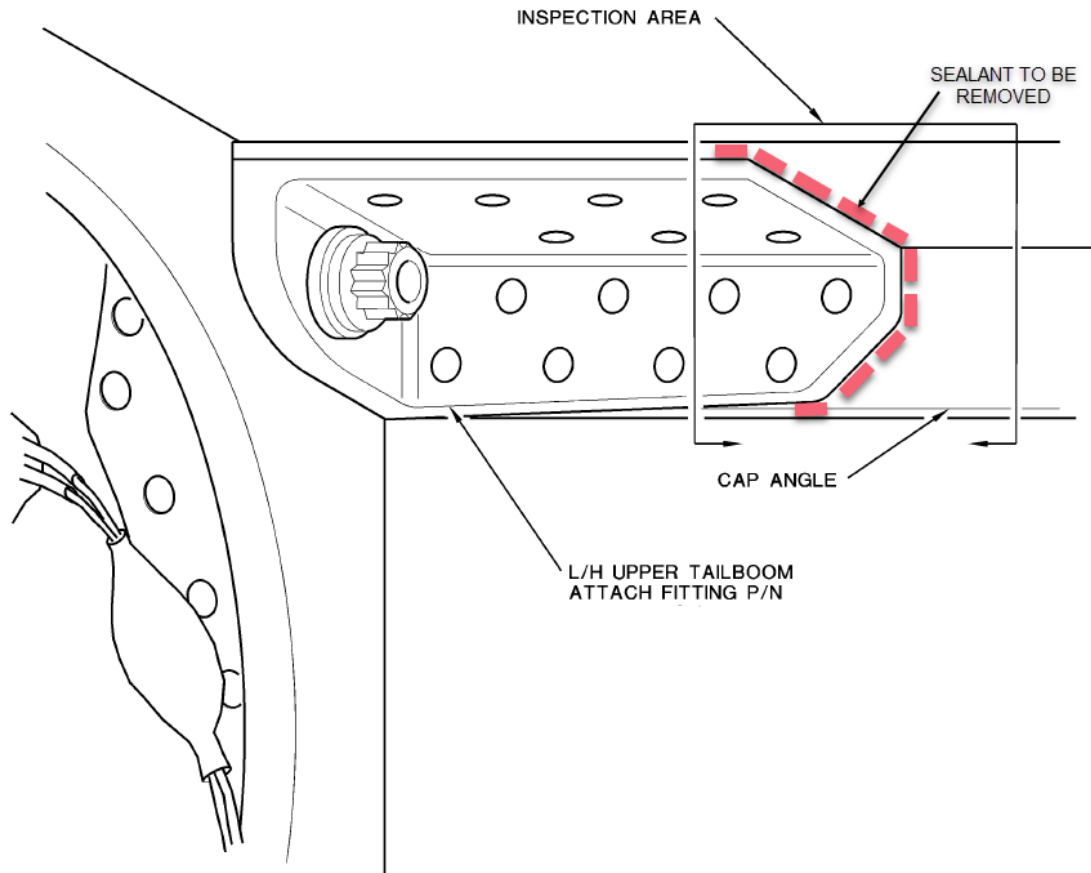
**Figure1. Fuselage Tailboom Attachment Inspection.**

Bell has investigated reports of fractured 212-030-191-001 cap angles. Some were found during routine inspection and some during the scheduled 100 Hours Tailboom Attachment Inspection. The investigation indicates that the model 412/412EP 100 flight hour Special Inspection interval established in 2000, introduced by the ASB 412-00-100 and the FAA AD 2000-18-09, is not adequate to detect all cracks before complete fracture of the cap angle. Back in 2000, no ASB was released to mandate the tailboom attachment Special Inspection on the Model 205A/205A-1. Since the risk of cracking/fracture exists on the 205-030-207-005 cap angle used on the model 205A/205-A1, this ASB introduces a recurring 25 flight hours tailboom attachment inspection. The Maintenance Manual Chapter 5 Special Inspections section will be revised to include this 25 Hours Tailboom Attachment Inspection.

2. If sealant is present, remove sealant from edge of fitting (Figure 1).
3. Inspect the cap angle area shown with a 10x magnifying glass and bright light.
4. If a crack is found, replace the cap angle before further flight. If the helicopter is at a location where the cap angle cannot be replaced, contact Product Support Engineering.
5. Touch up primer if damaged during sealant removal. Paint touch up is optional. Do not reapply sealant.
6. If no cracks are found, the helicopter can be returned to service.
7. Make an entry in the helicopter logbook and historical service records indicating findings and compliance with this Alert Service Bulletin.
