ALERT SERVICE BULLETIN

205B-08-51

MODEL AFFECTED: 205B

SUBJECT: MAIN ROTOR BLADE 212-015-501-005, -111, -113, -115, -117, -119 AND -121, INSPECTION OF.

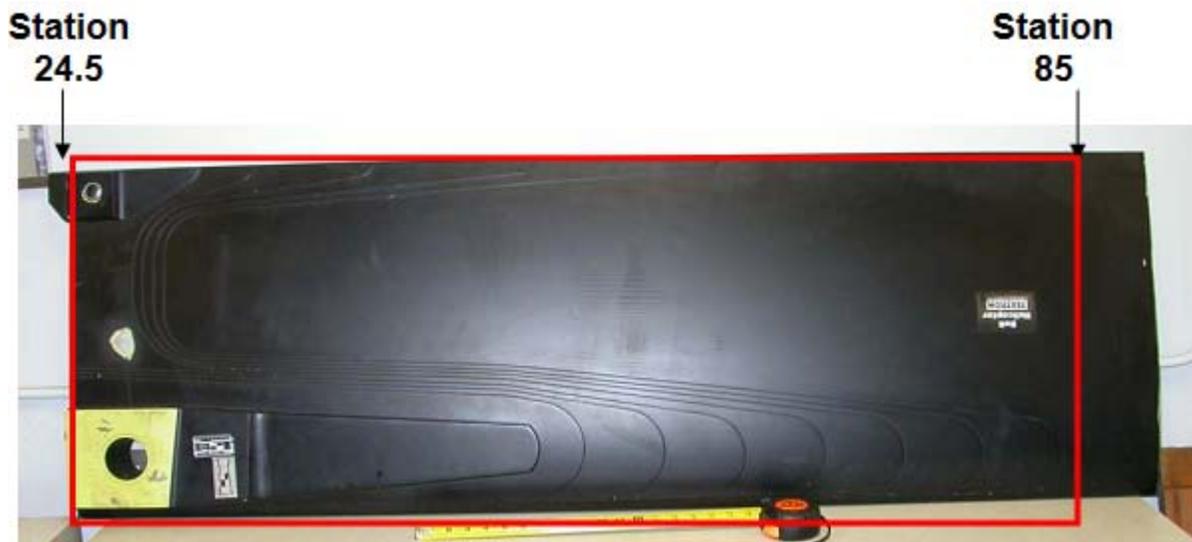
Figure 1 - Area to be inspected with 3X Power Magnifying Glass (Upper and Lower Surfaces)

4. Carry out a detailed visual inspection of the top and bottom inspection areas of the blade with a 3X power magnifying glass and a strong light source. Refer to Figure 1. Check for evidence of a dark line between the doublers, grip plates, and skin with excess alcohol bleeding out of possible edge voids. Any cracks in the finish must be investigated further by removing paint in the affected areas. Sand the affected area in a spanwise direction with an abrasive cloth or paper (C-406) 180 to 220 grit to determine if the grip plate/doublers are cracked or voided. Any crack in the paint finish, which follows the grip plate/doublers outline, may indicate a possible edge void.

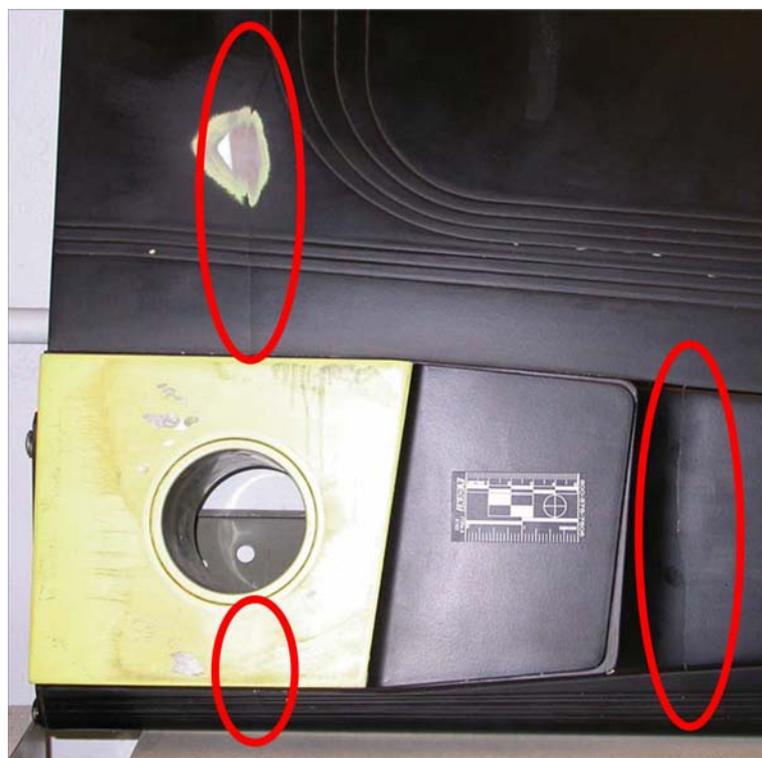
Figure 2 - Crack indications

6. If cracks in the grip plate/doublers are found, the affected blade must be immediately removed from service. If no cracks are detected, continue with step 7.
7. If edge voids between the grip plate/doublers/skin are found, determine the depth and length with a 0.0015 inch (0.038 mm) feeler gauge. If edge voids are suspected near the outboard tip of the grip plate/doublers, carry out a tap test of the affected area. Refer to the BHT-212-CR&O, 62-8 through 62-10 for void repair limits and inspection/repair instructions. If no voids are detected, continue with step 8.
8. Refinish the sanded area as per the BHT-212-CR&O, Chapter 62.
9. Following the inspection, apply a light coat of preservative oil (C-125) to all surfaces of blade.
10. Make an entry in the helicopter logbook and historical service records indicating findings and compliance with this Alert Service Bulletin.

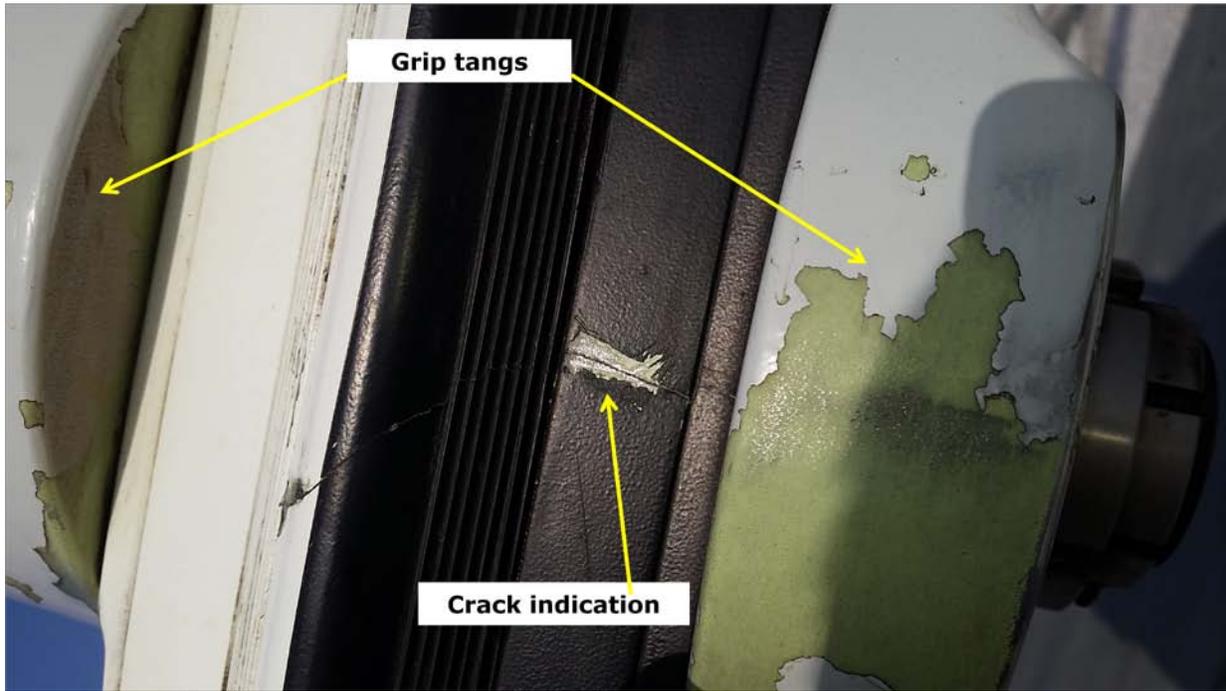
Figure 3 - Crack indication

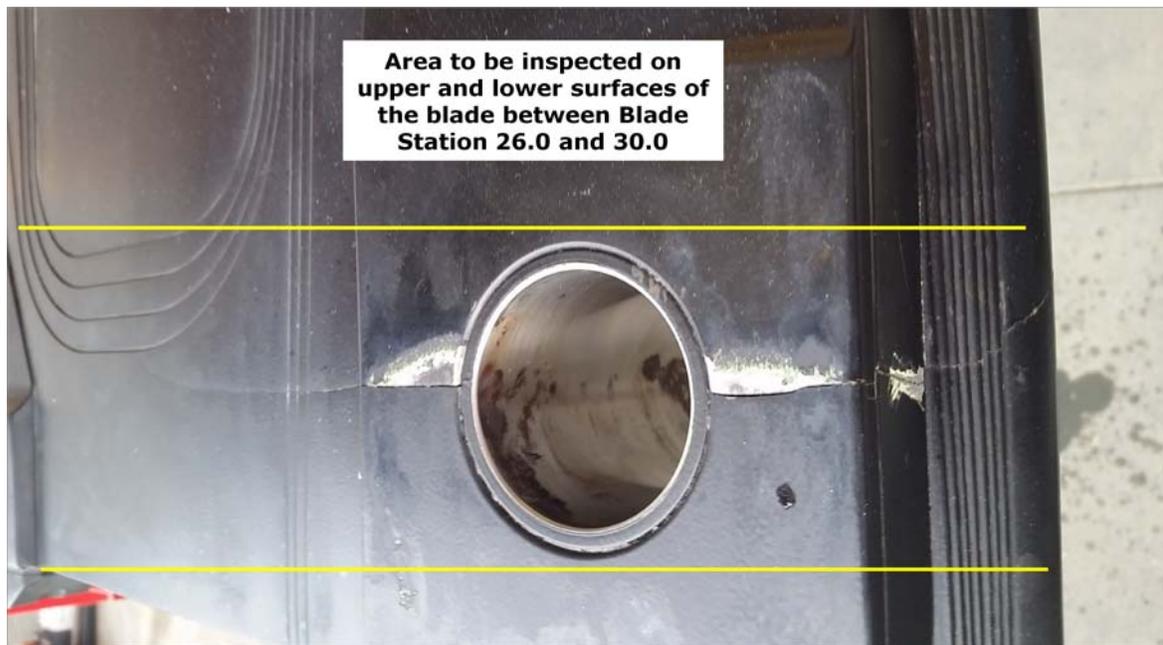
Figure 4 - Area to be inspected with a 10X Power Magnifying Glass (Upper and Lower Surfaces)

5. Carry out a detailed visual inspection of the top and bottom inspection areas in the blade bolt area with a 10X power magnifying glass and a strong light source (Figure 4). Inspect the leading edge and trailing edge sides of the blade at the blade bolt span station for evidence of cracks or dark lines in the grip plates going across the doublers (Figure 3). Any cracks in the finish must be investigated further by removing paint in the affected areas. Sand the affected area in a spanwise direction with an abrasive cloth or paper (C-406) 180 to 220 grit to determine if the grip plate/doublers are cracked or voided.

Note: It is not required to remove the blade for inspection. The areas under the grip tangs will not be visible.
