ALERT SERVICE BULLETIN

205B-15-64

MODEL AFFECTED: 205B

SUBJECT: MAIN ROTOR BLADE BOLT 204-011-151-001
INSPECTION, REWORK AND REPLACEMENT OF

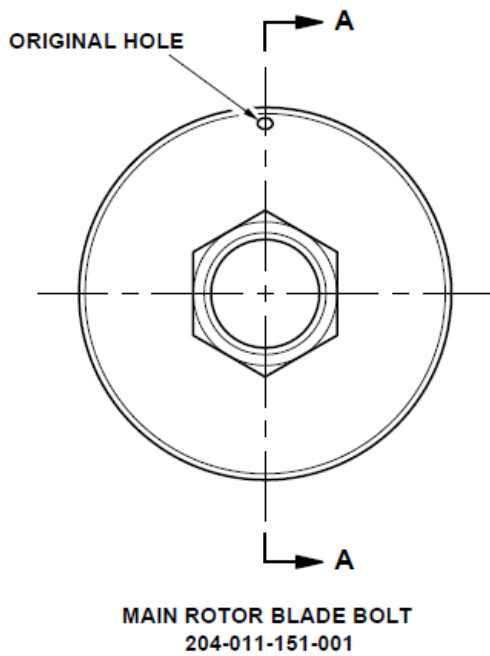
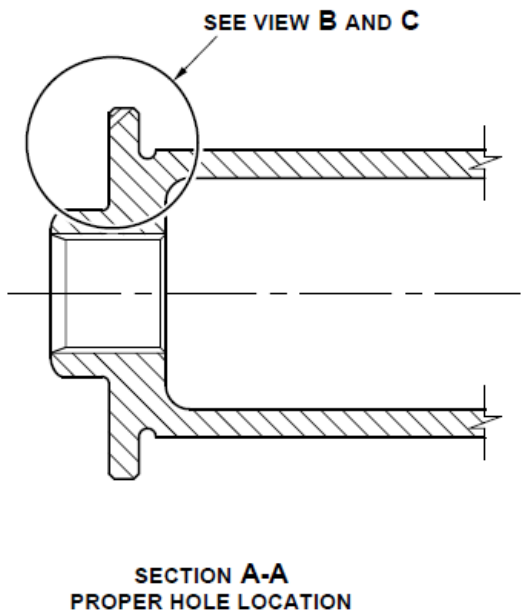
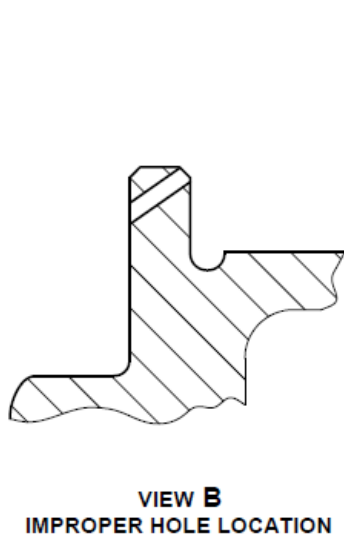
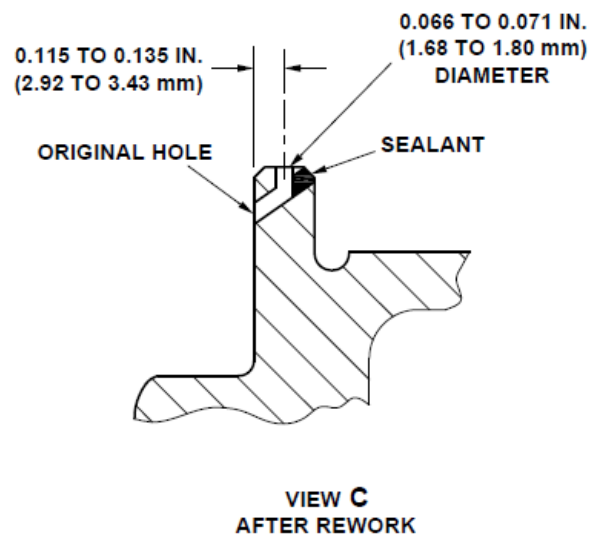
Figure 1. Main Rotor Blade Bolt Inspection and Rework

Main rotor blade bolts listed in Table 1 of the Accomplishment Instructions are suspected to have the lockwire hole for the lead weight plug incorrectly drilled. This non-conformity may prevent installation of the lockwire and lead to incorrect installation of the blade bolt. This bulletin mandates a one-time inspection for conformity of the affected blade bolts listed in Table 1 and provides rework instructions allowing the use of these blade bolts. After rework, affected blade bolts will require a repetitive 300 flight hours inspection of the reworked area. As a terminating action to this repetitive inspection, the reworked blade bolts will require replacement. As an alternative option to the rework, defective blade bolts that have not been installed and/or reworked can be returned to Bell Helicopter as "new part return" and a credit will be offered. Applicability of this bulletin to any spare part shall be determined prior to its installation on an affected helicopter.

1. Verify if any of the blade bolts listed in Table 1 are installed on a helicopter or in spare stock. If none of the blade bolts listed in Table 1 are found installed or in spares stock, go to step 3.
2. Blade bolts listed in Table 1 that have the safety wire hole drilled as shown in Figure 1, Section A-A, conform to the approved engineering. Go to step 3.
3. Make an entry in the helicopter logbook and historical service records indicating findings and compliance with this Alert Service Bulletin.
4. Blade bolts listed in Table 1 that have the safety wire hole drilled incorrectly as shown in Detail B, can either be returned to Bell Helicopter as “new part return”, or reworked as follows:

- a. Radially mark the location of the existing lockwire hole on the flange with a marker (Figure 1).
- b. Drill a 0.066 to 0.071 inch (1.68 to 1.80 mm) diameter hole in the center of the flange, as shown, to break into the existing safety wire hole.

- c. Break edges 0.0005 to 0.015 inch (0.013 to 0.38 mm) radius or 0.0005 to 0.015 inch (0.013 to 0.38 mm) x 40-50°.
- d. Verify the intersection of the two bolt holes with a 10X magnifying glass to ensure it is free of burrs or knife edges and that the opposing hole has no damage.
- e. Insert a piece of safety wire in the new hole that exits the upper surface of the flange and fill the lower end of the original safety wire hole with sealant (C-251). Make sure the sealant is flush with the end of the hole and the flange.
- f. Remove the piece of safety wire prior to sealant curing. Once the sealant has cured, fill and drain the new safety wire hole with primer (C-204).
- g. Reidentify the part number on the blade bolt assembly by adding the letter "R" after the last three digits using a permanent marker (i.e., 204-011-151-001R).
