ALERT SERVICE BULLETIN

205B-15-65

MODEL AFFECTED: 205B

SUBJECT: TAIL ROTOR FLIGHT CONTROL TUBE 212-001-055-101 AND BEARING DAS4-14A1-512, INSPECTION OF.

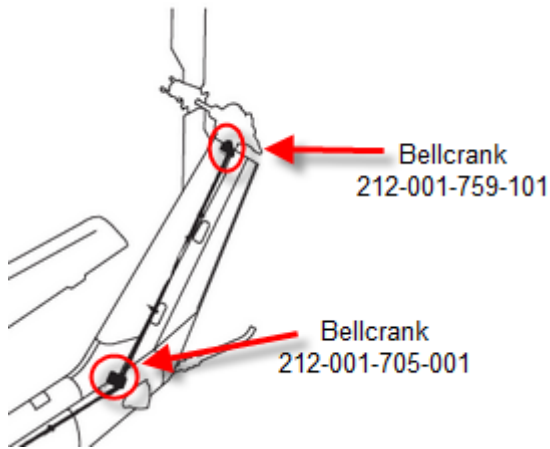
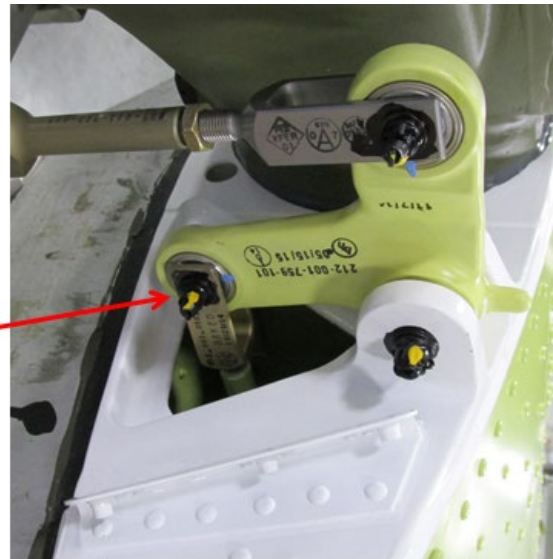
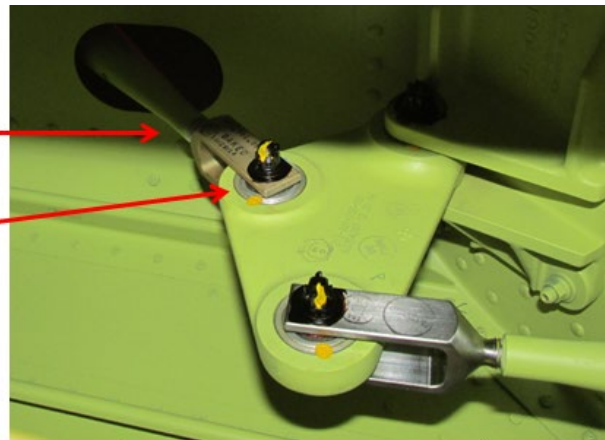
Figure 1

Bell Helicopter received a report of a tail rotor control tube 212-001-055-101 found cracked (Ref. OSN 205B-15-18). The investigation revealed that the bearing DAS4-14A1-512 where the lower end of the control tube connects did not rotate freely due to excessive wear damage. This condition resulted in excessive bending loads in the control tube causing fatigue cracking. This Alert Service Bulletin mandates an initial inspection of the tube and the bearings that the control tube connects to. In addition, a recurring 300 hours/12 months Special Inspection of the tube and the affected bearings will be added to Chapter 5 of the Maintenance Manual. Applicability of this bulletin to any spare part shall be determined prior to its installation on an affected helicopter.

1. Disconnect at this location
2. Bearing to be inspected

3. Disconnect both ends of the tail rotor control tube 212-001-055-101 from the corresponding bellcranks (Figure 1).
4. Without removing the tail rotor control tube, visually inspect the flight control tube 212-001-055-101 for cracks. If a crack is found, remove the tube from service.

5. Inspect both bearings DAS4-14A1-512 for freedom of movement. Bearings shall be free to move in all directions and rotate freely. If a defective bearing is found, replace the defective bearing in accordance with the BHT-ALL-SPM.
