ALERT SERVICE BULLETIN

205B-17-67  
3 March 2017

**MODEL AFFECTED:** 205B

**SUBJECT:** **MAGNETIC BRAKE ASSEMBLY 204-001-376-003, INSPECTION AND REPAIR OF.**

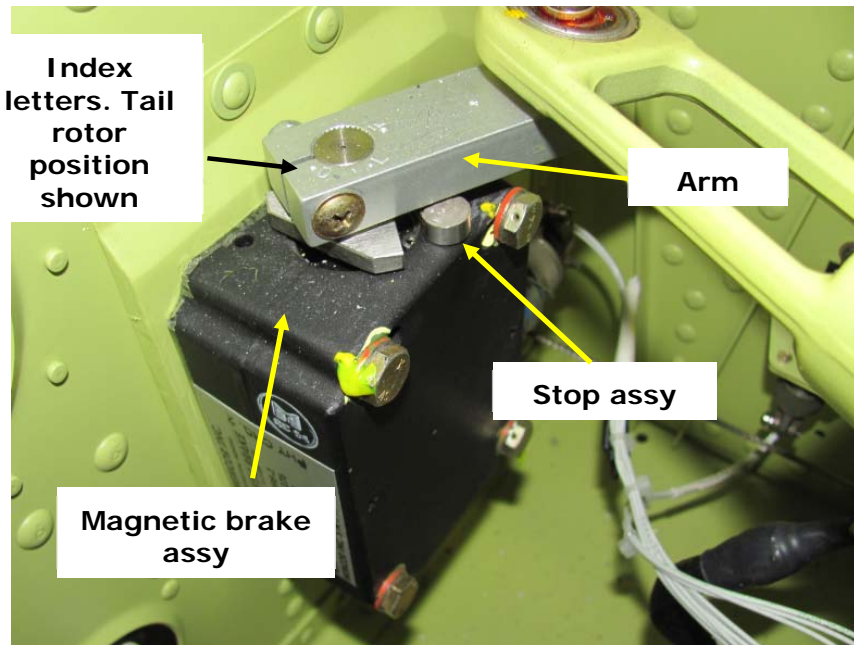
**Figure 1. Magnetic brake assembly.**

1. Prepare the helicopter for maintenance.
2. Gain access to the cyclic and tail rotor magnetic brake assembly (BHT-212-MM).
3. Perform a detailed visual inspection of the stop assemblies (Figures 1 and 2). Figures 3 and 4 show a stop assembly found disbonded.

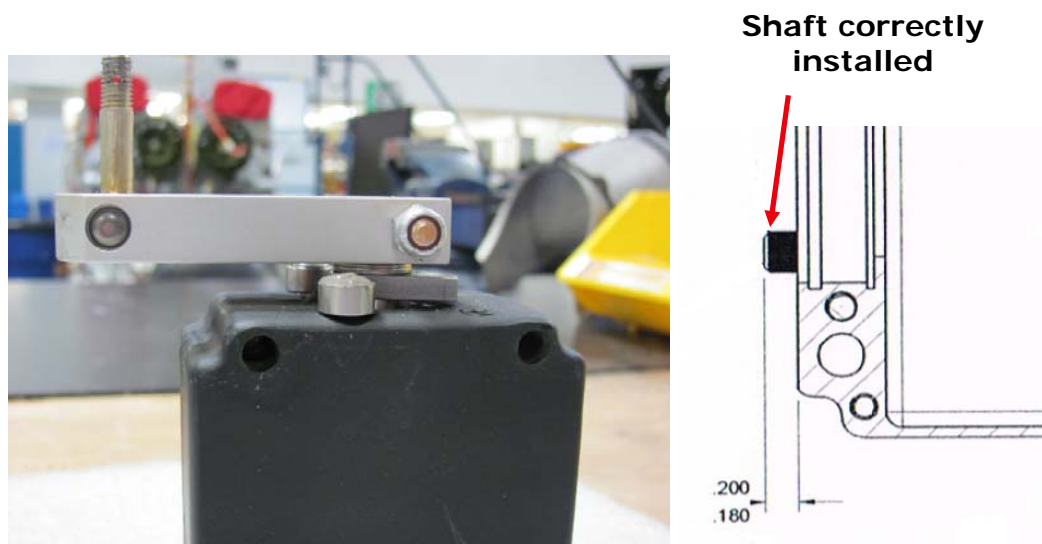
**Figure 2. Magnetic brake assembly with stops correctly installed.**

8. The shaft should protrude from the housing surface between 0.180 inch (4.57 mm) and 0.200 inch (5.08 mm) (Figure 2).
9. Allow sufficient time for the adhesive (C-317) to cure (24 hours at 21°C to 35°C (70°F to 95°F) and return the magnetic brake assembly to service.

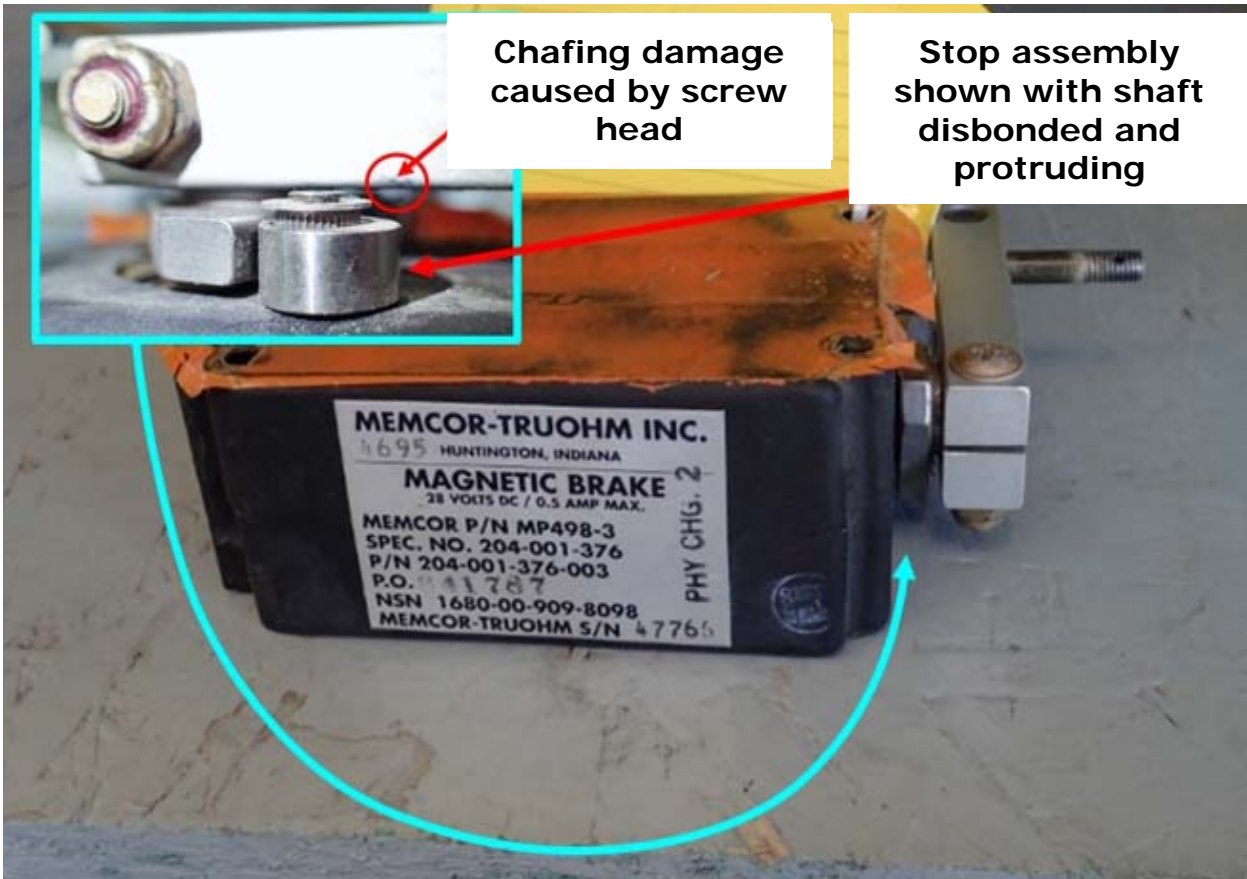
Bell Helicopter has received reports of magnetic brake assembly P/N 204-001-376-003 (Memcor-Truohm P/N MP498-3) adjustable stop assembly contacting the magnetic brake arm. With time in service, the stop assembly shaft may disbond from the housing, back out and cause interference or limit the magnetic brake arm range of motion. This condition, although not desirable, will not affect the proper function of the flight controls.

Figure 3. Stop assembly with disbonded shaft.

4. By hand, pull on the stop assembly to verify if the stop shaft is disbonded from the housing assembly.
5. If the shaft shows evidence of disbonding, inspect the lower side of the arm for possible chafing damage and accomplish Part II. The maximum allowable mechanical damage is 0.030 inch. (0.762 mm).

6. Apply adhesive (C-317) to the mating surfaces of the housing and the shaft.
7. Install the stop assembly in the housing bore and remove excess of adhesive (C-317).

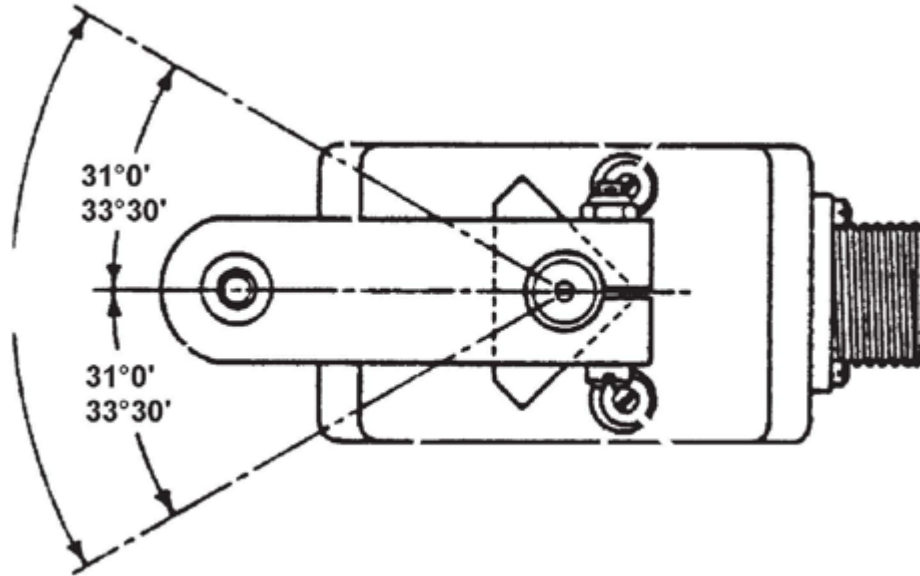
Regardless of arm letter indexing, total travel of the arm in relation to the stops is the same.

**Figure 5. Arm total travel.**

Regardless of arm letter indexing, in case the stop assemblies require adjustment for proper arm travel, refer to the Figure 5.
