ALERT SERVICE BULLETIN

205B-20-69

MODEL AFFECTED: 205B

SUBJECT: TAILBOOM LEFT HAND FIN SPAR CAP P/N 212-030-447-117, INSPECTION OF.

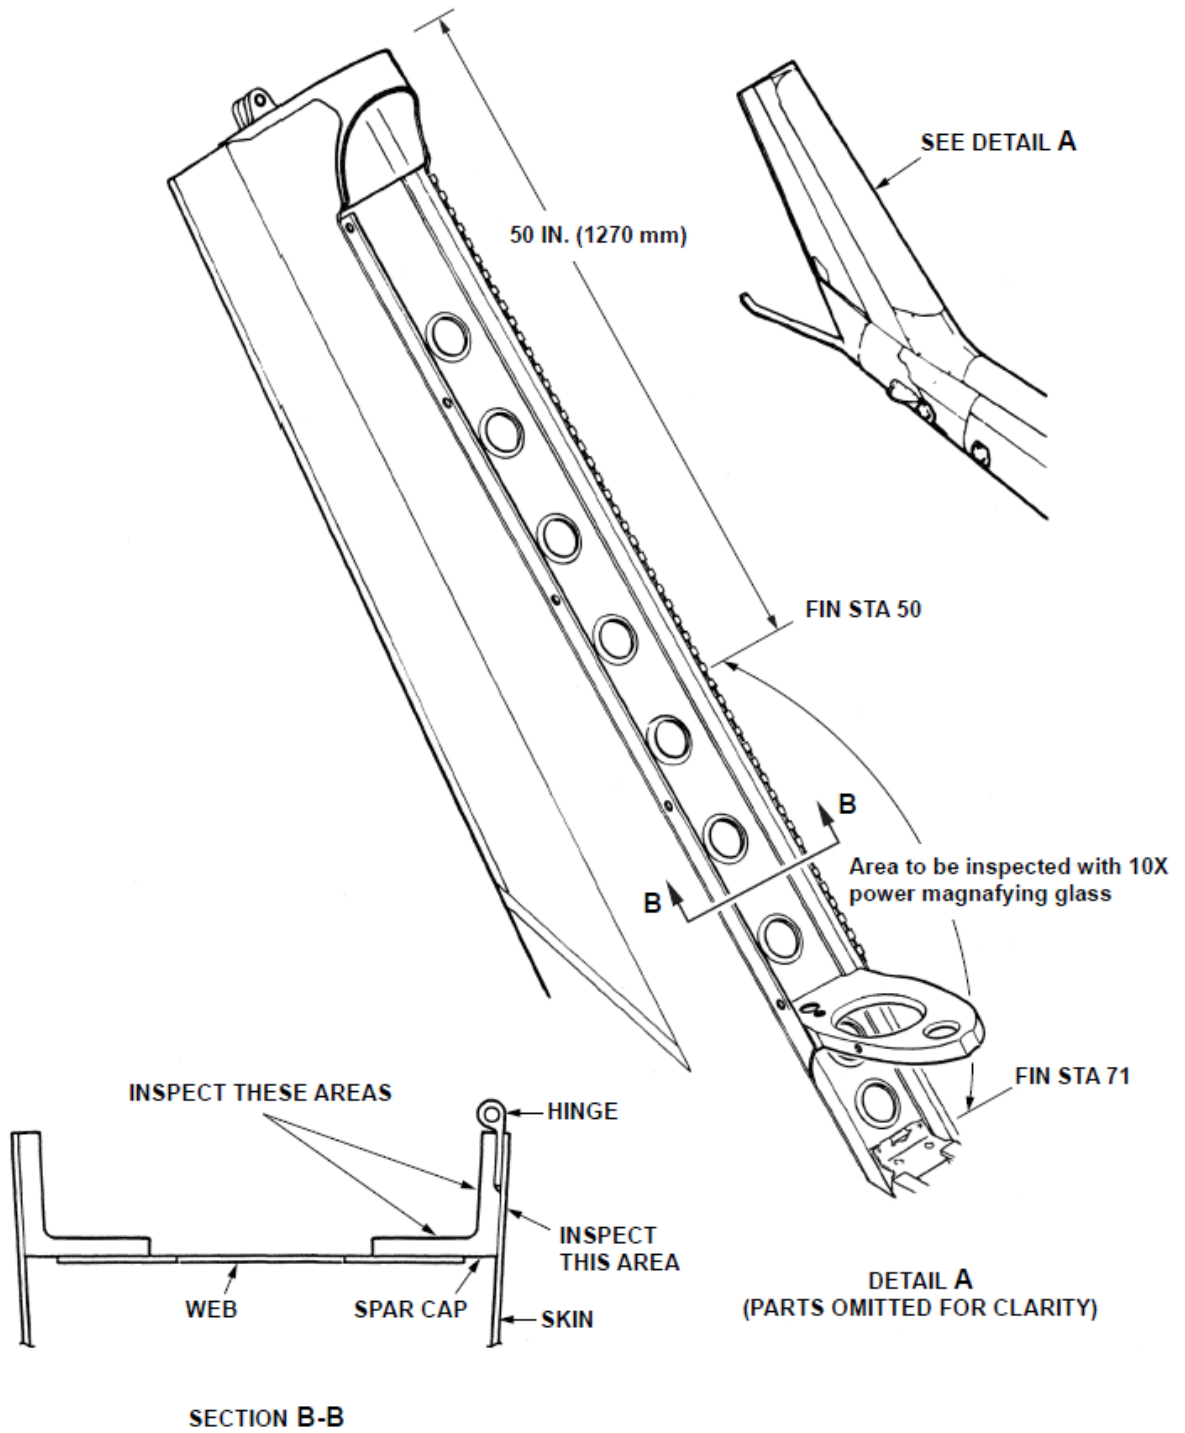
Figure 1. Spar cap inspection.

Bell has received a report of a fractured fin spar cap P/N 212-030-447-117. The crack occurred at vertical fin station (F.S.) 71 through the first rivet hole attaching the skin 212-030-099-105 to the spar cap. If undetected, the fin spar cap cracking may lead to additional structural damage. This bulletin introduces a 100 flight-hour inspection of the affected area of the fin spar cap using 10X magnifying glass.

1. Prepare the helicopter for maintenance.
2. Gain access to the spar cap angle by removing the 42-degree gearbox cover and opening the vertical fin driveshaft cover.
3. Clean exposed surfaces of spar cap to facilitate inspection.
4. Inspect both flanges of the spar cap between F.S. 50 and F.S. 71 using 10x magnifying glass and a bright light for cracks, loose rivets and other damage (Figure 1).
5. Inspect the exterior of the fin skin in the area in contact with the spar cap for cracks, loose rivets and/or distortion.
6. If no cracks or other damage is found, close the driveshaft cover, reinstall the 42-degree gearbox cover and return the helicopter to service.
7. If a crack or other damage is found, contact Product Support Engineering before further flight:
