**ALERT SERVICE BULLETIN**

**206-16-135**

**SUBJECT:** Air Conditioner Compressor Pulley Installation,  
Fastener Change

**Title:** SB 206-051616; Bell 206 Air Conditioner Compressor Pulley Install Fastener change

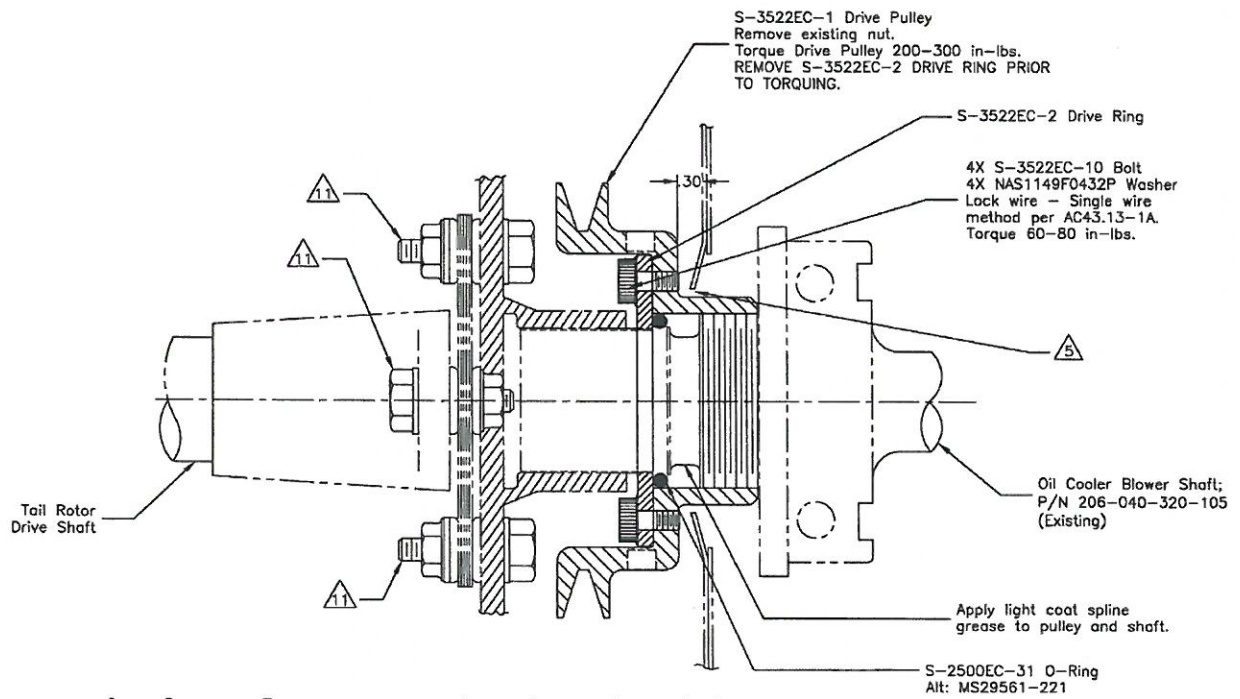
Figure 1. Compressor Pulley Installation configuration

Referring to Figure 1 on Sheet 2, the installation of the ACC air conditioning pulley onto the tail rotor drive shaft involves separating the Thomas coupling joint by removing the set of four fasteners at the joint (identified by flag note 11 in the view). The air conditioning kit has included a set of new fasteners including specialized bevel washers to replace the OEM hardware at this location. ACC has become aware that the fasteners provided in the kit were a larger diameter than the original fasteners on earlier models and therefore were unable to have been installed. The ACC supplied beveled washers however could possibly have been used with the OEM fasteners because of their larger bore size.

The required action is to verify that only the OEM fasteners are in place, including the OEM bevel washers, and that the placement and direction of the bevel washers are per the Bell Service Document 65-99-00.

The ACC drawing covering the installation of the compressor pulley has been revised to call for the replacement of the OEM fasteners as shown in note 11 of Figure 1 on sheet 2.

Re-use pre-existing hardware including bolts, flat washers, bevel washers and nuts. Install, torque and safety wire per Bell service document 65-99-00, paying special to the location and direction of the bevel washers. (Sht 11)
