ALERT SERVICE BULLETIN

206-19-137

MODEL AFFECTED: 206A/B and TH-67

SUBJECT: TAIL ROTOR BLADE ROOT END, INSPECTION OF

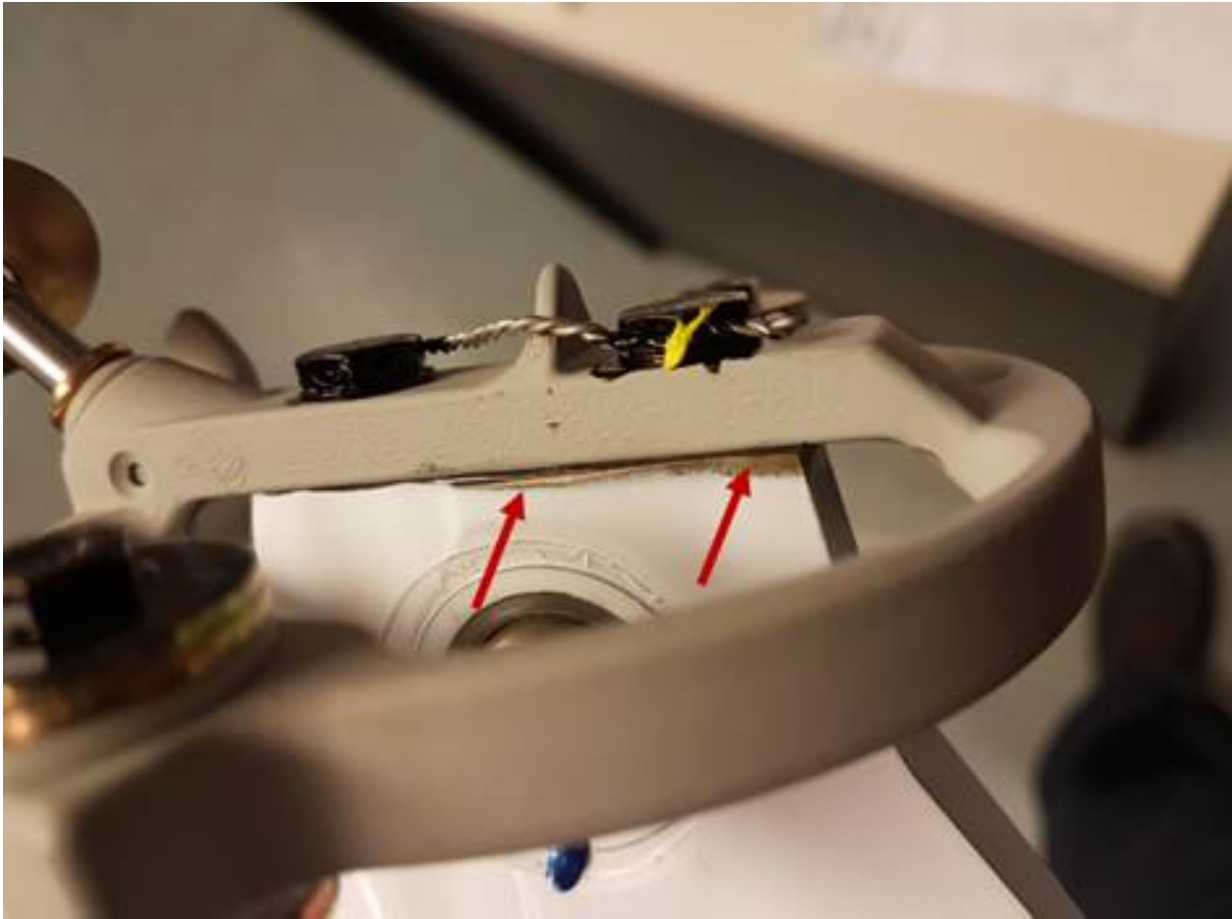
FIGURE 1 - Tail Rotor Blade Root End without Sealant

Bell has become aware of a condition that affects the installation of the pitch horn assembly to tail rotor blade root end. Per the assembly instructions, sealant is applied to cover any remaining bare unpainted sections of the tail rotor blade root end. It is possible that some tail rotor blade assemblies delivered are missing this sealant. This bulletin provides instructions to inspect for possible corrosion or damage on any exposed bare metal surfaces with a subsequent requirement to apply sealant to protect the area.

- b. Confirm there is no exposed unpainted tail rotor blade root end surfaces adjacent to the pitch horn (Figure 1).
 - c. If surfaces are found properly sealed (Figure 2), go to step 3.

- d. If some bare metal surfaces are found exposed (Figure 1), inspect for corrosion.
 - (1) If no corrosion is found, apply a smooth coat of sealant (C-308) to all sections of unpainted surfaces of tail rotor blade root end. Blend into pitch horn face and fair smooth (Figure 2). Allow sufficient time for sealant (C-308) to cure before flight. Go to step 3.
