ALERT SERVICE BULLETIN

206-24-143

MODEL AFFECTED: 206A/B and TH-67

SUBJECT: TAIL ROTOR SEGMENTED DRIVESHAFT ASSEMBLY, ONE-TIME INSPECTION OF

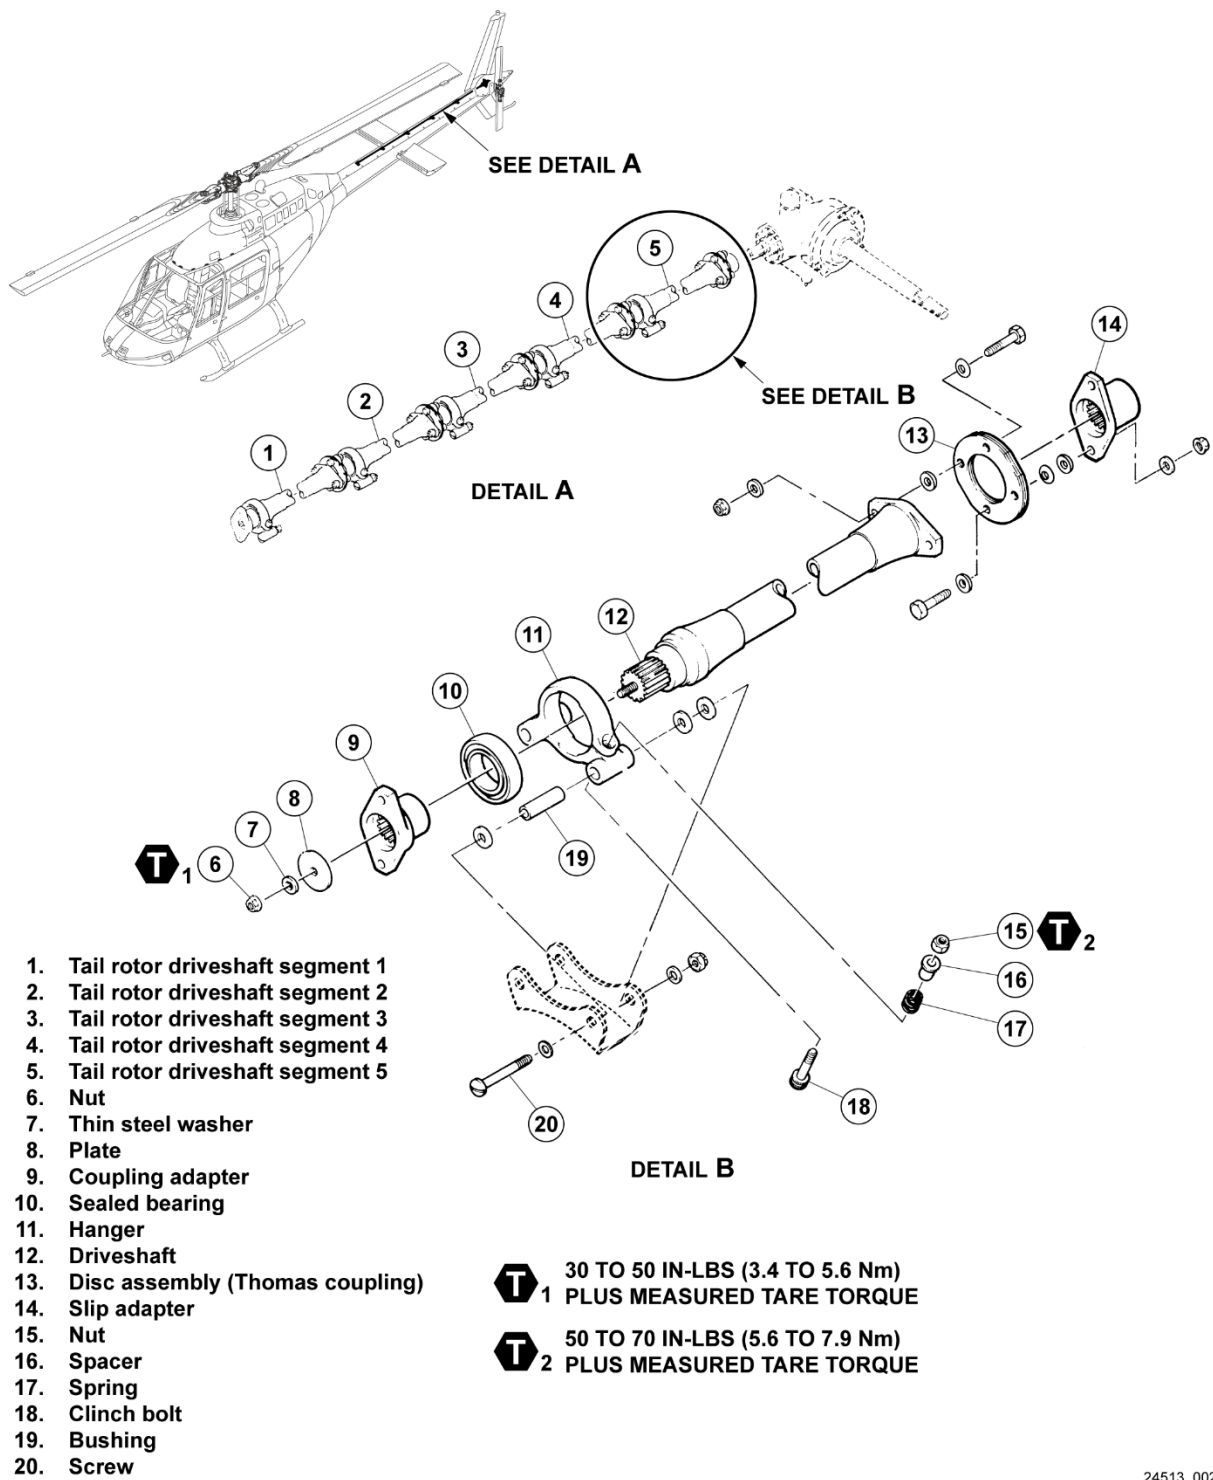
Figure 1 – Tail Rotor Drive System

Bell has received reports of looseness of the splined adapter on the tail rotor driveshaft segment assembly. The investigation noted that the retaining nut holding the splined adapter to the driveshaft was found with less than the required torque.

3. Inspect the tail rotor segmented driveshaft assembly splined adapters (9, Figure 1) for any noticeable axial (fore and aft) and radial play between the splined adapter (9) and the driveshaft (12) at all five locations (Figure 1).

This Alert Service Bulletin (ASB) is being released to require a one-time inspection and re-torque of the splined adapter retaining hardware.

- (2) Remove any torque seal lacquer (C-249) that may be applied to nut (6) on all five of the tail rotor segmented driveshaft assemblies.
 - (3) Unseat the nut (6) by loosening the nut by $\frac{1}{2}$ to 1 turn at each of the five tail rotor segmented driveshaft assemblies.

- (4) Measure the tare torque of the nut (6) using a dial indicator torque wrench.
 - (a) If the tare torque of the nut meets the minimum 3.5 inch-pounds (0.4 Nm), go to step (3.a.(5)).

- (b) If the tare torque of the nut is less than 3.5 (0.4 Nm), replace the nut with a serviceable nut and proceed to step (3.a.(4)(a)).
 - (5) Torque the nut (6) 30 to 50 inch-pounds (3.4 to 5.6 Nm) and add the measured tare torque in steps (3.a.(4)) to the specified torque.

- (6) Apply torque seal lacquer (C-249) across the threads of the stud of the driveshaft (12), the nut (6) and the plate (8). Go to step (4).
 - b. If radial or axial play is noted, perform the following:

- (a) Inspect the splined adapter (9) and splines of the driveshaft (12). Replace or repair parts if required (BHT-206B3-CR&O).
- (3) Assemble the applicable tail rotor driveshaft assembly with serviceable parts (BHT-206B3-CR&O).
