## ALERT SERVICE BULLETIN

**206-24-144**

**MODEL AFFECTED:** 206A/B and TH-67

**SUBJECT:** SWASHPLATE OUTER RING AND COLLECTIVE LEVER, CLEARANCE CHECK OF

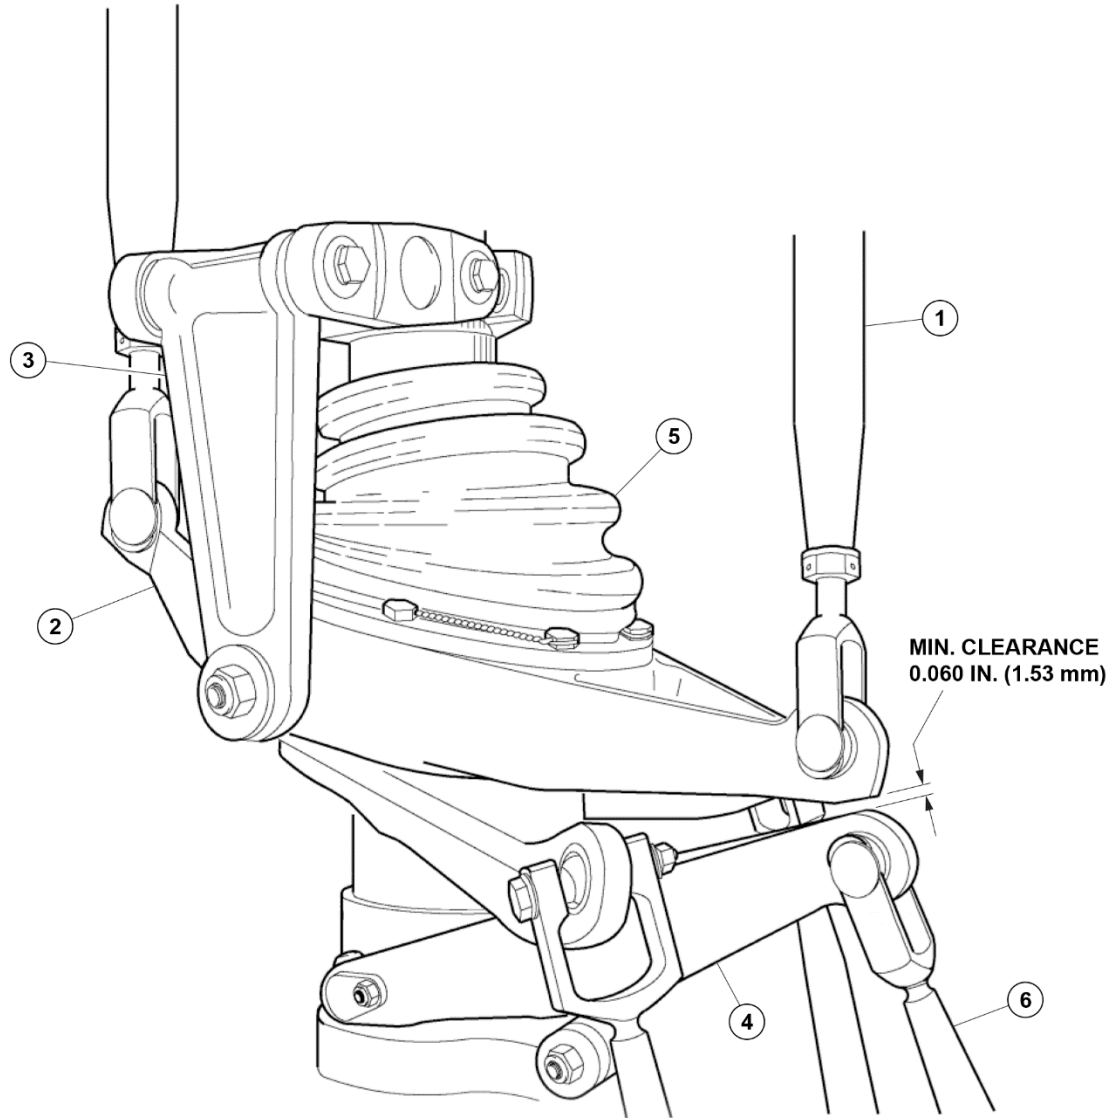
**Figure 1 - Collective lever assembly - clearance check**

Bell has received reports of swashplate drive collar set fracture due to contact between the swashplate outer ring and collective lever assembly. Incorrect rigging and lack of clearance check between the swashplate outer ring and the collective lever are the suspected root causes. **PART I** of this ASB mandates a one-time clearance check for proper clearance between the swashplate outer ring and the collective lever. **PART II** introduces a new requirement to ensure proper clearance is achieved between the swashplate outer ring and the collective lever after accomplishment of main rotor flight controls rigging. All applicable Maintenance Manuals (MM) will be revised to incorporate the new clearance check requirement.

When rotating the swashplate outer ring, make sure it does not contact the collective lever assembly. If contact is made, damage to the outer ring and collective lever can occur.

7. Slowly rotate the swashplate outer ring (2, Figure 1) until one of the pitch link attachment points is directly over the collective lever assembly (4).

8. Measure and record the clearance between the collective lever assembly (4) and the swashplate outer ring (2).
9. Repeat steps 7 and 8 for the second pitch link attachment point.

10. If clearance is 0.060 inch (1.53mm) or more at both pitch link attachment points, go to step 12.
11. If clearance is less than 0.060 inch (1.53 mm) at one or both pitch link attachment points, rigging of the collective and cyclic flight controls (BHT-206A/B-SERIES-MM, Chapter 67) is required prior to next flight.
